# **GEOTECHNICAL INVESTIGATION AND PEER REVIEW**

**VALLEJO PROPERTIES – VISTA COVE**  
VALLEJO, CALIFORNIA

**PRELIMINARY GEOTECHNICAL EXPLORATION**

September 12, 2022

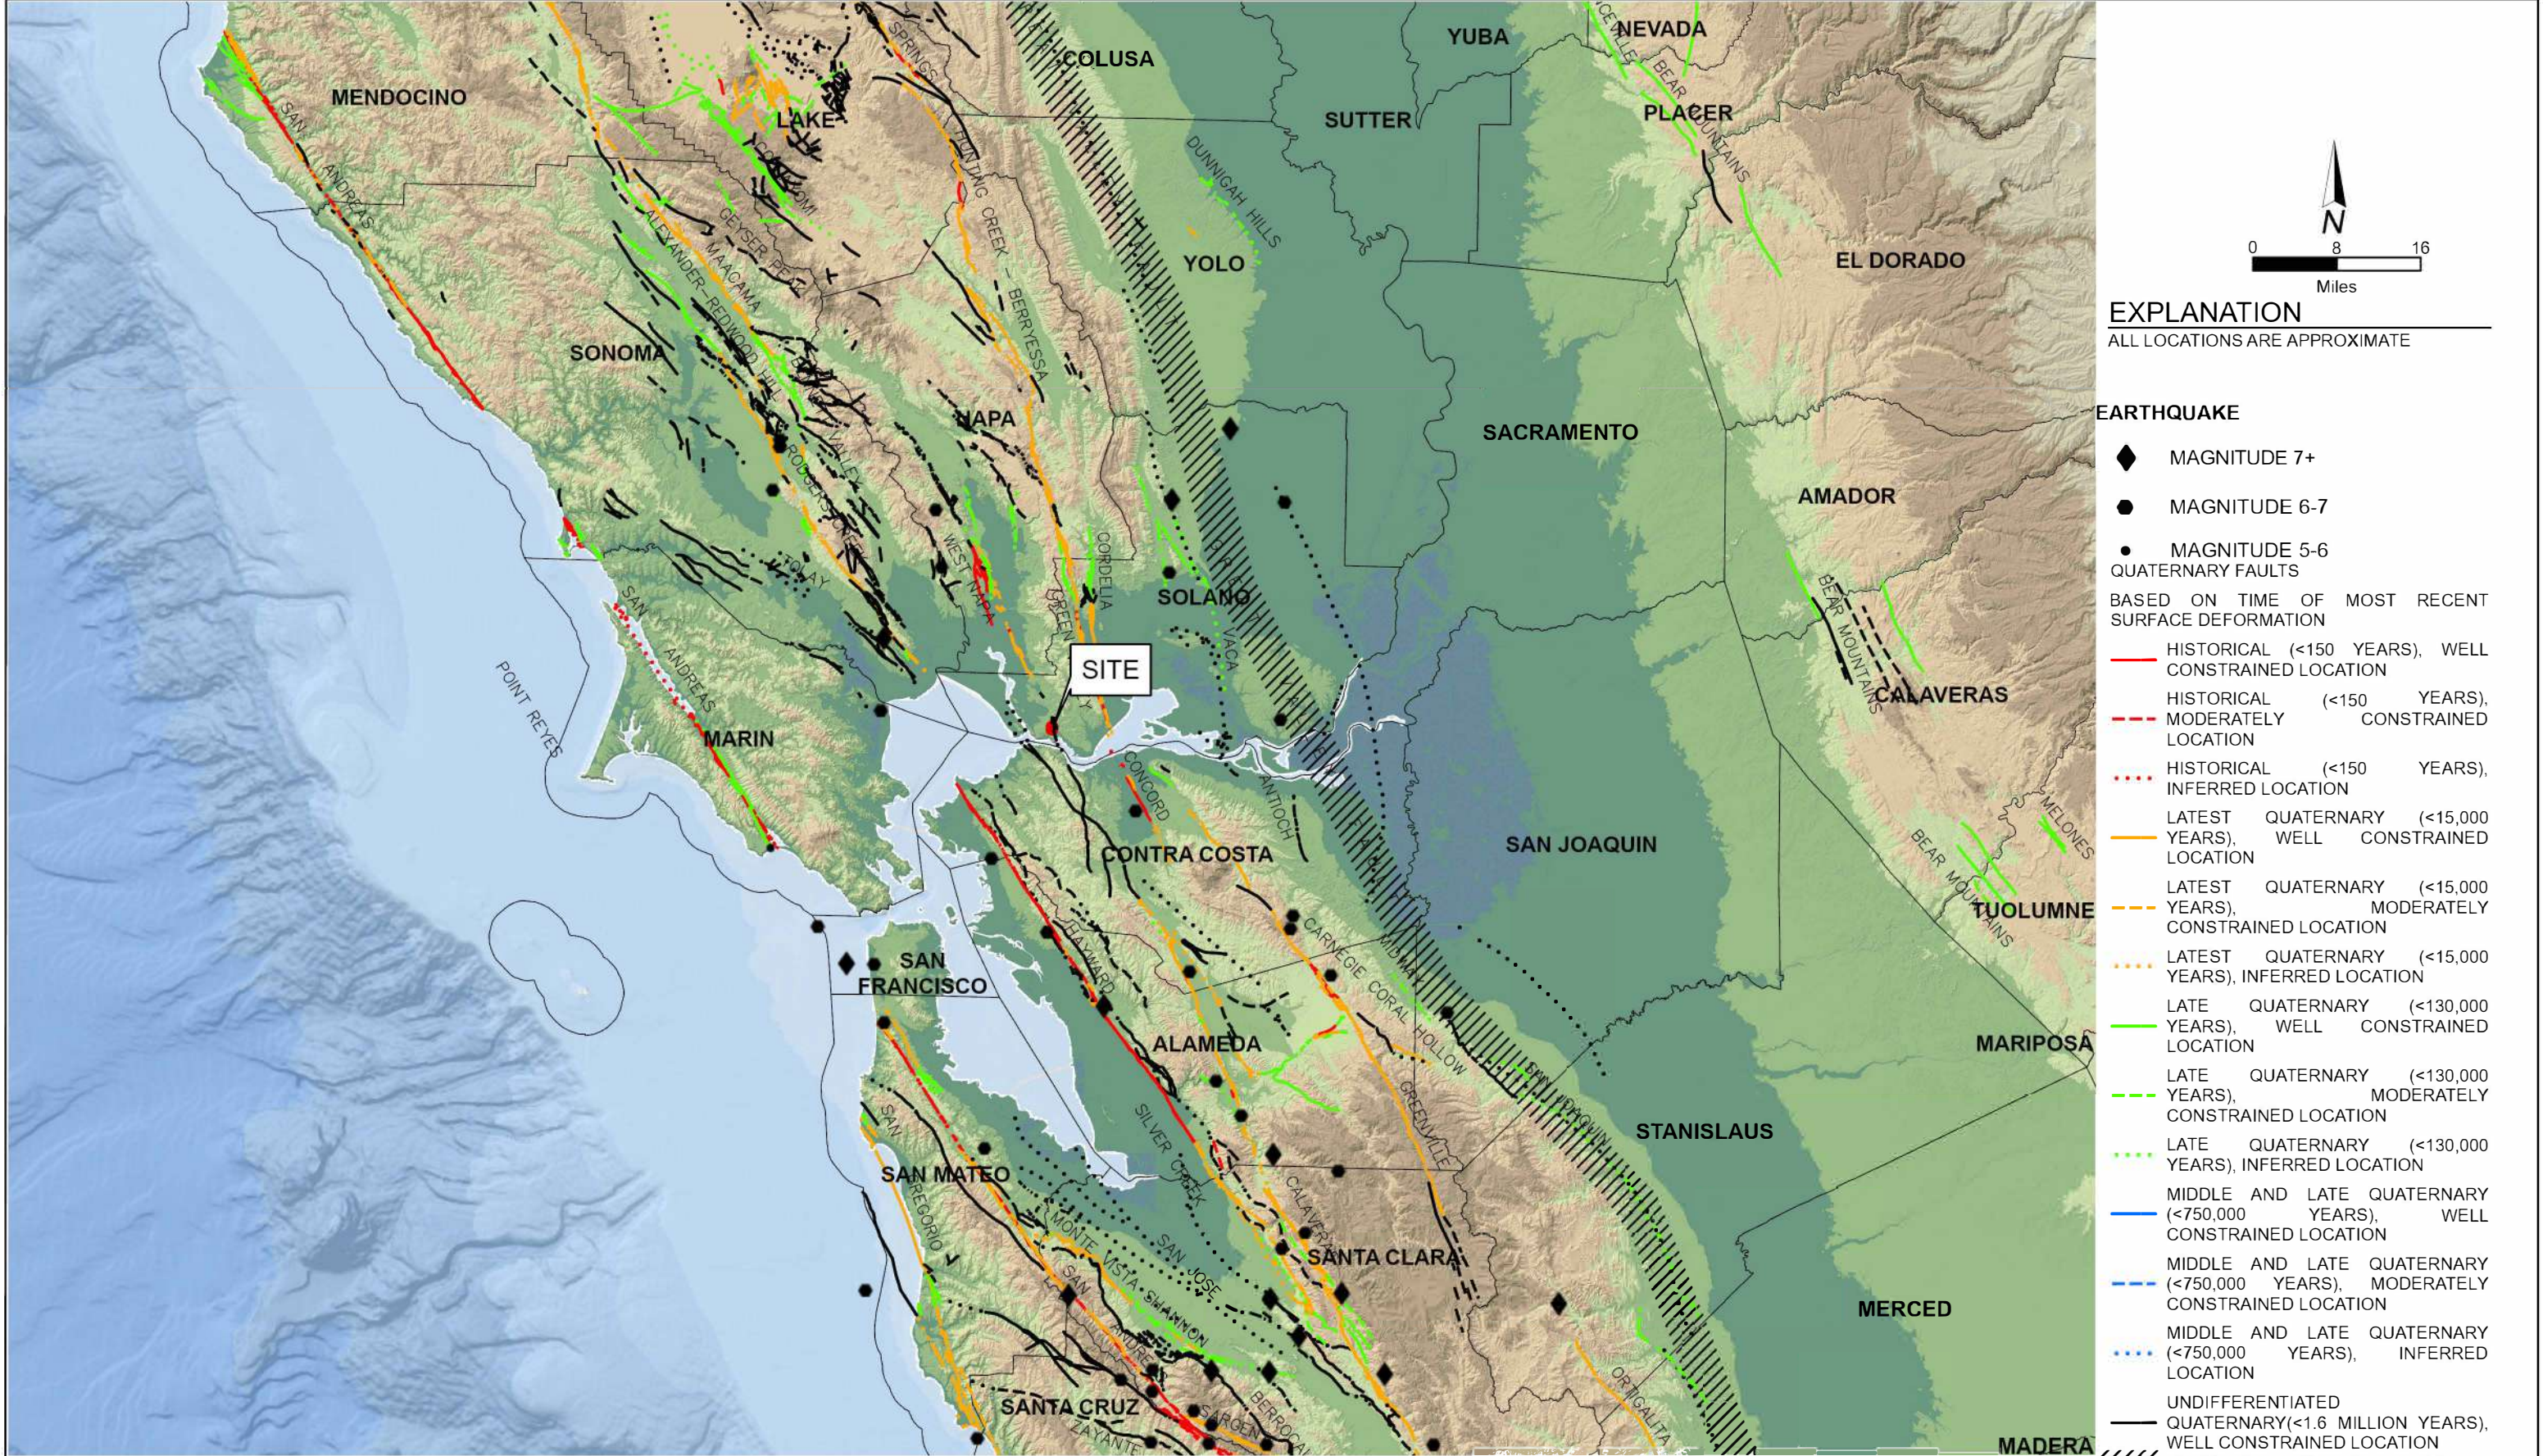
BASE MAP SOURCE  
ESRI, GEBCO, DELORME, NATURALVUE  
COLOR HILLSHADE IMAGE BASED ON THE NATIONAL ELEVATION DATA SET (NED) AT 30 METER RESOLUTION  
U.S.G.S. QUATERNARY FAULT DATABASE, 2018  
U.S.G.S. HISTORIC EARTHQUAKE DATABASE (1800-PRESENT)

Numerous small earthquakes occur every year in the nearby San Francisco Bay Region, and larger earthquakes have been recorded and can be expected to occur in the future. Figure 4 shows the approximate locations of these faults and significant historic earthquakes recorded within the region.

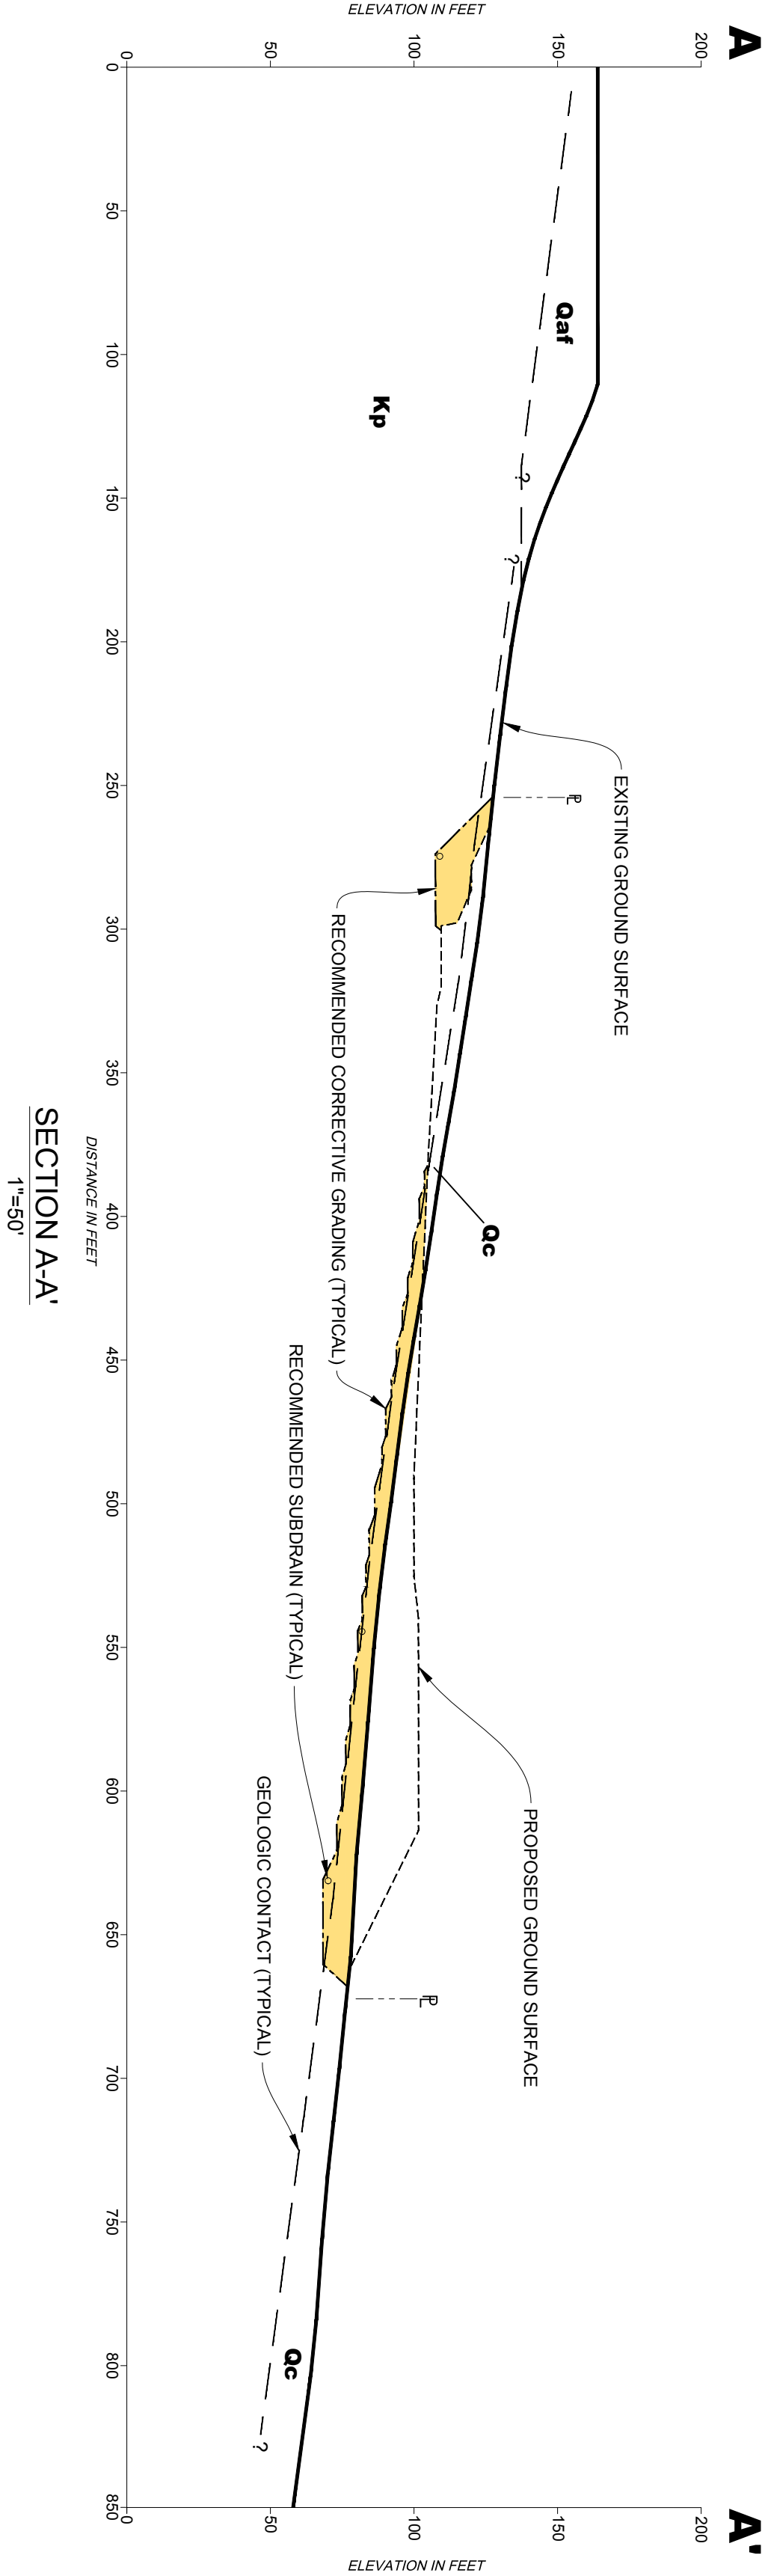
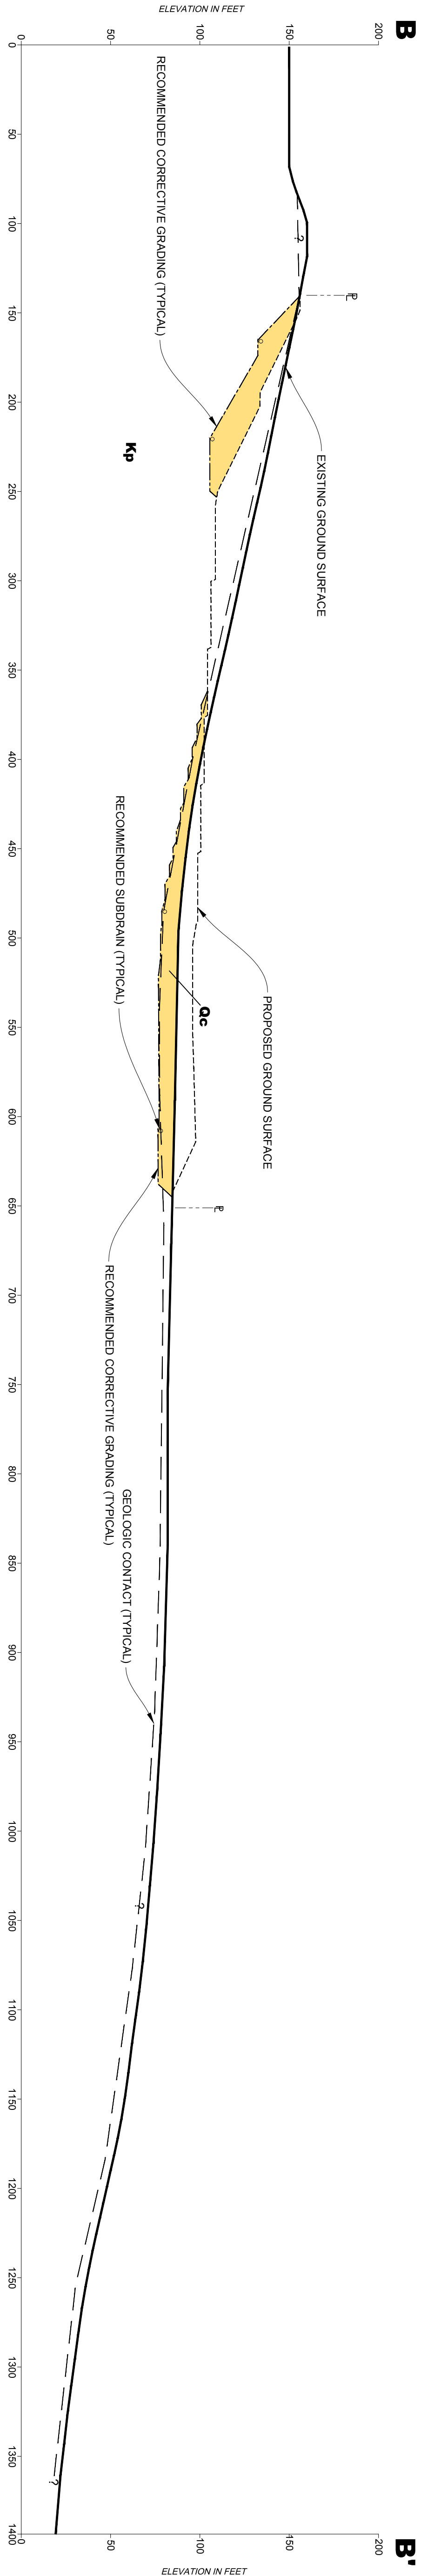
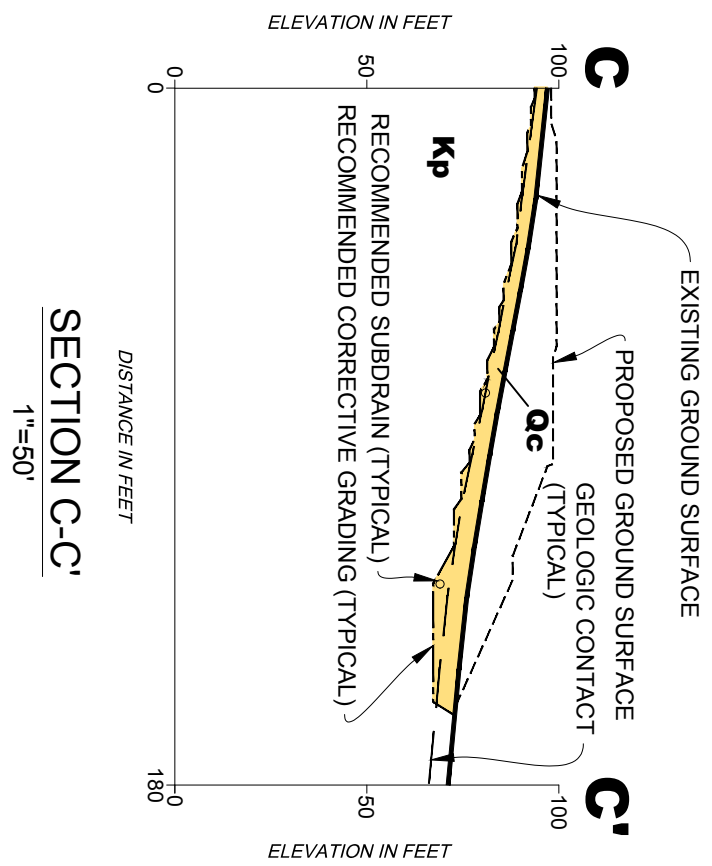
- EXPLANATION**
- Qaf** EXISTING FILL
- ac** COLLUVIUM
- Kp** PANOCHE FORMATION BEDROCK
- REMOVAL AREA**

Surface geologic mapping, based on photo review and site reconnaissance, was performed as part of this study, as depicted in Figure 2 and interpreted on cross sections in Figure 6. Mapping was supplemented by subsurface findings, as described in subsequent sections of the report. Site mapping focused on bedrock exposures, existing fills, landsliding, and geomorphological features to provide a preliminary surface geologic map. Below are descriptions of the geologic units observed during mapping at the site, as shown in Figure 2.

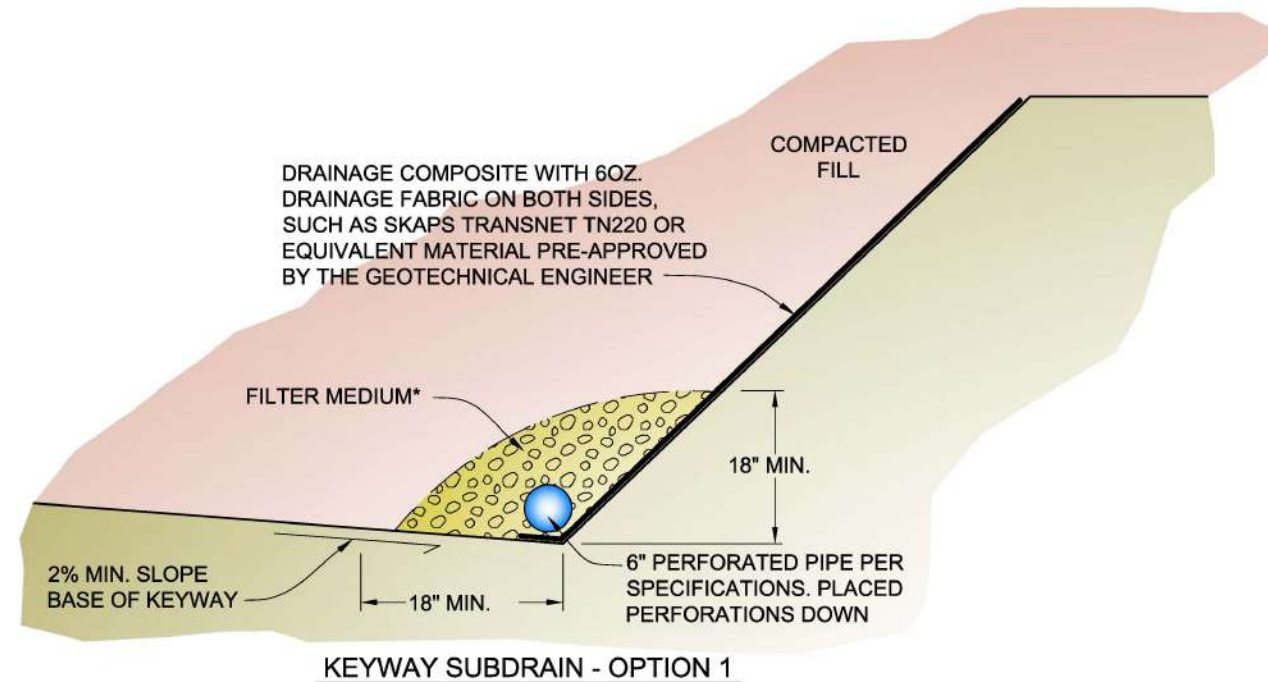
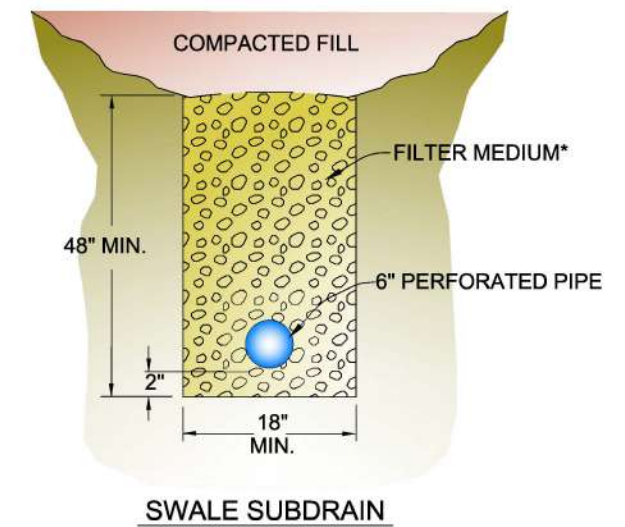
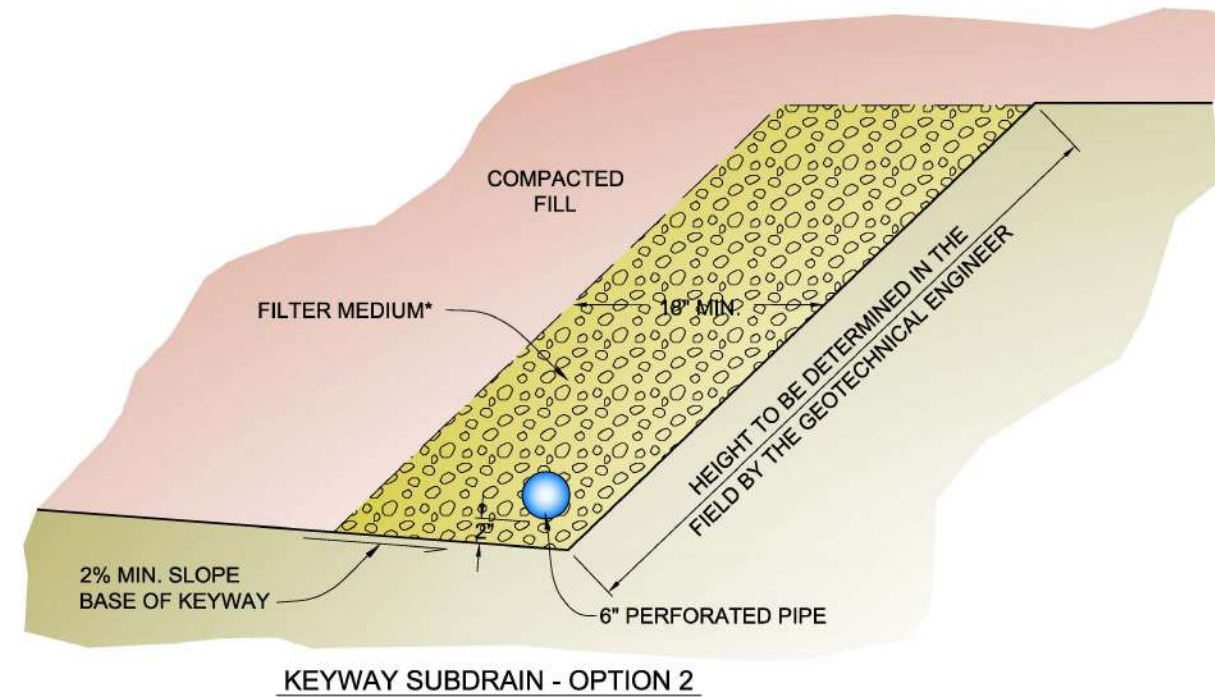
FIGURE NO.  
**8**

**\*FILTER MEDIUM**

**ALTERNATIVE A**

| FLOW RATE (ASTM D-4491) | 80 gal/min/ft |
| PUNCTURE STRENGTH (ASTM D-4833) | 80 lbs |

1. ALL PIPE JOINTS SHALL BE GLUED
2. ALL PERFORATED PIPE PLACED PERFORATIONS DOWN
3. 1% FALL (MINIMUM) ON ALL TRENCHES AND DRAIN LINES

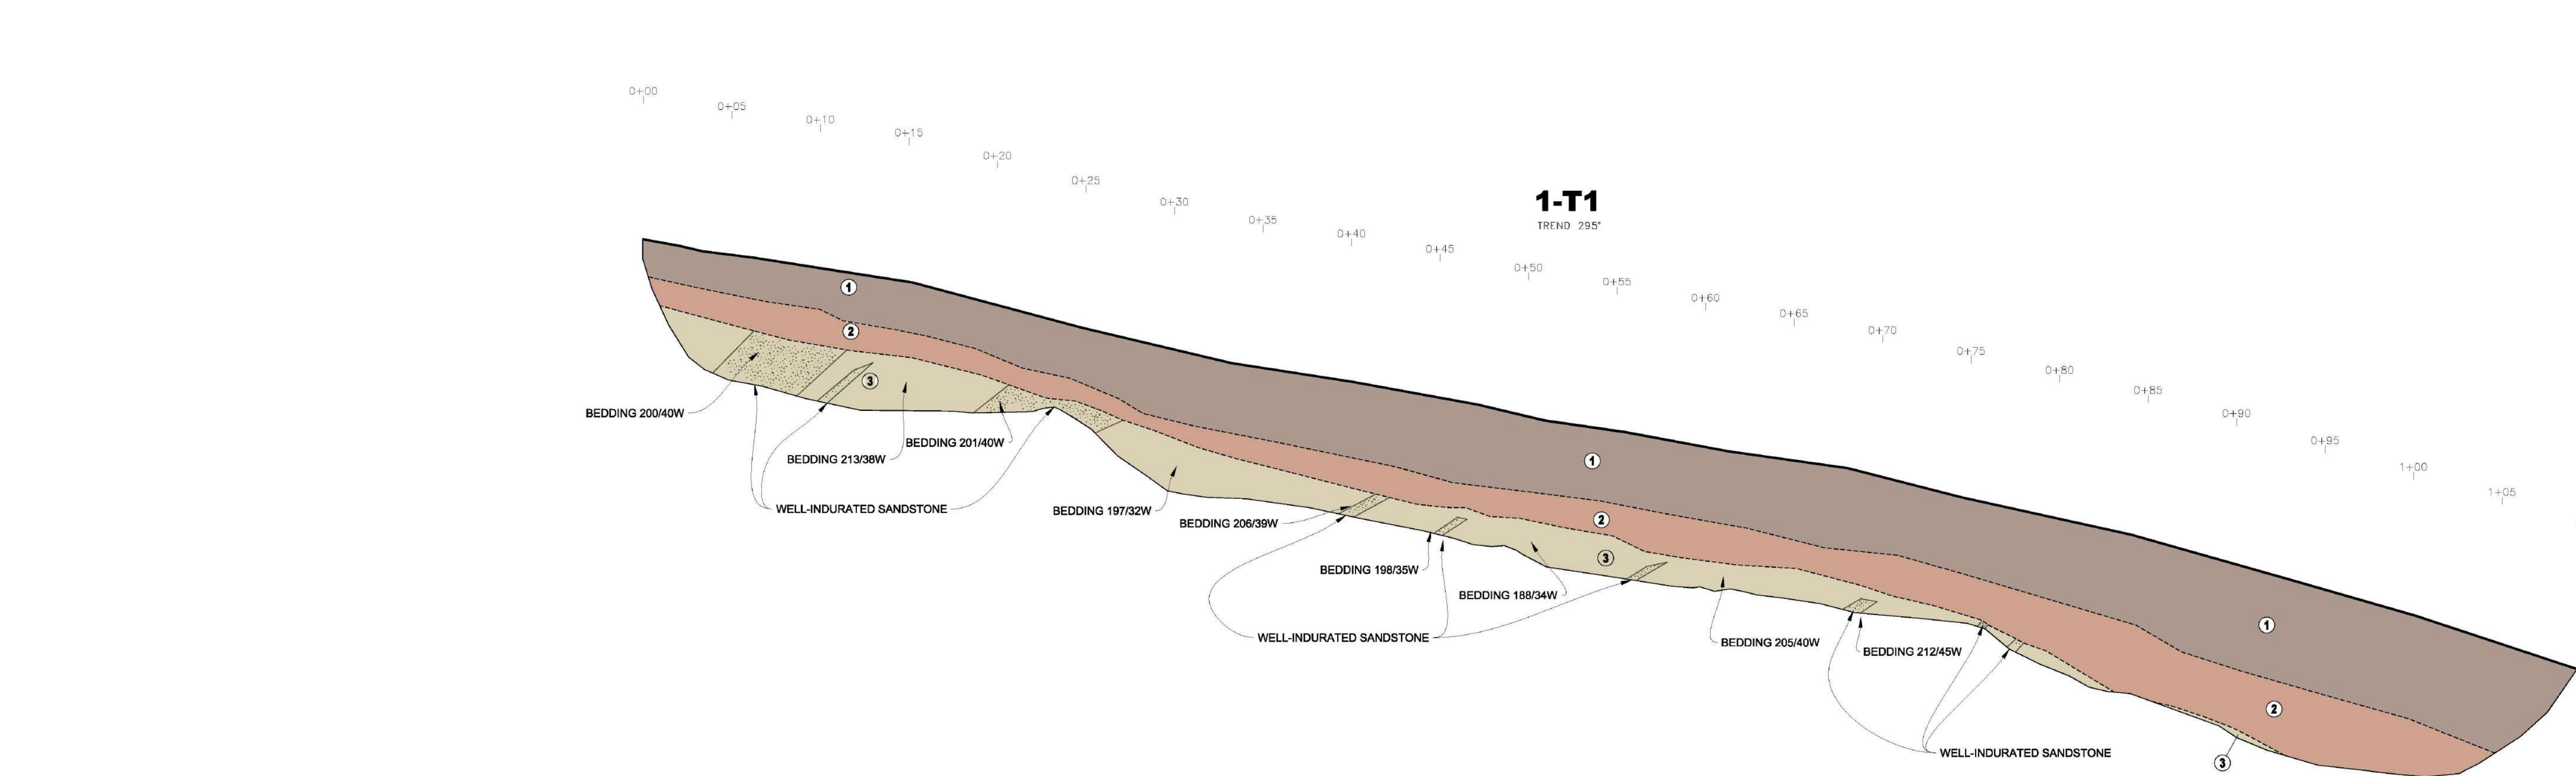
- 1-T1 EXPLANATION**
- ① CLAY, dark brown, stiff, dry, blocky pedogenic structure, organic material and roots present at surface thinning out with depth (COLLUVIUM)
  - ② CLAY, brown to light reddish brown, stiff, moist, blocky pedogenic structures, very thin rootlets, grades to residual soils in areas of weak claystone, gradational contact with underlying bedrock (COLLUVIUM).
  - ③ SANDSTONE interbedded with CLAYSTONE, light brown to grayish brown, fine-grained sandstone, moderately to well indurated interbedded with grey to greyish brown claystone, highly fractured, weak, with FeO staining, moderately to completely weathered (PANOCHÉ FORMATION)

An ENGEO Geologist logged the borings, test pits, and trench in the field. The exploration logs are included in Appendix A of this report. The trench log is included in Figure 9. The logs depict subsurface conditions encountered at the time of our exploration; however, subsurface conditions will vary with time.

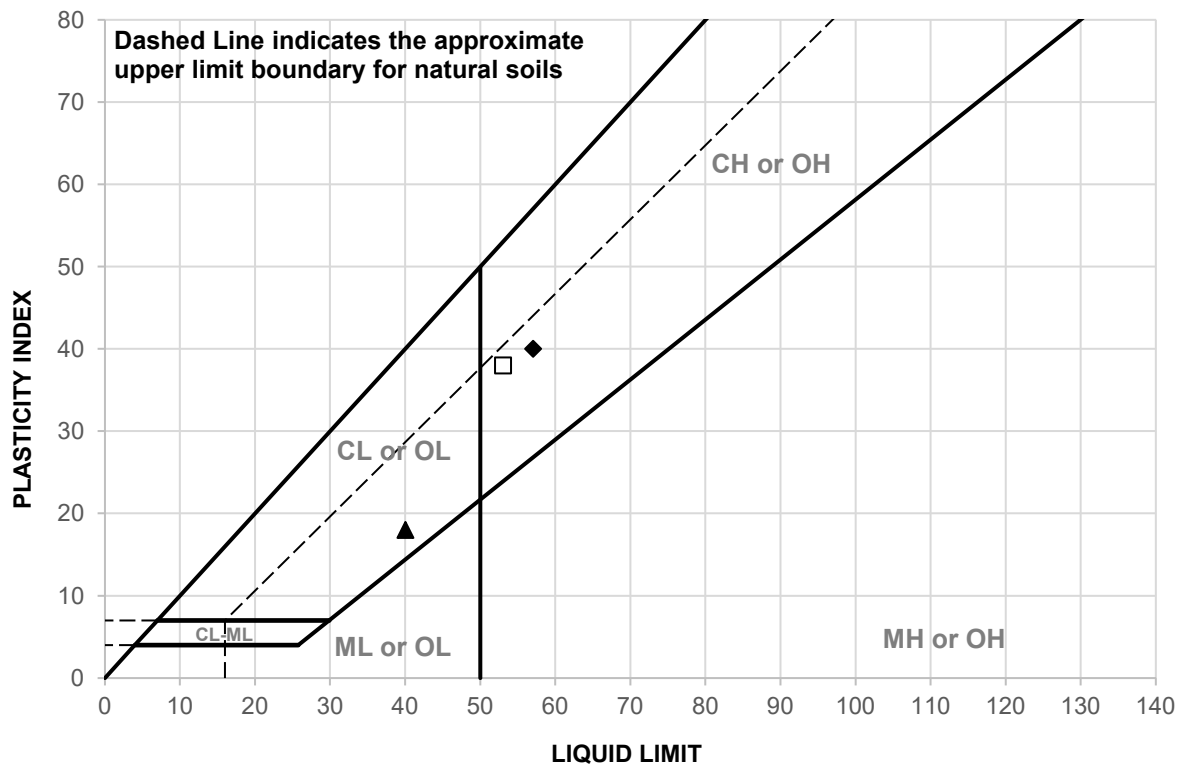
# LIQUID AND PLASTIC LIMITS TEST REPORT

| | SAMPLE ID | DEPTH (ft) | MATERIAL DESCRIPTION | LL | PL | PI |
| ▲ | 1-B1@13 | 13 | See exploration logs | 40 | 22 | 18 |

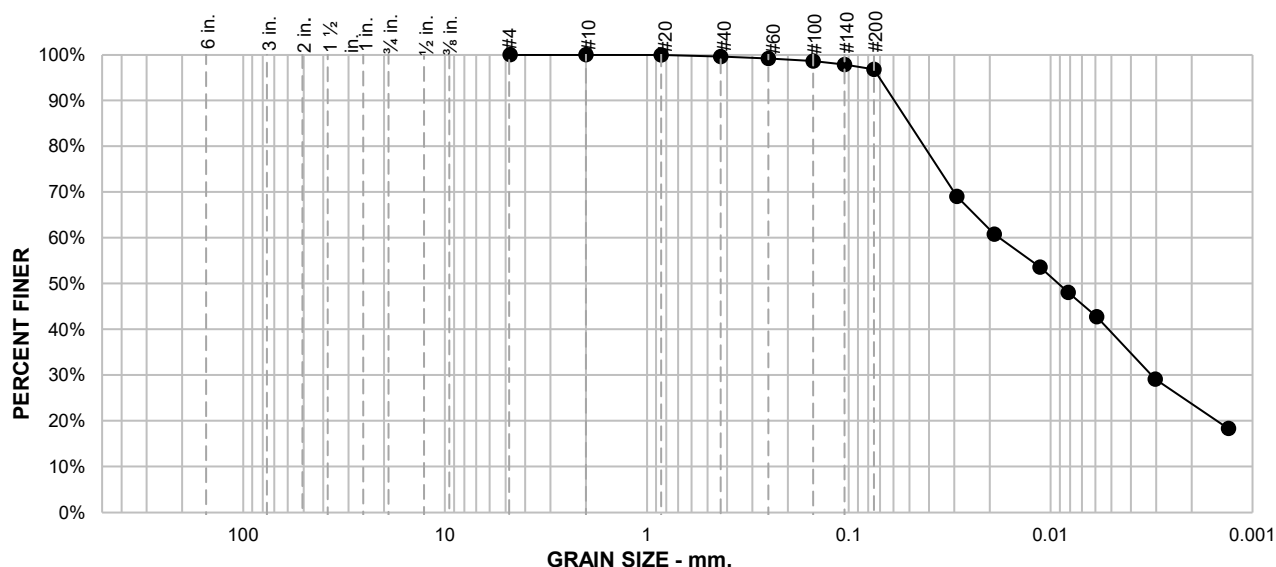
# PARTICLE SIZE DISTRIBUTION REPORT

SAMPLE ID: 1-B1@13

DEPTH (ft): 13

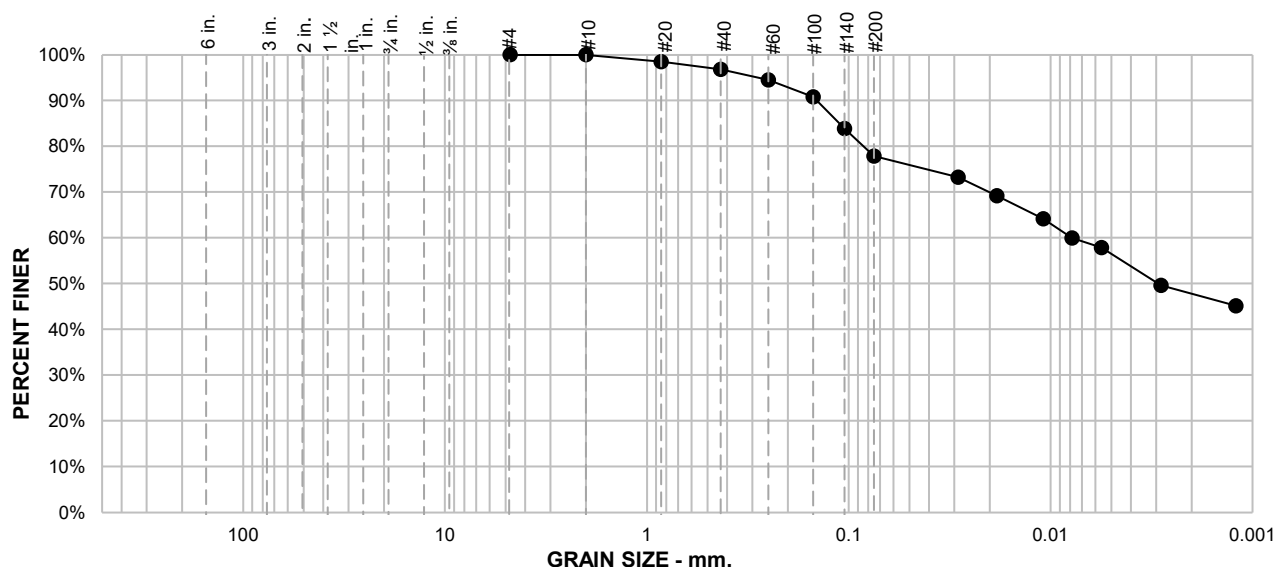
# PARTICLE SIZE DISTRIBUTION REPORT

SAMPLE ID: T-1@5

DEPTH (ft): 5

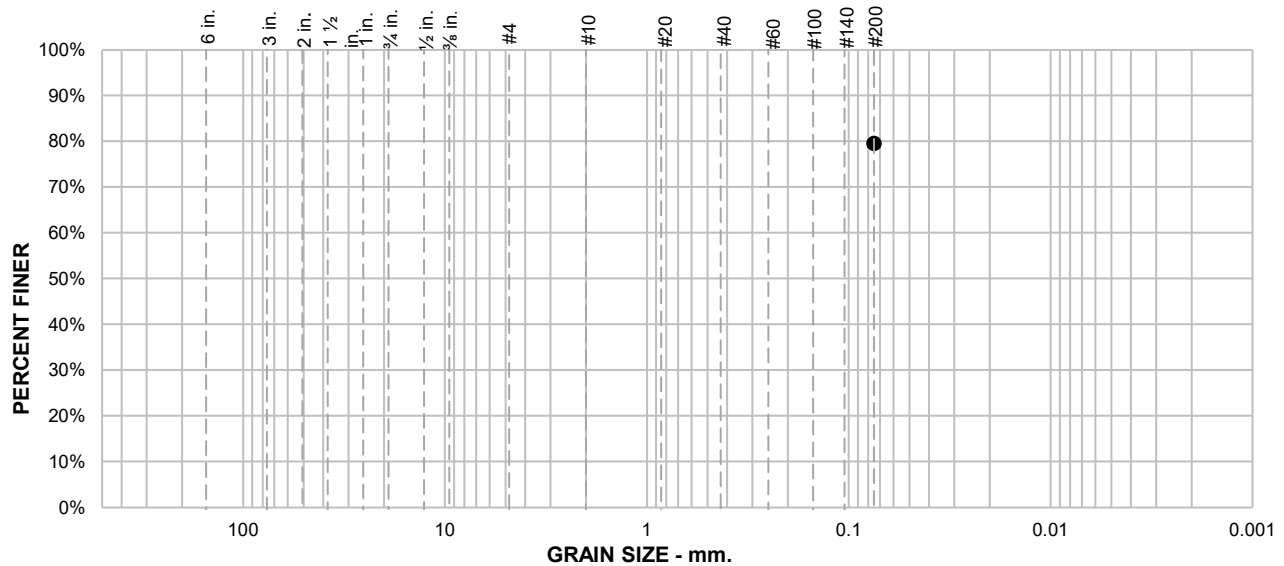
# PARTICLE SIZE DISTRIBUTION REPORT

SAMPLE ID: T-1@3.5

DEPTH (ft): 3.5
