# PRIORITY DEVELOPMENT PROJECT (PDP) STORM WATER QUALITY MANAGEMENT PLAN (SWQMP) FOR

#### 2072 Via Casa Alta

January 13, 2025

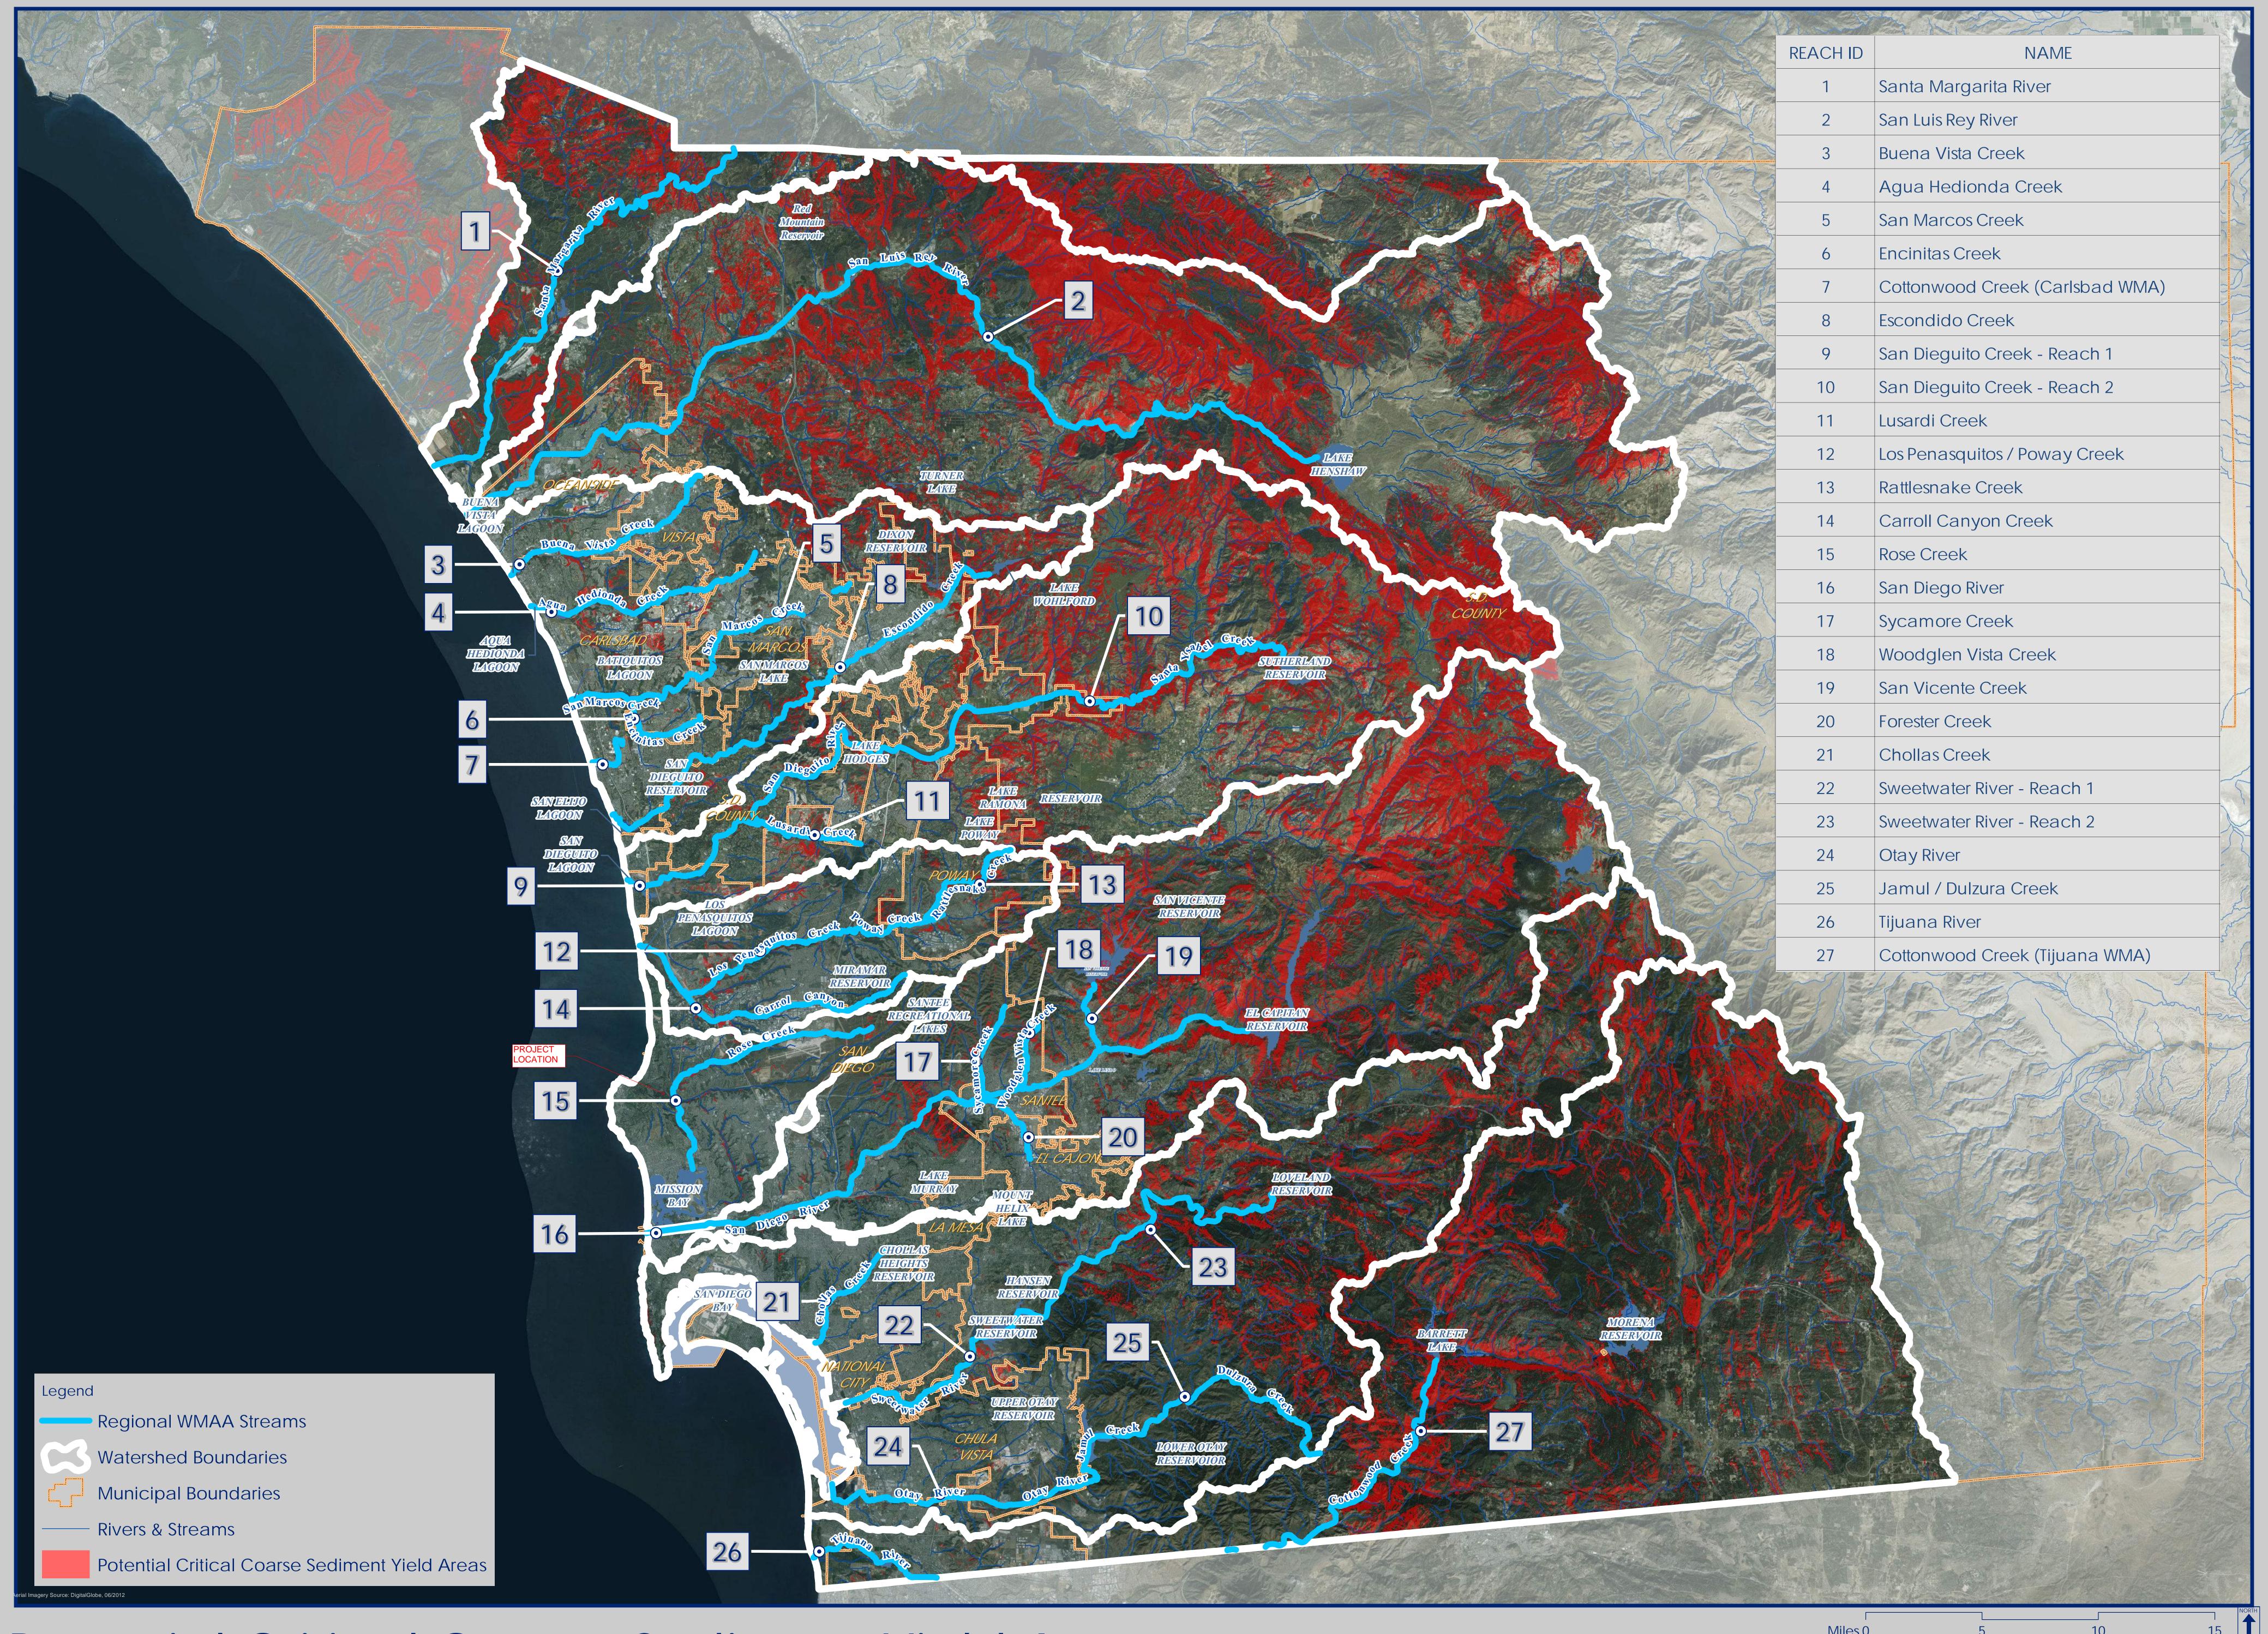
Potential Critical Coarse Sediment Yield Areas Regional San Diego County Watersheds

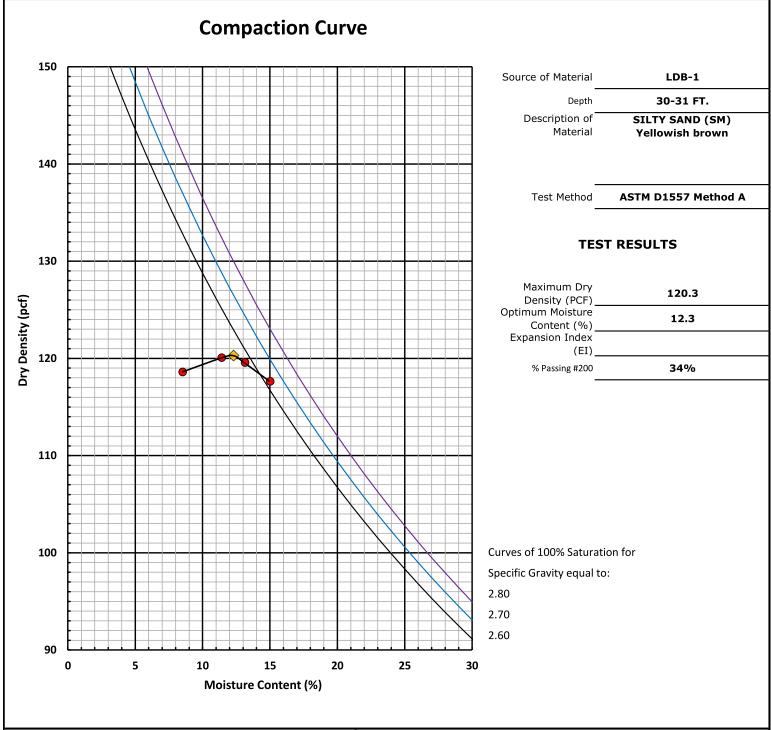
## **MOISTURE-DENSITY RELATIONSHIP**

# **Laboratory Test Results**

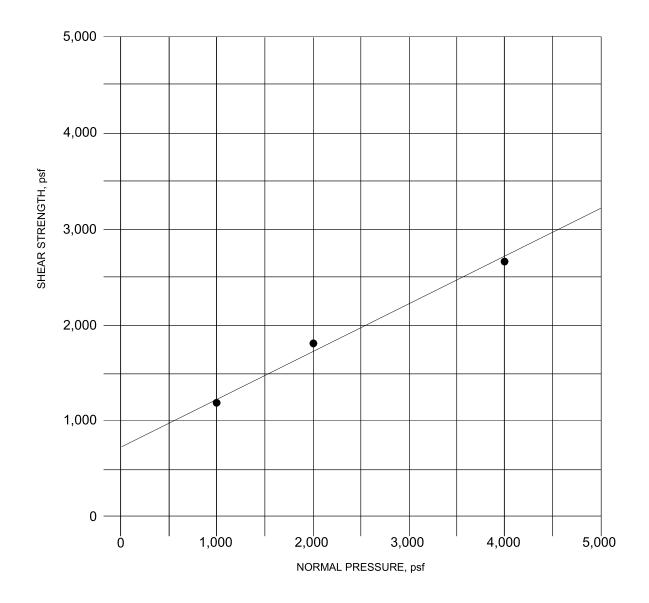
# **Laboratory Test Results**

| Sp | pecimen I.D. | Classification | $\gamma_{\!_{d}}$ | MC% | С | ф |
| • | T-1 @ 29-29.5' | SILTY SAND (SM), Undisturbed, Saturated | | | 756 | 25.9 |

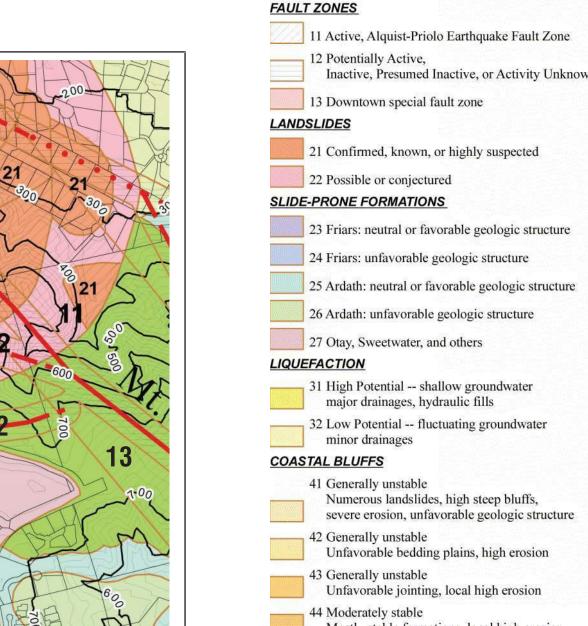
### Geologic Hazard Categories

| | 51 Level mesas underlain by terrace deposits and bedrock nomimal risk |
| | 52 Other level areas, gently sloping to steep terrain, favorable geologic structure, Low risk |

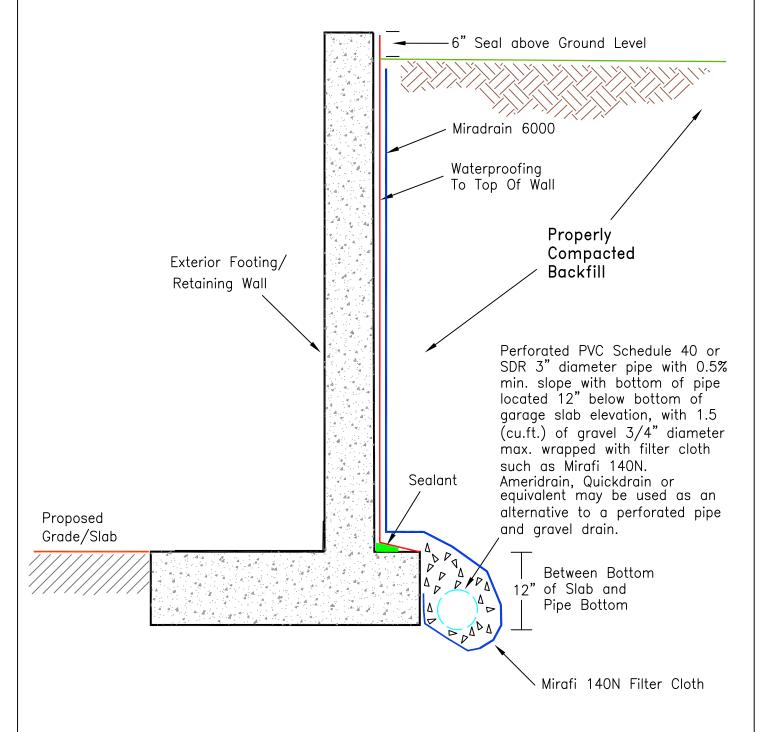
# SUBGRADE RETAINING WALL DRAINAGE RECOMMENDATIONS

NOTE: As an option to Miradrain 6000, gravel or crushed rock 3/4" maximum diameter may be used with a minimum 12" thickness along the exterior face of the wall and 2.0 cu/ft of pipe.
