**REPORT OF PRELIMINARY GEOTECHNICAL AND GEOLOGIC FAULT  
INVESTIGATION**

Proposed Javaheri Residence  
2072 Via Casa Alta  
La Jolla, California

**JOB NO. 21-13556**

Subject: **Report of Preliminary Geotechnical Investigation and Geologic Fault Investigation**  
Proposed Javaheri Residence  
2072 Via Casa Alta  
La Jolla, California

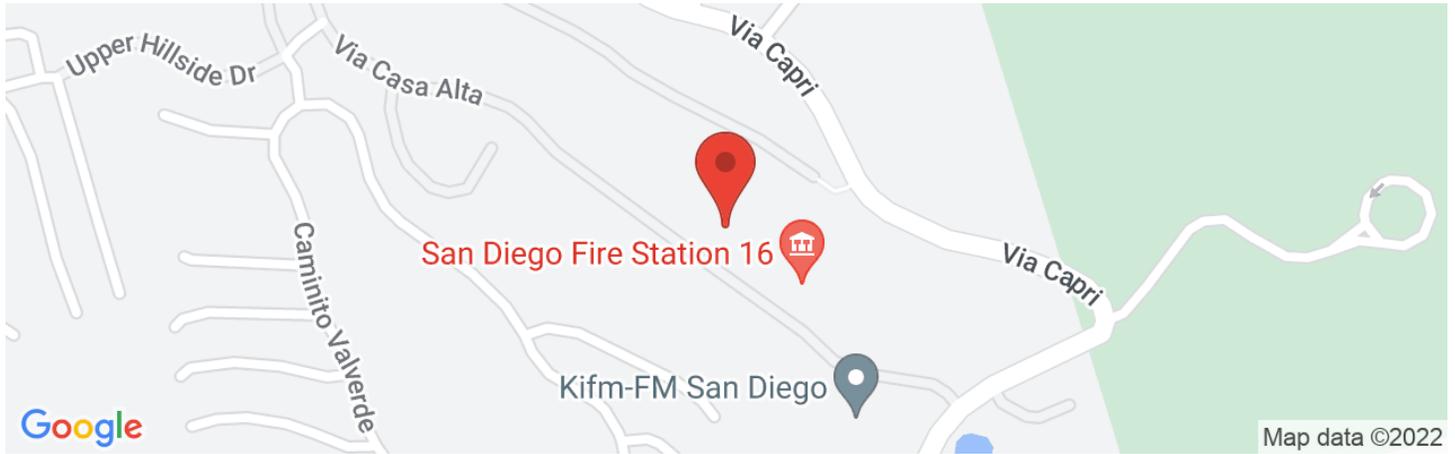
<b>Date</b>	7/22/2022, 10:32:17 AM
<b>Design Code Reference Document</b>	ASCE7-16
<b>Risk Category</b>	II
<b>Site Class</b>	C - Very Dense Soil and Soft Rock

Type	Value	Description
$S_S$	1.416	$MCE_R$ ground motion. (for 0.2 second period)
$S_1$	0.494	$MCE_R$ ground motion. (for 1.0s period)
$S_{MS}$	1.699	Site-modified spectral acceleration value
$S_{M1}$	0.742	Site-modified spectral acceleration value
$S_{DS}$	1.133	Numeric seismic design value at 0.2 second SA
$S_{D1}$	0.494	Numeric seismic design value at 1.0 second SA
