BYER GEOTECHNICAL, INC.

Transmittal of Addendum Geologic and Soils Engineering Exploration Update Response to City of Los Angeles Review Letter Proposed Tentative Tract Map # 73957 Thirteen-Lot Subdivision, Eleven New Residences Western Empire Tract (MP 18-162/163 [SHT 4]), Lot 202½ (Arb. 2) 8100, 8150, and 8160 West McGroarty Street (aka 10000 North McVine Trail) Sunland, California

April 18, 2018 BG 21103

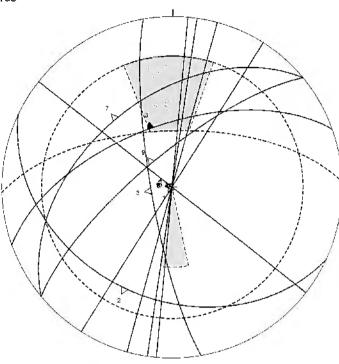
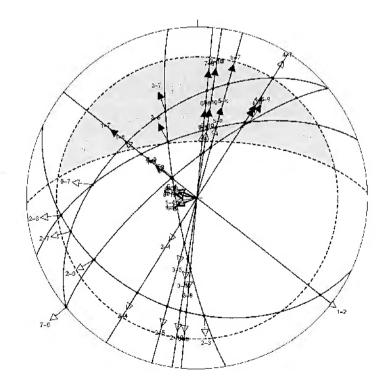
Kinematic Feasibility for Planar and Flexural Topple Failures

The upper stereonet shows the 10 planes mapped closest to location # K.Each plane is indicated by a great circle and by a triangle that indicates the line of true dip, and is labeled with the data point number. (Refer to Table 1 for orientation and type of plane.) The slope face and friction circle are shown as dashed black lines and together define the Sector of Planar Failure (SPF), which is shaded gray. The friction circle is drawn for a phi angle of 24.2 degrees, which incorporates a factor of safety FS = 1.5. The Sector of Flexural Topple Failure (STF), also shaded gray, forms a triangle near the center of the upper stereonet, Triangles that plot outside of the SPF and STF are unshaded, indicating that planar or flexural topple failure on that plane is kinematically unfeasible. Triangles that plot inside the SPF or STF are shaded, indicating that planar or flexural topple failure is kinematically feasible based on friction alone. These cases are further analyzed as summarized on Tables 4 and 5,

Kinematic Feasibility for Wedge Failures

The lower stereonet shows arrows for intersections between the 10 planes mapped at iocation \ddagger K.The shaded area indicates the Sector of Wedge Failure (SWF), using a friction circle that is drawn for a phi angle of 18.6 degrees, which incorporates a factor of safety FS = 2. Arrows that plot outside of the SWF are unshaded, indicating that a wedge failure is kinematically unfeasible. Arrows that plot inside the SWF are black, indicating that a wedge failure is kinematically feasible. Sets of planes with a potential wedge failure are further analyzed as summarized on Table 3.

On Kinematic Analysis Plots #1 and #2, the STF is plotted on the upper stereonet. Each plane is plotted as a great circle with a triangle indicating the line of true dip. Triangles that plot inside the SPF are shaded black. None of the joint planes mapped plot inside the flexural toppling failures on the existing steep cut slopes is negligible.

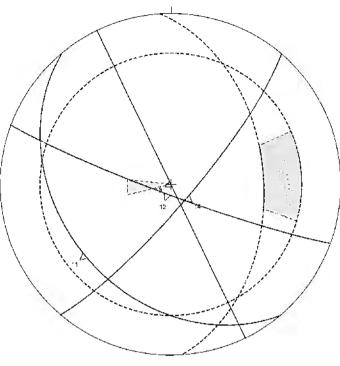
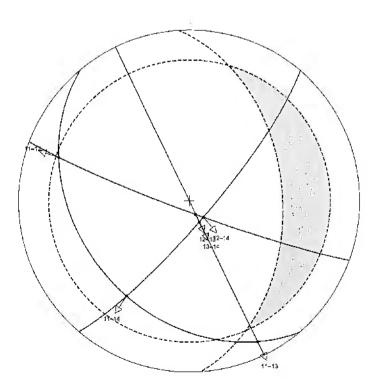
KINEMATIC ANALYSIS PLOT # 2 (LOCATION # M)

Kinematic Feasibility for Planar and Flexural Topple Failures

The upper stereonet shows the 4 planes mapped closest to location # M.Each plane is indicated by a great circle and by a triangle that indicates the line of true dip, and is labeled with the data point number. (Refer to Table 1 for orientation and type of plane.) The slope face and friction circle are shown as dashed black lines and together define the Sector of Planar Failure (SPF), which is shaded gray. The friction circle is drawn for a phi angle of 24.2 degrees, which incorporates a factor of safety FS = 1.5. The Sector of Flexural Topple Failure (STF), also shaded gray, forms a triangle near the center of the upper stereonet. Triangles that plot outside of the SPF and STF are unshaded, indicating that planar or flexural topple failure on that plane is kinematically unfeasible. Triangles that plot inside the SPF or STF are shaded, indicating that planar or flexural topple failure is kinematically feasible based on friction alone. These cases are further analyzed as summarized on Tables 4 and 5,

Kinematic Feasibility for Wedge Failures

The lower stereonet shows arrows for intersections between the 4 planes mapped at location II M.The shaded area indicates the Sector of Wedge Failure (SWF), using a friction circle that is drawn for a phi angle of 18.6 degrees, which incorporates a factor of safety FS = 2. Arrows that plot outside of the SWF are unshaded, indicating that a wedge failure is kinematically unfeasible. Arrows that plot inside the SWF are black, indicating that a wedge failure is kinematically feasible. Sets of planes with a potential wedge failure are further analyzed as summarized on Table 3,

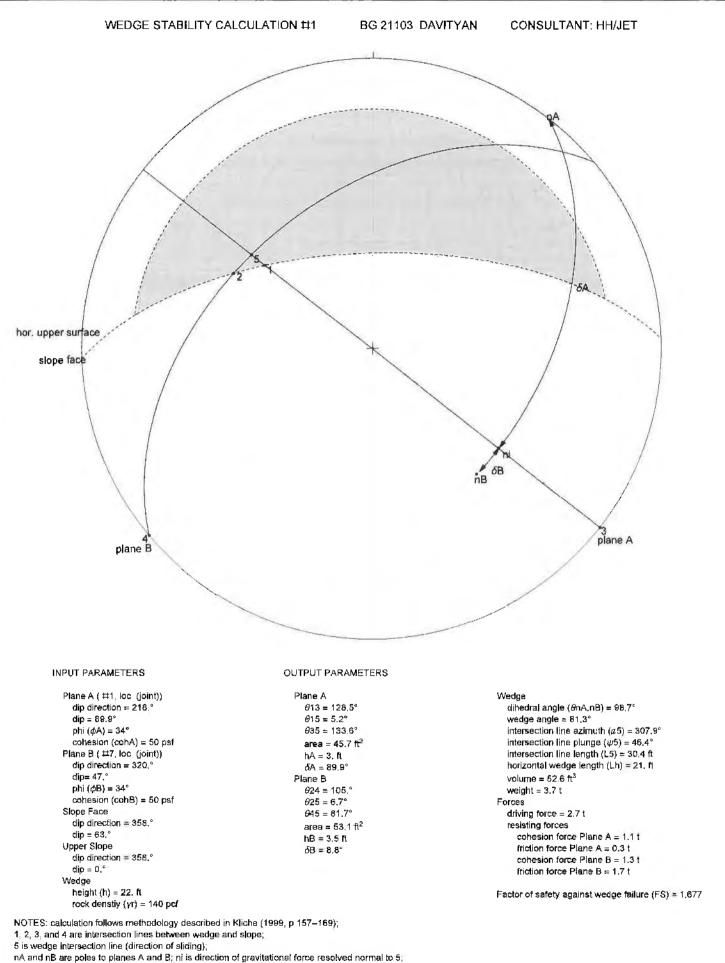
dA and db are angles used to resolve gravitational force on planes A and B.

SWF and indicate kinematically feasible wedge failures. These cases are further analyzed as presented on Wedge Stability Calculations #1 - #12. The factors of safety are calculated for zero cohesion on the two intersecting planes. If this condition leads to a factor of safety less than 1.5, the cohesion is increased in steps of 10 pounds-per-square-foot until the factor of safety is 1.5 or greater, and the slope gradient that eliminates the wedge is listed. In all cases, the cohesion required for a factor of safety in excess of 1.5 is 130 pounds-per-square-foot or less. All wedges with a factor of safety less than 1.5 in the absence of cohesion will be eliminated by a 1:1 trim. Since there is no information available on a minimum value for the cohesive strength of joint planes in this area, a 1:1 slope trim is recommended.

K ·	4	7	{302, 90}		wedge is not kinematically feasible			
к	4	8	{302, 90}		wedge is not kinematically feasible			
K	4	9	{302, 90}		see Wedge Stability Calculation #7	22	FS = 2.83 for cohesion = 0 psf	
К	4	10	{302, 90}		wedge is not kinematically feasible		· ·	· · · · · · · · · · · · · · · · · · ·
К	6	7	{340, 60}		wedge is not kinematically feasible			· · · · · · · · · · · · · · · · · · ·
<u>_K</u>	6	8	{340, 60}		see Wedge Stability Calculation #8		FS = 1.56 for cohesion = 70 psf	slope trim to 57.7 degrees eliminates wedge
К.	6	9	{340, 60}		see Wedge Stability Calculation #9		FS = 2.71 for cohesion = 0 psf	
К	6	10	{340, 60}		see Wedge Stability Calculation #10		FS = 1.54 for cohesion = 70 psf	slope trim to 57.2 degrees eliminates wedge
К	7	8	{320, 47}		see Wedge Stability Calculation #11	22	FS = 1.58 for cohesion = 0 psf	·····
к	7	9	{320, 47}		wedge is not kinematically feasible			
К	7	10	{320, 47}		see Wedge Stability Calculation #12	22	FS = 1.73 for cohesion = 0 psf	· · · · · · · · · · · · · · · · · · ·

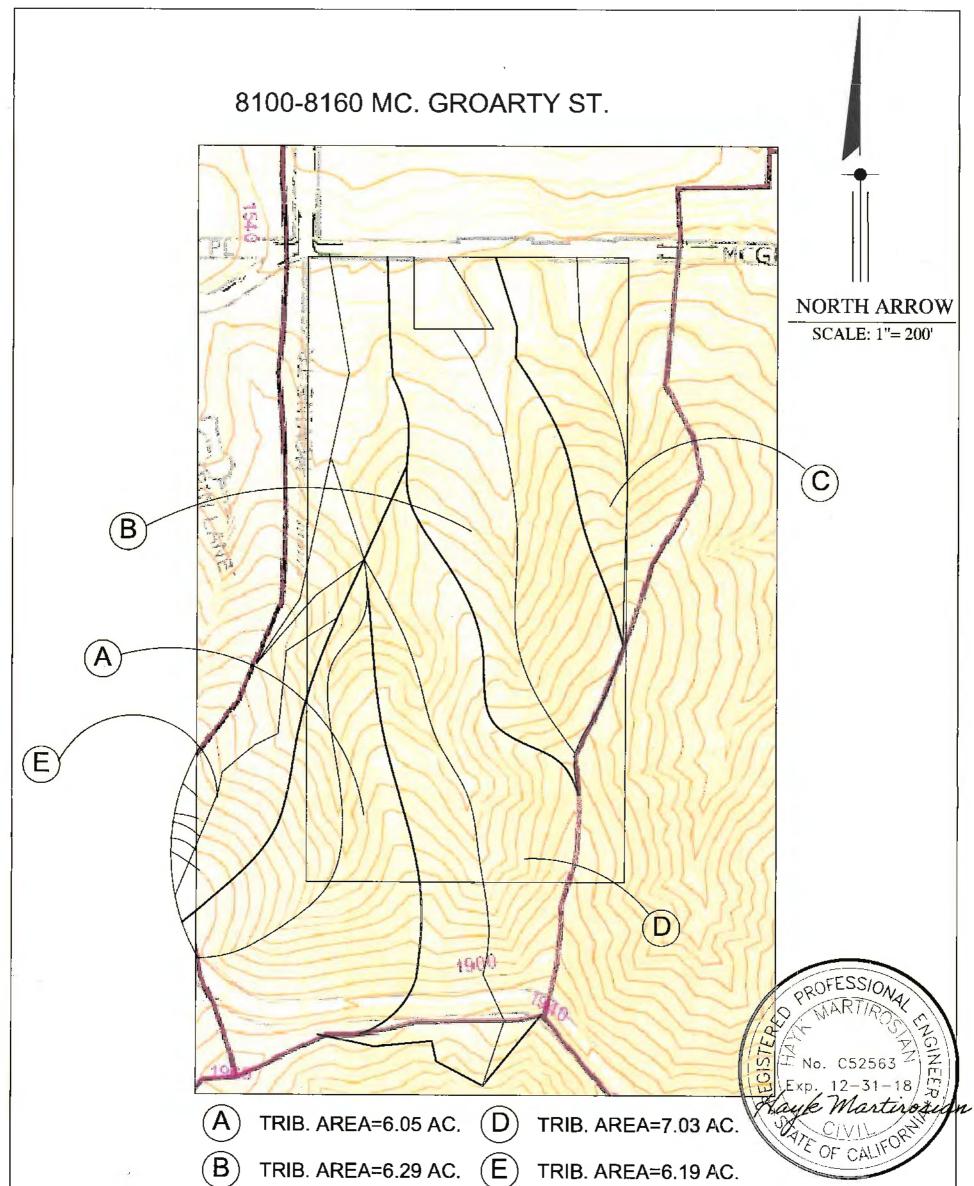
TRIB. AREA=4.00 AC. С TOT.TRIB. AREA=29.56 AC. CHANNELIZED FLOW CAPACITY "Ccf" **TEMPORARY STORAGE CAPACITY "Cst"** (\mathbf{A}) Ccf=6.05 ac. x (10) cfs=60.50 cfs A Cst=6.05 ac. x (400) cy/ac.=2420 cy. B Ccf= 6.29 ac. x (10) cfs=62.90 cfs B Ccf= 6.29 ac. x (400) cy/ac=2516 cy Ccf= 4.00 ac. x (10) cfs=40.00 cfs C Ccf= 4.00 ac. x (400) cy/ac=1600 cy Ccf= 7.03 ac. x (10) cfs=70.3 cfs D Ccf= 7.03 ac. x (400) cy/ac=2812 cy Ccf= 6.19 ac. x (10) cfs=61.90 cfs E E) Ccf= 6.19 ac. x (400) cy/ac=2476 cy

- Response: Slopes steeper than 1:1 consist of bedrock and have no soil cover.
- Item 5. The figure used by the civil engineer for mudflow analysis does not appear to provide topography for the entire watershed above the subject site. Revise the map and area calculations for the entire watershed. As previously requested, provide design calculations and recommendations for construction within a potential mudflow hazard area per Section 91.7014.3. Show the tributary drainage/contributing watershed area on the regional topography map and, provide calculations for debris flow control systems within and at the base of concentrated drainage areas, using the minimum design parameters specified in section 7014.3 of the LA City Building Code. Show all proposed debris flow eontrol systems and drainage structures on the geologic map. Note: (s) If such calculations are to be provided by a civil engineer, include the wet-signed original of the civil engineer's report, in the addendum; (b) Protective devices shall be permanent structures designed to either isolate, contain, deflect or channelize any potential debris flows.

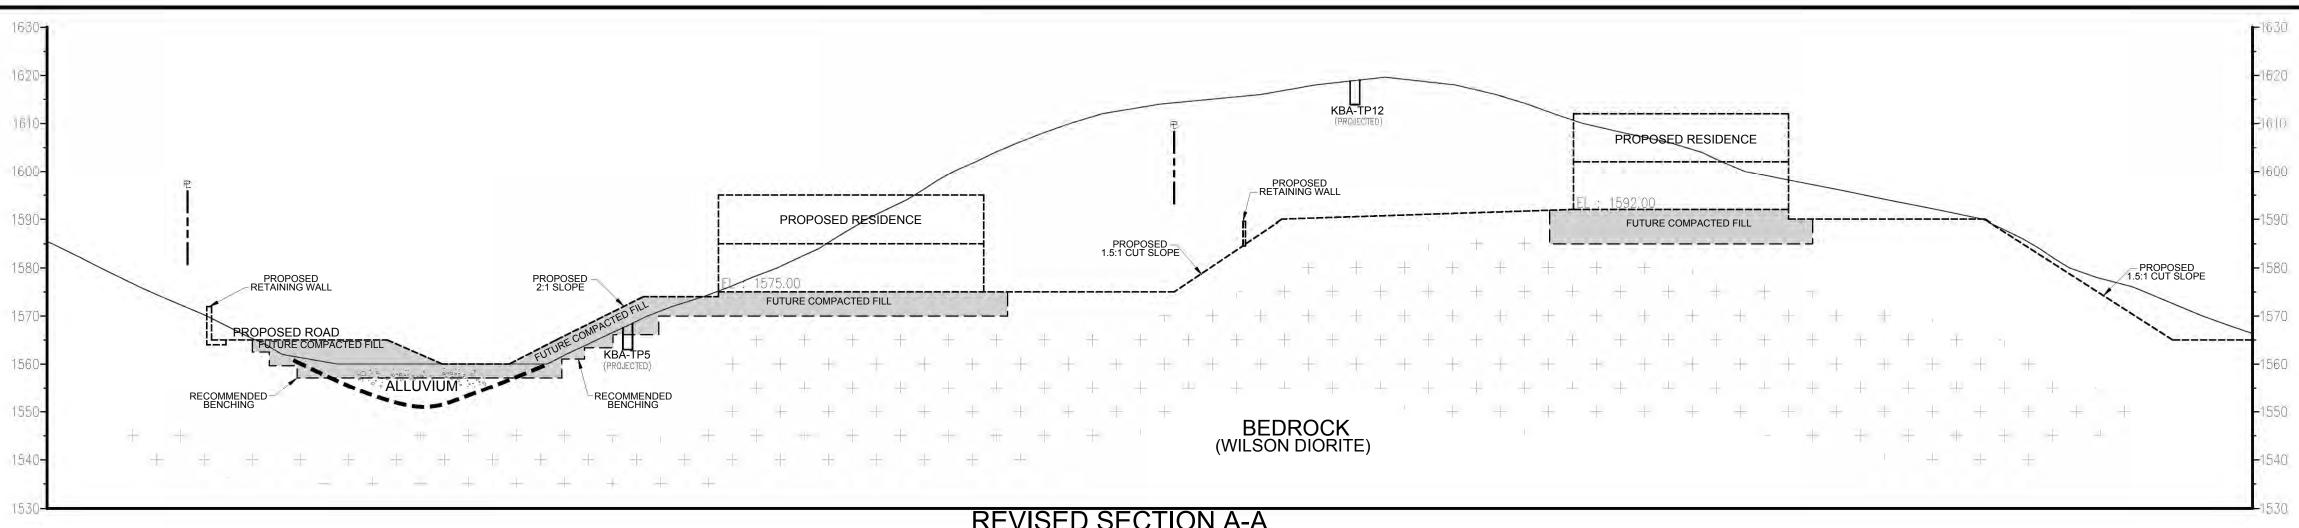
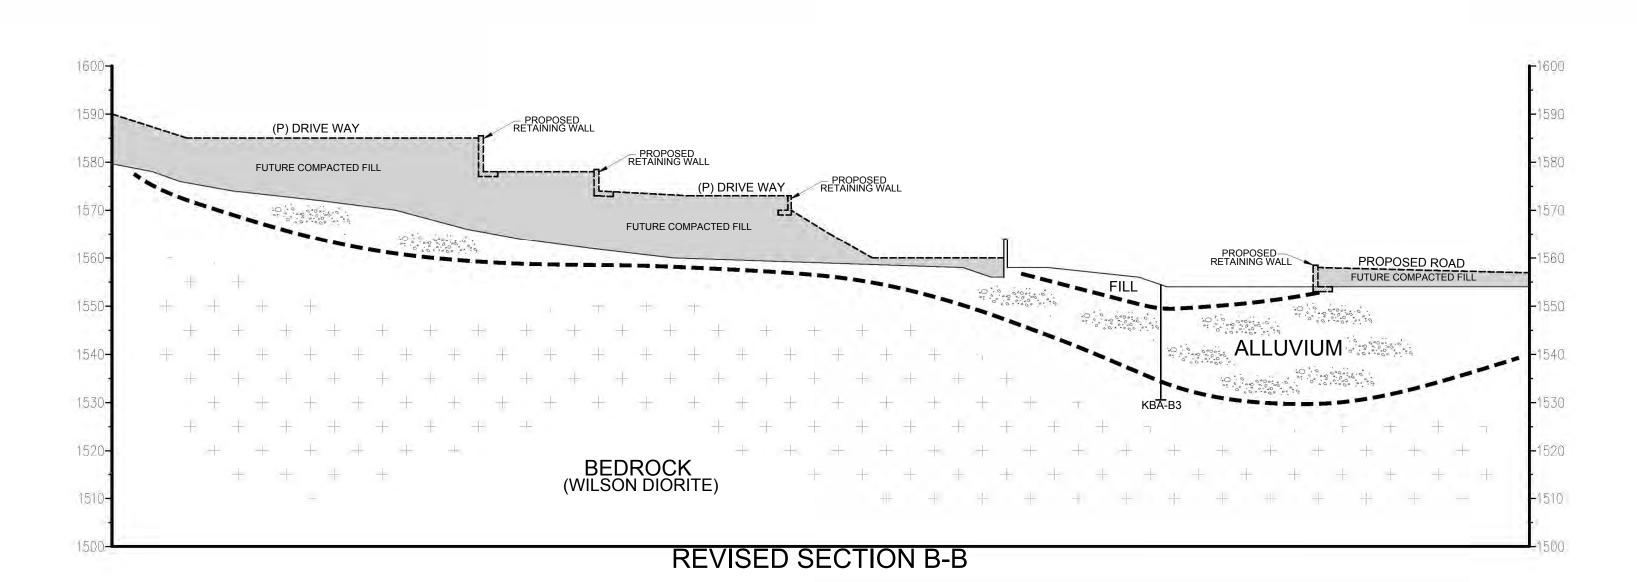
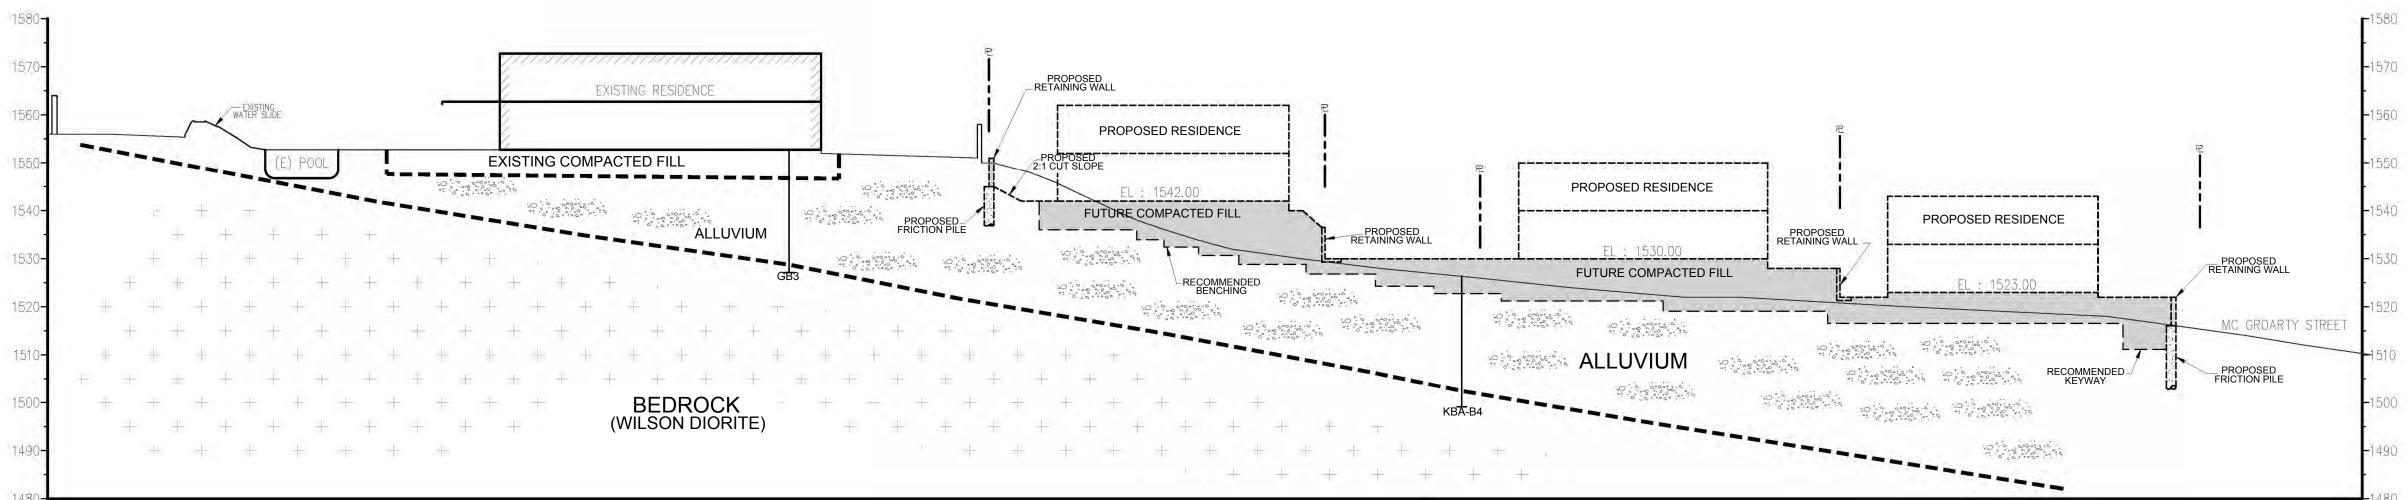
REVISED SECTIONS A, B, & C

REVISED SECTION A-A

REVISED SECTION C-C

- Response: As noted in the referenced response letter (response to Item 11), dated November 13, 2017, and discussed with the reviewers in the meeting on December 13, 2017, Byer Geotechnical has previously addressed this item and the Revised Geologic Map and sections are based on the most recent grading plan dated January 30, 2018.
