#### CONDOR EARTH

**Proposed Winery Cave and Portals**

1581 Oakville Grade, Oakville, CA

Geologic Assessment and Preliminary Recommendations

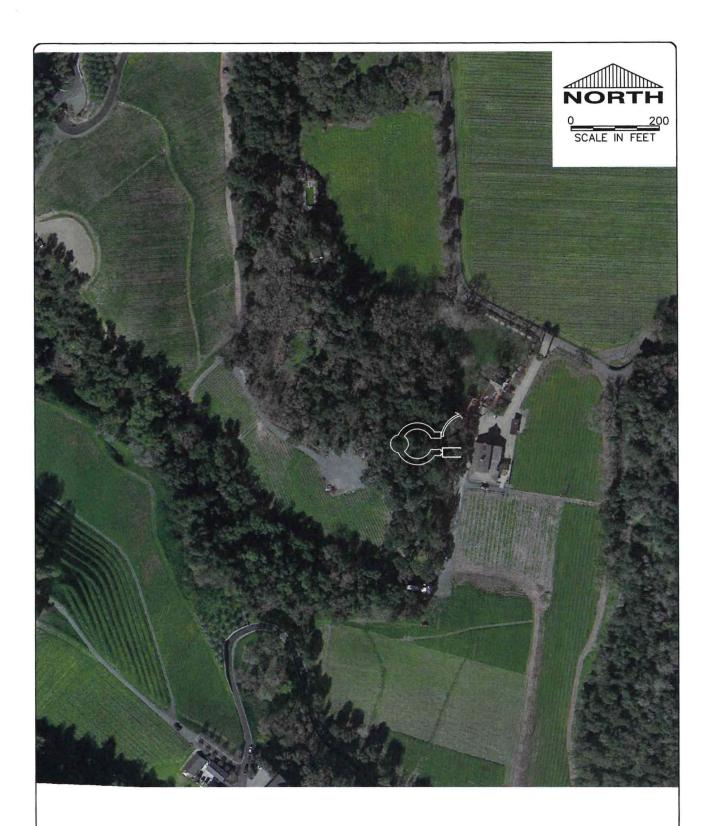
FIGURE 2

SITE MAP
THE VINEYARD HOUSE WINERY
1581 OAKVILLE GRADE
OAKVILLE, CALIFORNIA 94562

The proposed project site is located approximately 1.3 miles southwest of Oakville and occupies the flank of a low ridge near the base of the Mayacamas Mountain Range on the west side of Napa Valley, as shown on Figure 1. The parcel has been previously improved, including a historic residence, a relatively new barn, and vineyard and landscaped areas. The proposed winery cave is located west of the barn and underlying an east-facing hillside supporting oak woodland and vineyards (Figure 2). The understory vegetation of the oak woodland area has been cleared and reveals a moderately-sloping hillside. The existing ground surface rises about 60 feet from the location of the proposed main cave portal near the existing barn to the rear portion of the proposed cave.

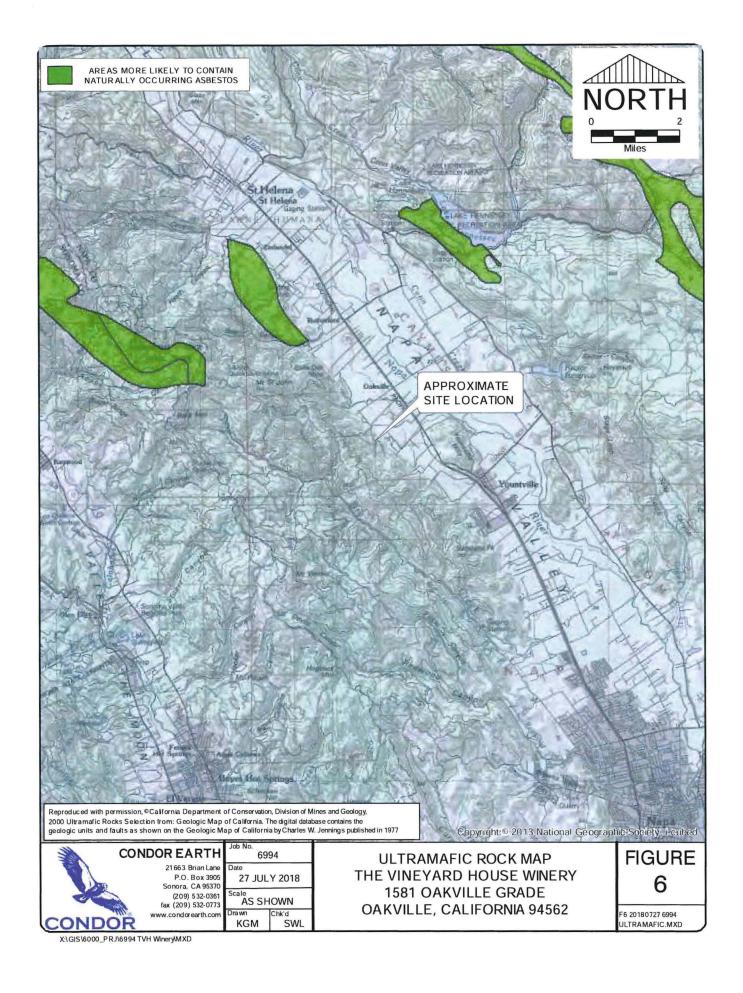
Figure 6 illustrates that the site is not underlain by ultramafic rock (rock that could potentially contain naturally-occurring asbestos). Figure 7 illustrates that Napa County is located within a zone of low potential for natural radon hazard.
