# **APPENDIX 3.3-3**

## **SECRETARY OF THE INTERIOR (SOI)**

### **COMPATIBILITY ASSESSMENT FOR THE OLD**

### **SCHOOLHOUSE**

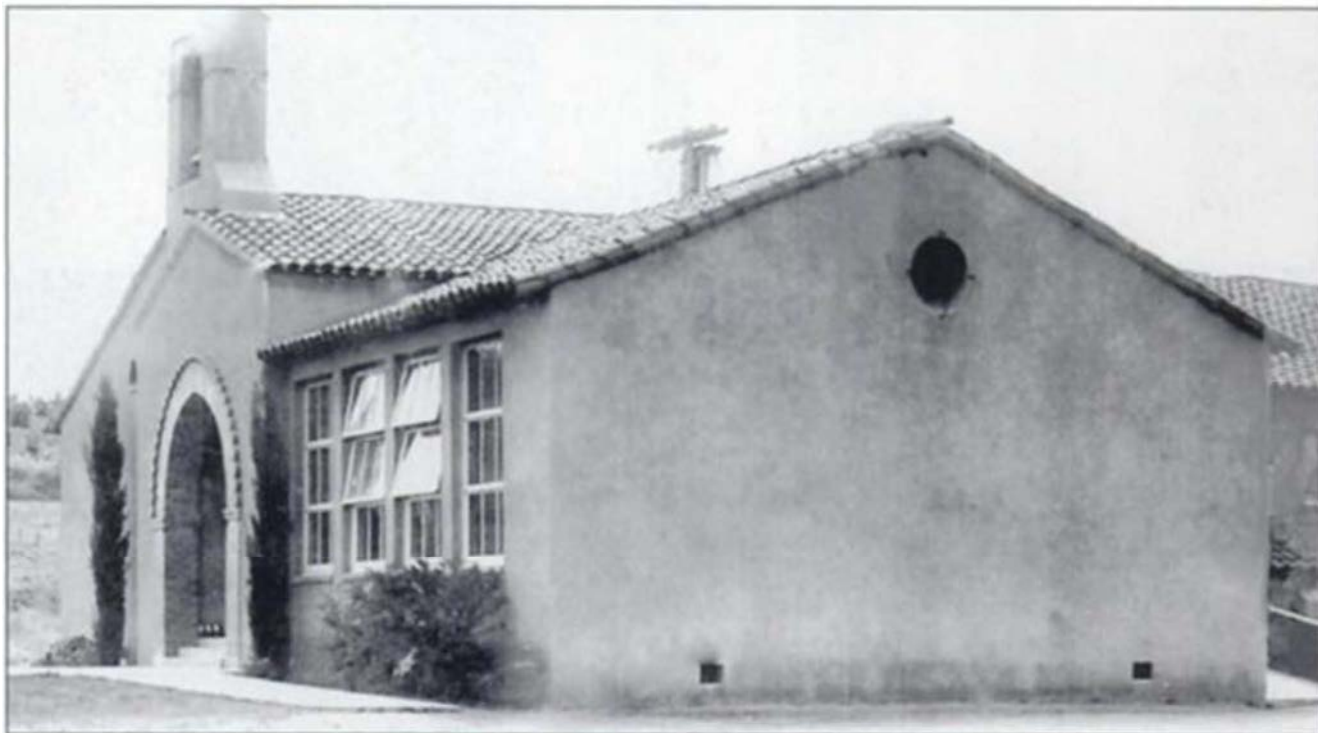
**Figure 4. Building #3, 1932 photograph of north façade (left) and west elevation (right) (Holtzclaw 2006).**

Built in 1929 (Figures 4 through 6), Building #3 is an excellent representation of the Mission Revival style. Originally built for the purpose of a school house. According to consultation with Eric Smith (Director of Facilities and Safety for the school district), from 1969 to 1991, this building was used as the District office for the Encinitas School District until the district staff moved to its current building located at 101 S. Rancho Santa Fe Rd (EUSD n.d.). The building returned to its original use as a school building.

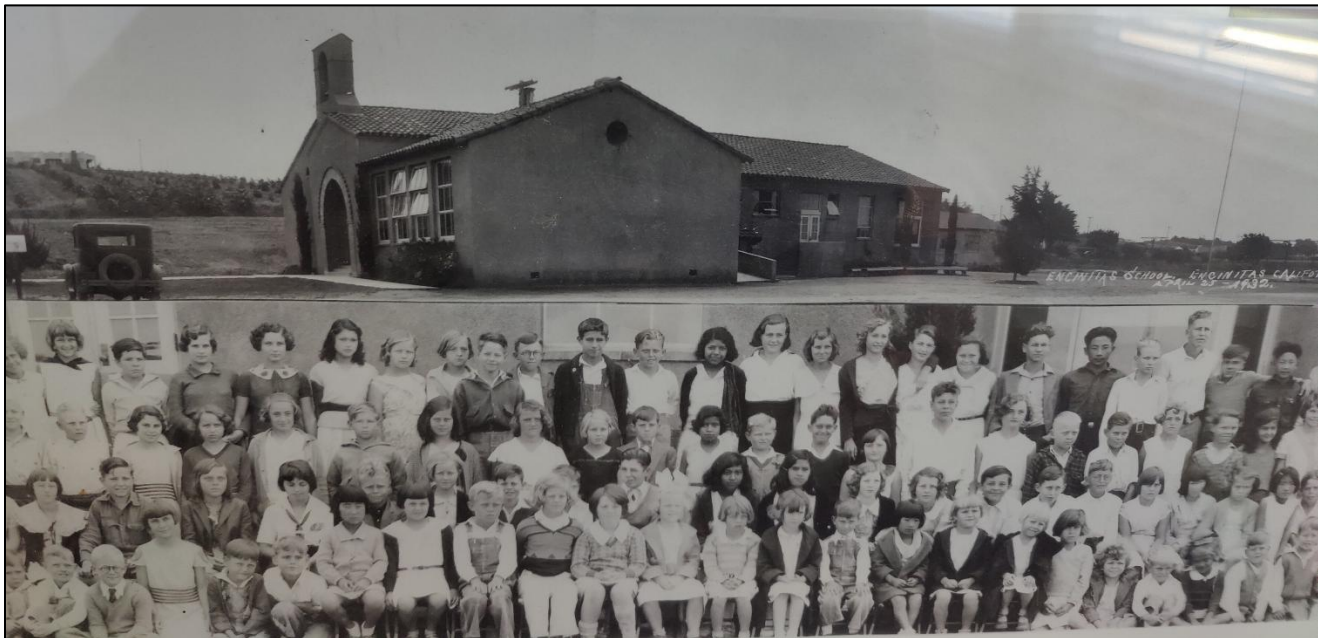
**Figure 5. “Encinitas School, Encinitas California, April 25 -1932”, Building #3 (photograph located at Paul Ecke Central Elementary).**

| NO. | LOCATION | FEATURE | DLRGroup 2025 DESIGN PLAN | COMPATIBILITY WITH SOI STANDARDS | IMAGE(S) |
|---|---|---|---|---|---|
| 6. | Western end of (recessed) south elevation and west elevation | Addition of secondary doors | Addition of double doors at western end of (recessed) south elevation and two single doors at west elevation. | <p><b>Acceptable but with conditions.</b> A review of a 1932 photograph (Figure #5) of the schoolhouse depicts a set of narrow double doors (wood frame with glass panes) and transom window near the midpoint of the west elevation (no longer extant). The photograph also depicts a shallow pitched access ramp (no longer extant) along the western end of the south elevation which indicates the presence of a door. A portion of the enclosure (topped with red tile roofed overhang) leading to the basement (no longer extant) is also visible.</p> <p>The 1998 reconstruction plans (Appendix C; Leidenfrost/Horowitz &amp; Associates 1998) for “Building 3” depicts double doors at the western end of the south elevation which were removed and filled in as a result of that project. Therefore, the 2025 proposed plan to install double doors in that exact location would restore a lost feature of the building’s original plan. This would be considered a positive to the building’s integrity of design.</p> <p>The 1998 reconstruction plans removed and filled in the openings for the original narrow pedestrian door and basement door (with access steps). Access to the basement was filled in with dirt and gravel to align with adjacent landscaping. The proposed 2025 Project plans will install two single pedestrian doors near the location of the building’s original (though no longer extant) doors. This installment will not restore the missing</p> | <p>2025 Proposed Project</p> <p>Basement access</p> <p>1998 Building 3 reconstruction plan. Doors were removed and openings filled in as part of Project. Basement access was also filled in with dirt and gravel.</p> |

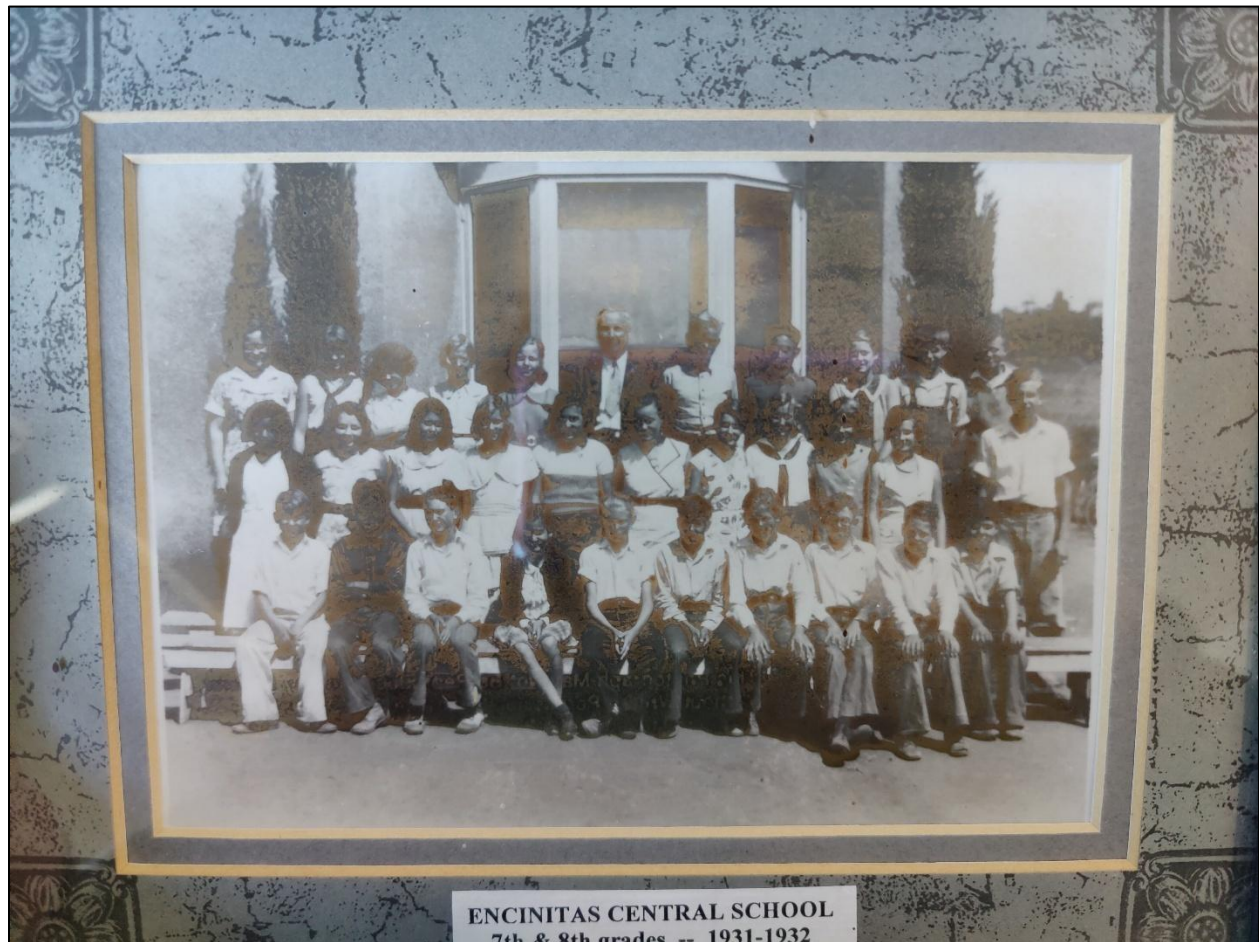
**Figure 6. “Encinitas Central School, 7<sup>th</sup> And 8<sup>th</sup> Grades, 1931-1932”, showing the southern end of the west elevation of Building #3 (photograph located at Paul Ecke Central Elementary).**

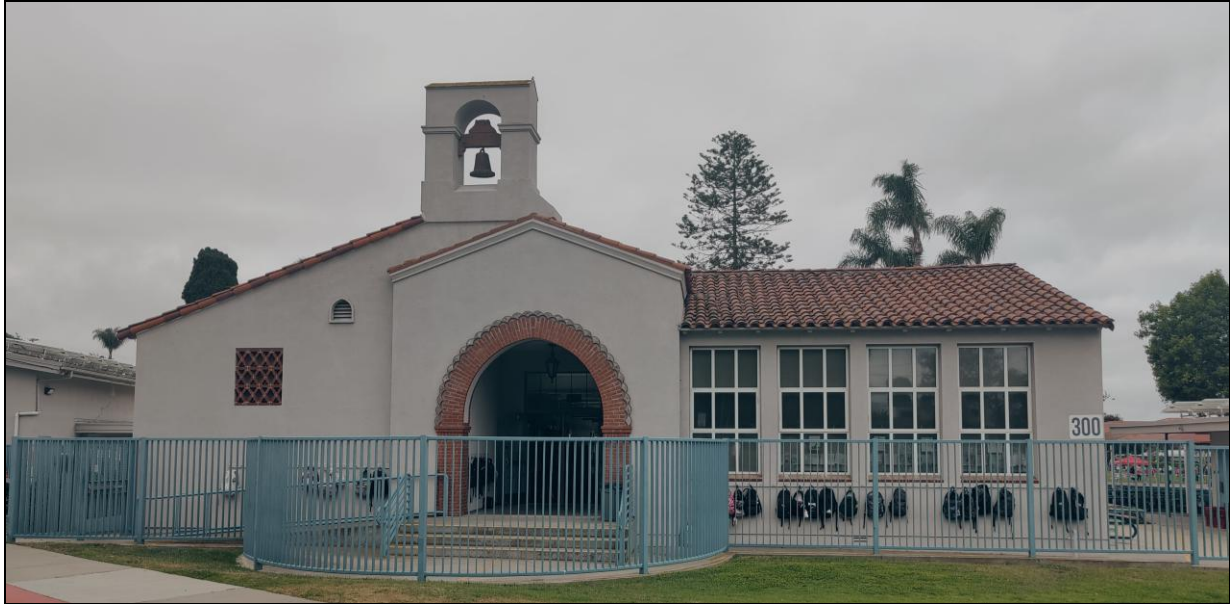
**Figure 7. Building #3, north elevation, facing south.**

Built in 1929, this school building is constructed in the Mission Revival style (Figures 7 through 14). The building is one story and has an L-shaped footprint and an intersecting gabled roof, with shallow to no eave overhang. The roof is clad in red Spanish tile. A belltower with a gabled roof and bell is at the north-facing end of the roof. The main entrance is located at the north façade and consists of an arched entryway with decorative red brick and concrete scalloped edges. The entrance is recessed with half glass double doors and 10-paned transom window. At the west end of the north façade are four large rectangular windows (three paneled with an outward facing awning window, nine-paned), organized in a set of four with brick windowsills. A decorative brick screen/lattice and bell-shaped louvered roof vent are at the eastern end of this façade.

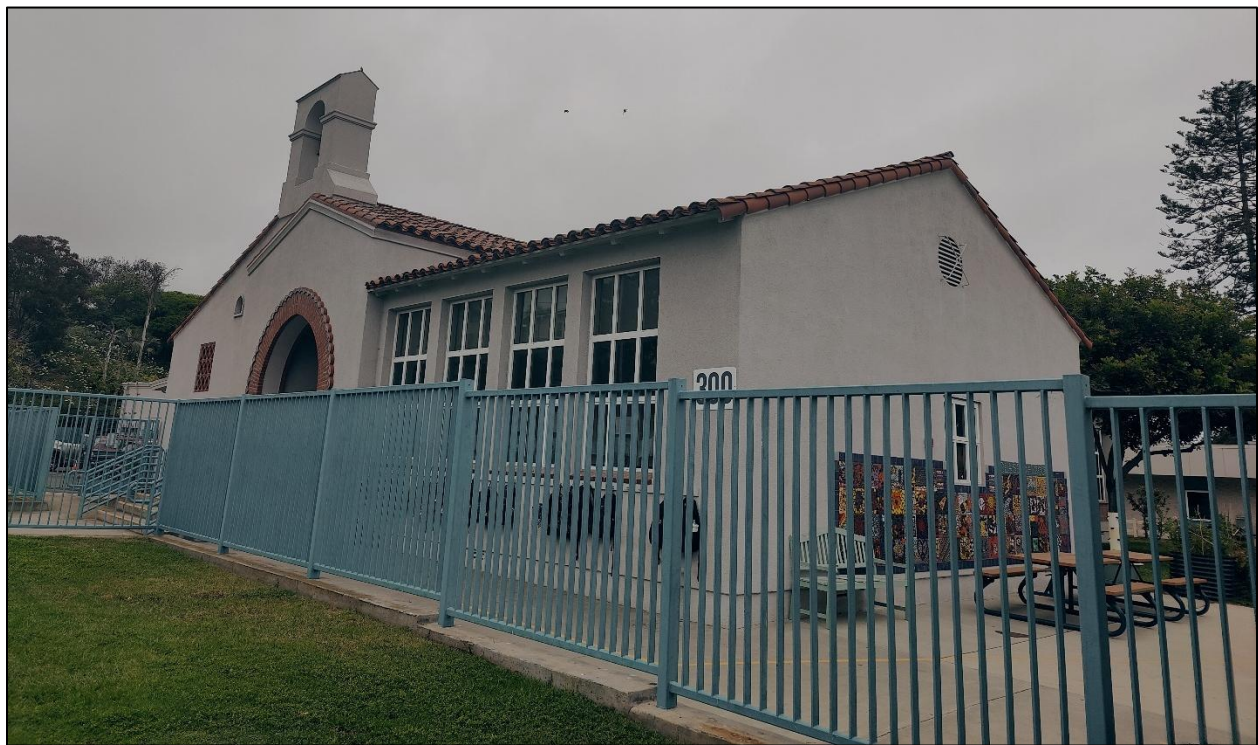
**Figure 8. Building #3, north façade (left) and partial view of west elevation, facing southeast**

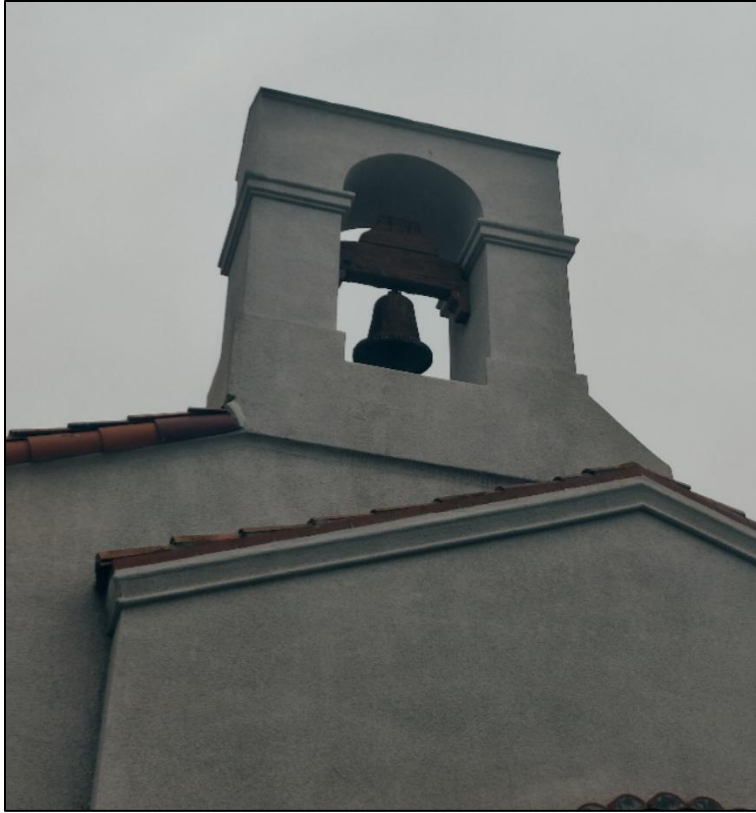
**Figure 9. Bell tower at north façade.**

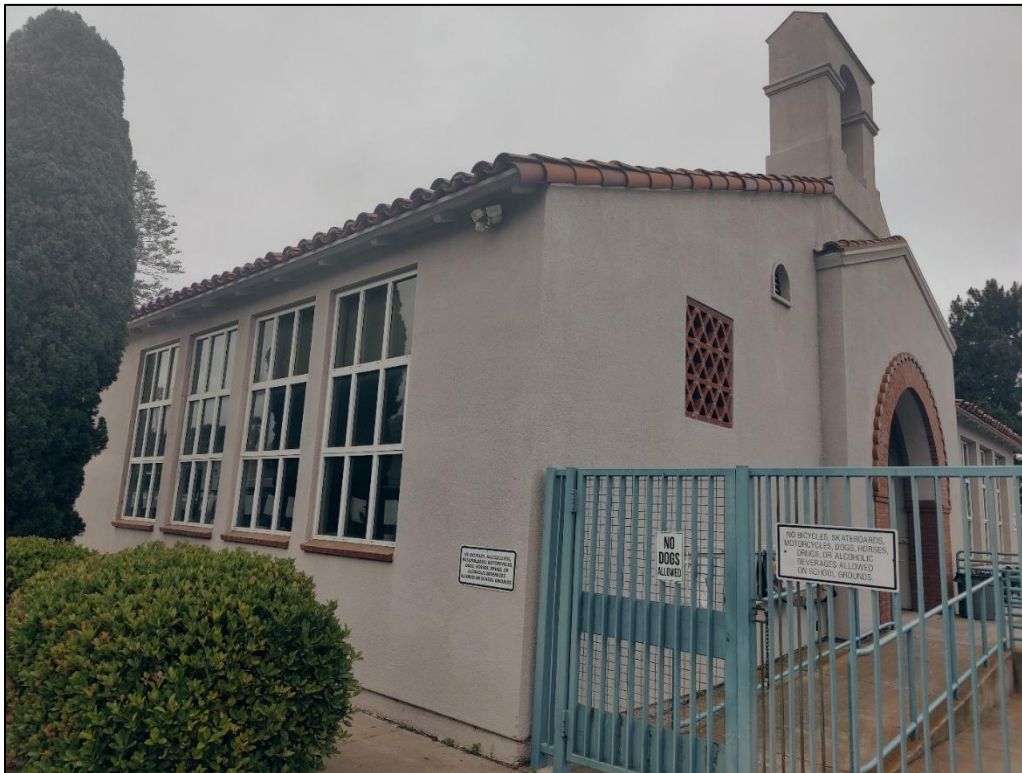
**Figure 10. Partial view of east elevation (left) and north façade (right), facing southwest**

The east elevation has three sets of rectangular windows organized in sets of four, with brick sills identical in material and design to the windows of the north façade. A concrete ADA compliant ramp and staircase is at the south elevation. At the gabled eave level are four louvered gabled vents, two large and two small. The entrance at the south elevation consists of a half glass, 4-paned, double doors with 10-paned transom window. The west elevation has multiple fixed windows of varying size. A recessed three-sided canted bay window with decorative brick at its base is at the southern end of this elevation. A small six-paned window is at the northern end of the west elevation, with a round louvered vent above it at the eave level.

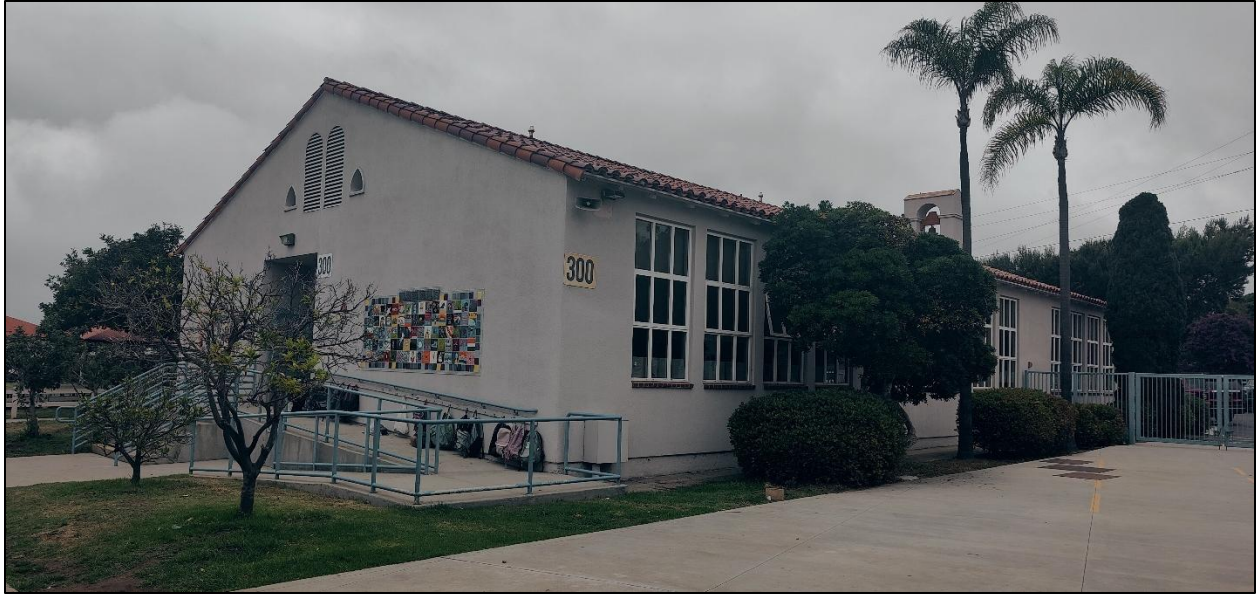
**Figure 11. South elevation (left) and east elevation (right), facing northwest.**

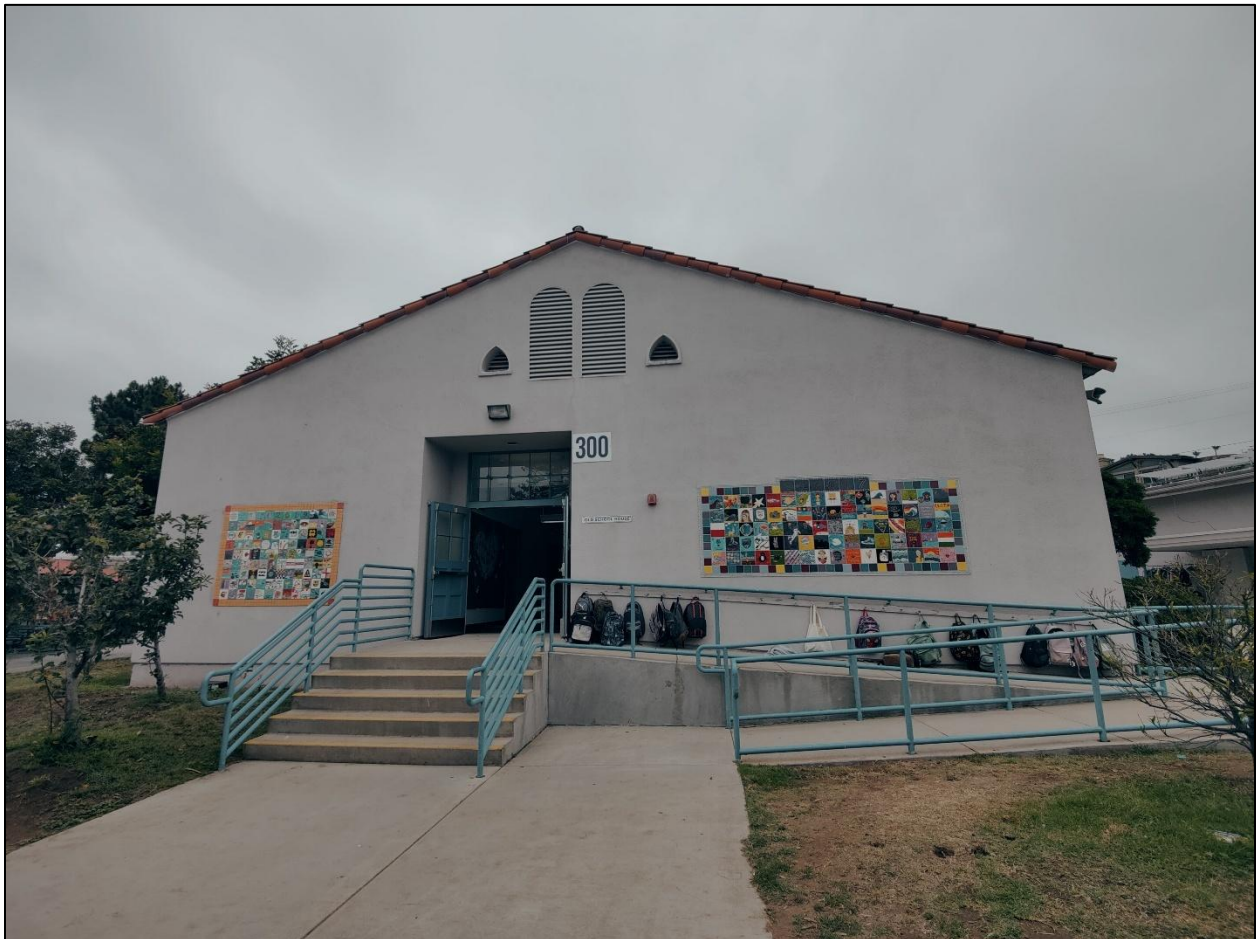
**Figure 12. South elevation, facing north.**

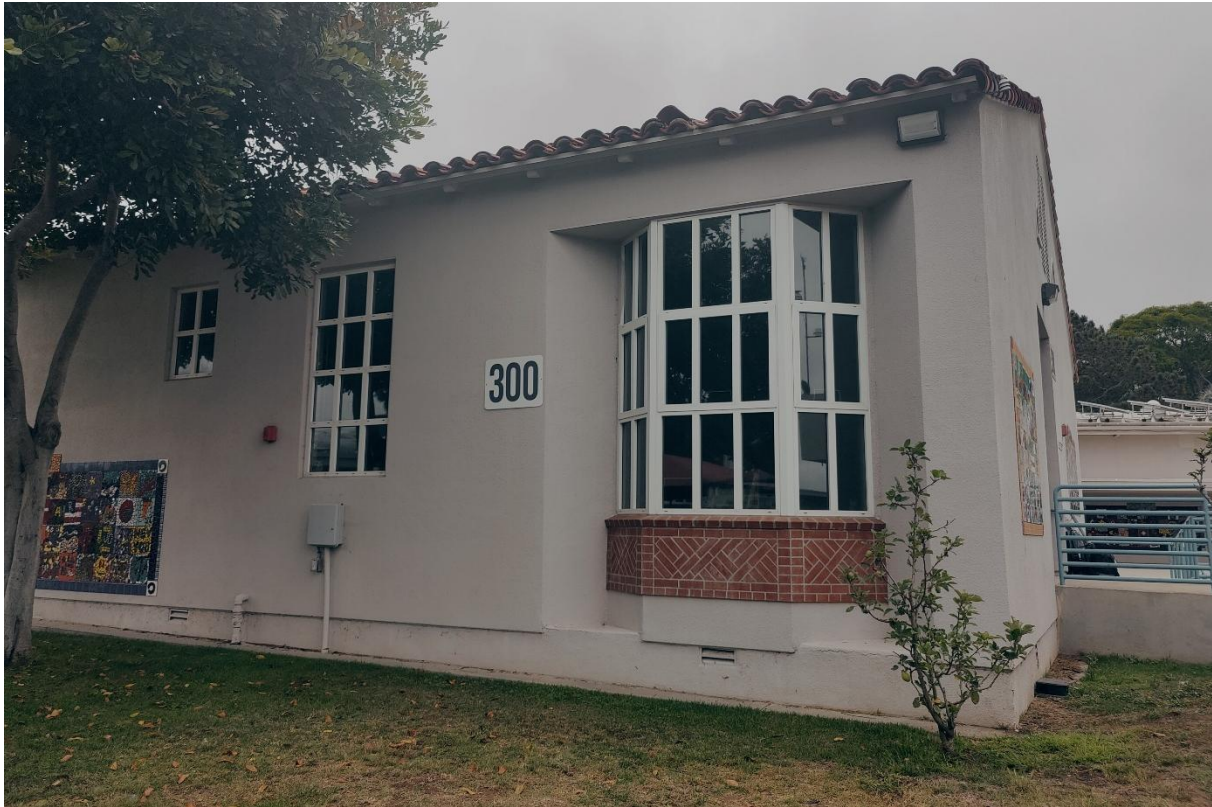
**Figure 13. Canted window and decorative brick apron at southern end of west elevation, facing east.**

- o *#5, Proposed work: Removal of canted bay window and brick apron to be replaced with a double-door and transom window.* The canted bay window and brick apron is a distinct character defining feature of this building. Removal of this feature would have a significant adverse impact on the building's historic design, workmanship, and feeling.

- #4: The primary entrance of this building is an important character defining feature that is visible to the public and should **not** be removed or altered in such a way that its original intended use is erased.
- #5: The canted bay window and decorative brick apron should be left extant as it is a unique character defining feature.
- #7: An alternative recommendation would be to mount said equipment out of the public's field of view such as in the existing carve-out at the southern facing segment of the roof.

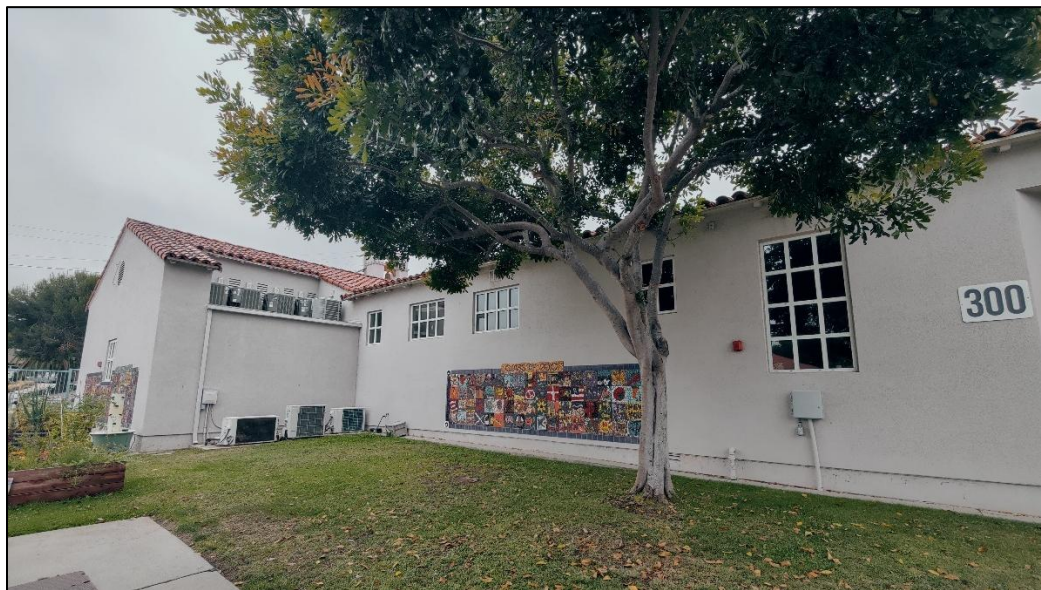
**Figure 14. Overview of west elevation, facing northeast.**

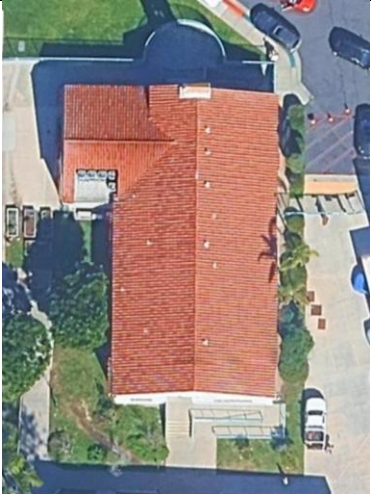
| Location | Feature | Comments | Photograph |
|---|---|---|---|
| Building Footprint | Building L-shaped footprint | Original L-shaped footprint of the building remains intact. | <div></div> <div>1932 USDA aerial photograph.<br/>Current aerial (Google Maps).</div> |

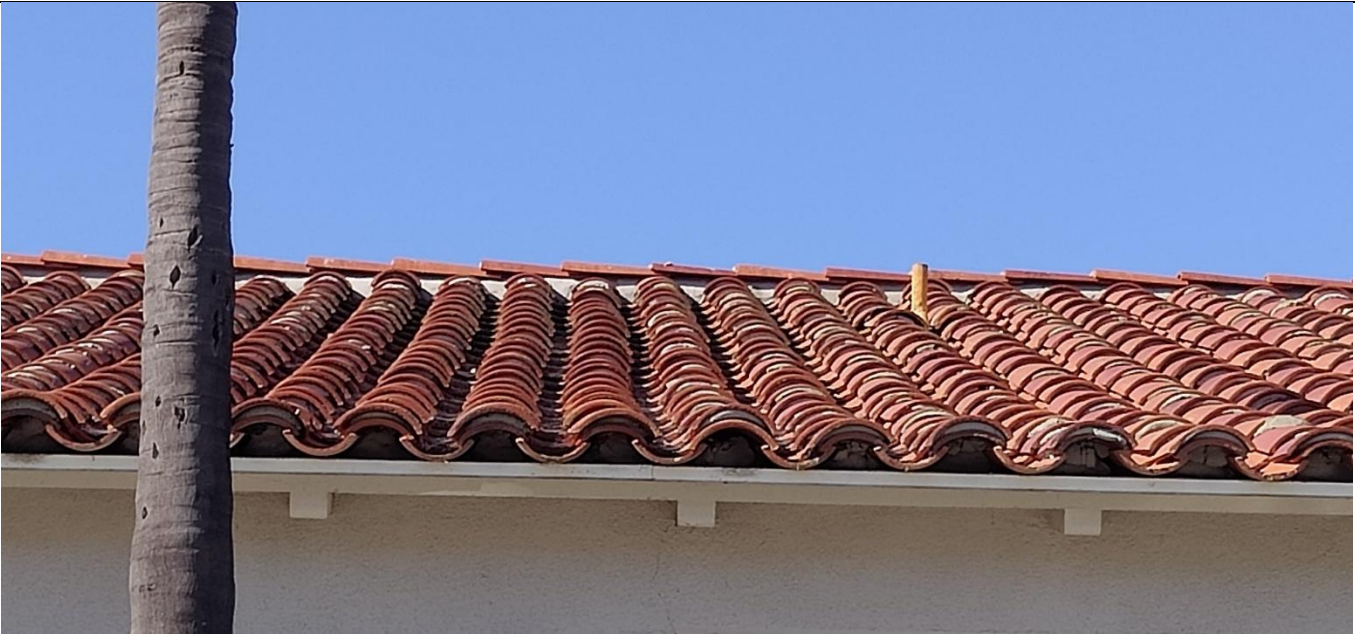
| Location | Feature | Comments | Photograph |
|---|---|---|---|
| Roof | Red Spanish style roof tile | Materials are replacement (replacement 1998) however the style of the tile is consistent with the original tile design. | |

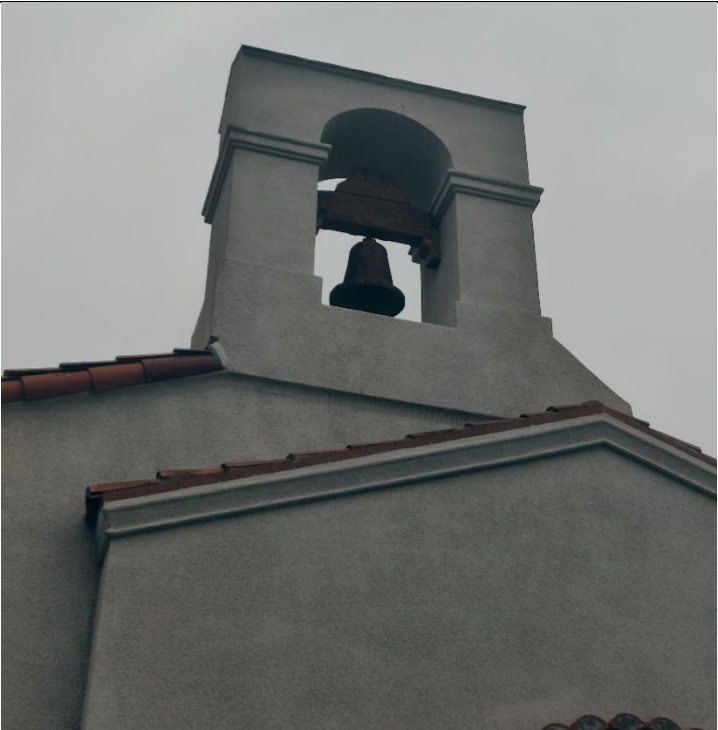
| Location | Feature | Comments | Photograph |
|---|---|---|---|
| Roof of north facade | Belltower and bell | Stucco and red tiles are likely replacements but are consistent with the original building design. Bell may be original. | |

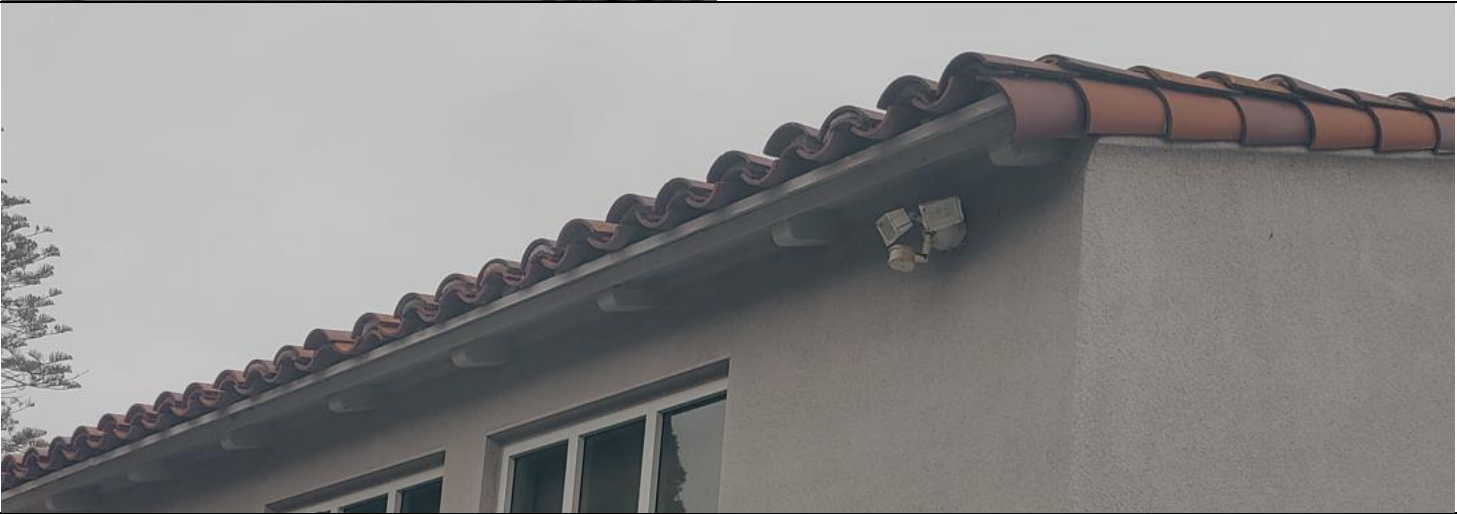
| Location | Feature | Comments | Photograph |
|---|---|---|---|
| Roof | Roof style and exposed eaves | Intersecting gabled roof with shallow to no eave overhang, exposed rafter tails at east and partial west elevations. | |

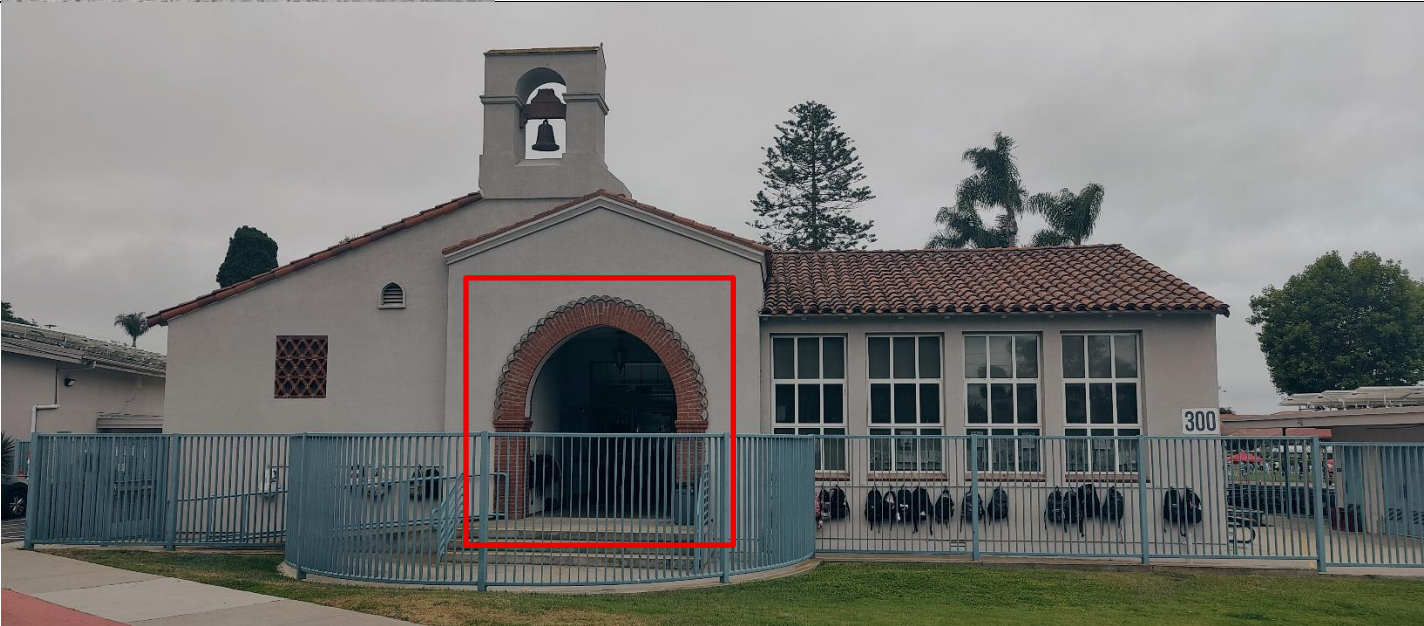
| Location | Feature | Comments | Photograph |
|---|---|---|---|
| North Facade | Primary entrance configuration | Recessed entrance, decorative brick archway, double doors (four panel glass, two-pane), and 10-pane transom windows. Materials are likely not original (replaced in 1998) but are consistent with the original building design. | <div></div> |

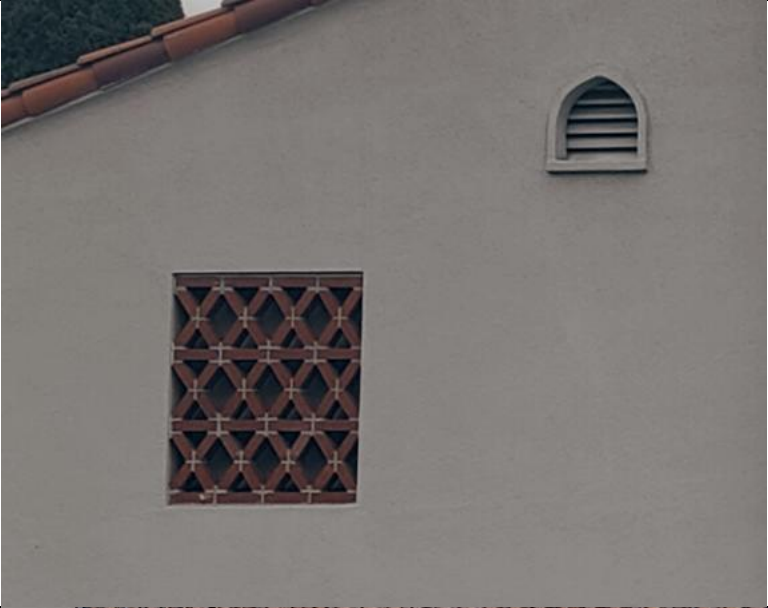
| Location | Feature | Comments | Photograph |
|---|---|---|---|
| North facade | Decorative brick screen/lattice and bell-shaped louvered roof vent | Materials are likely replacement from the 1998 renovation project. | |

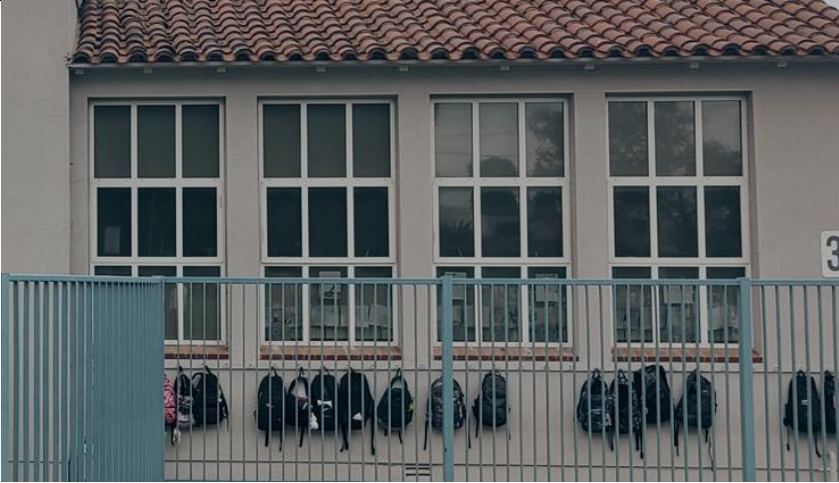
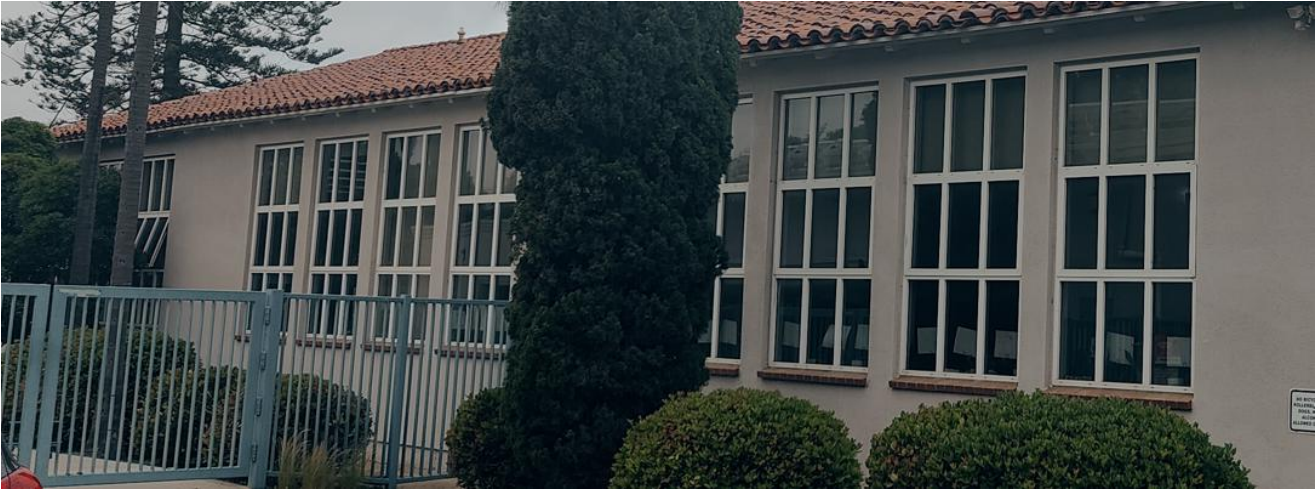
| Location | Feature | Comments | Photograph |
|---|---|---|---|
| Noth and east elevations | Window size, style, and configuration at the north and east elevations | The materials are replacements (replaced in 1998) but are consistent with the features' original design. | <div><p>North façade</p><p>East elevation</p></div> |

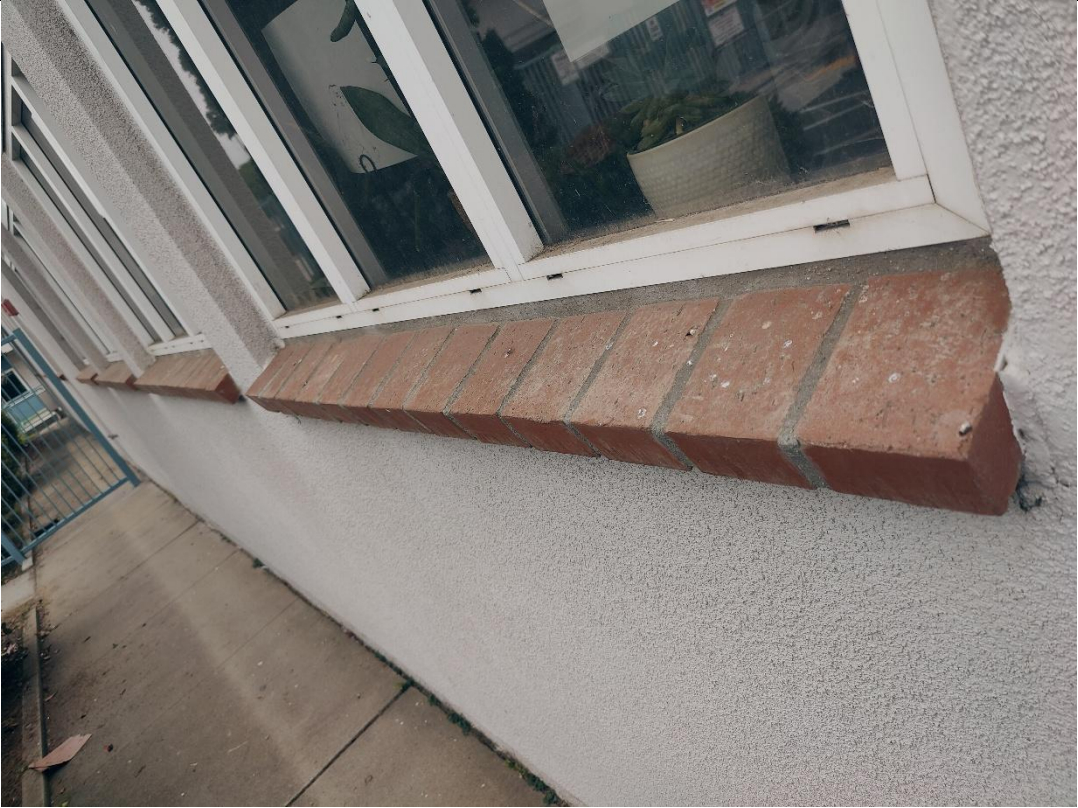
| Location | Feature | Comments | Photograph |
|---|---|---|---|
| North and east elevation | Red brick windowsills | Brick windowsills in a header course.<br><br>Materials are likely replacement (1998). | |

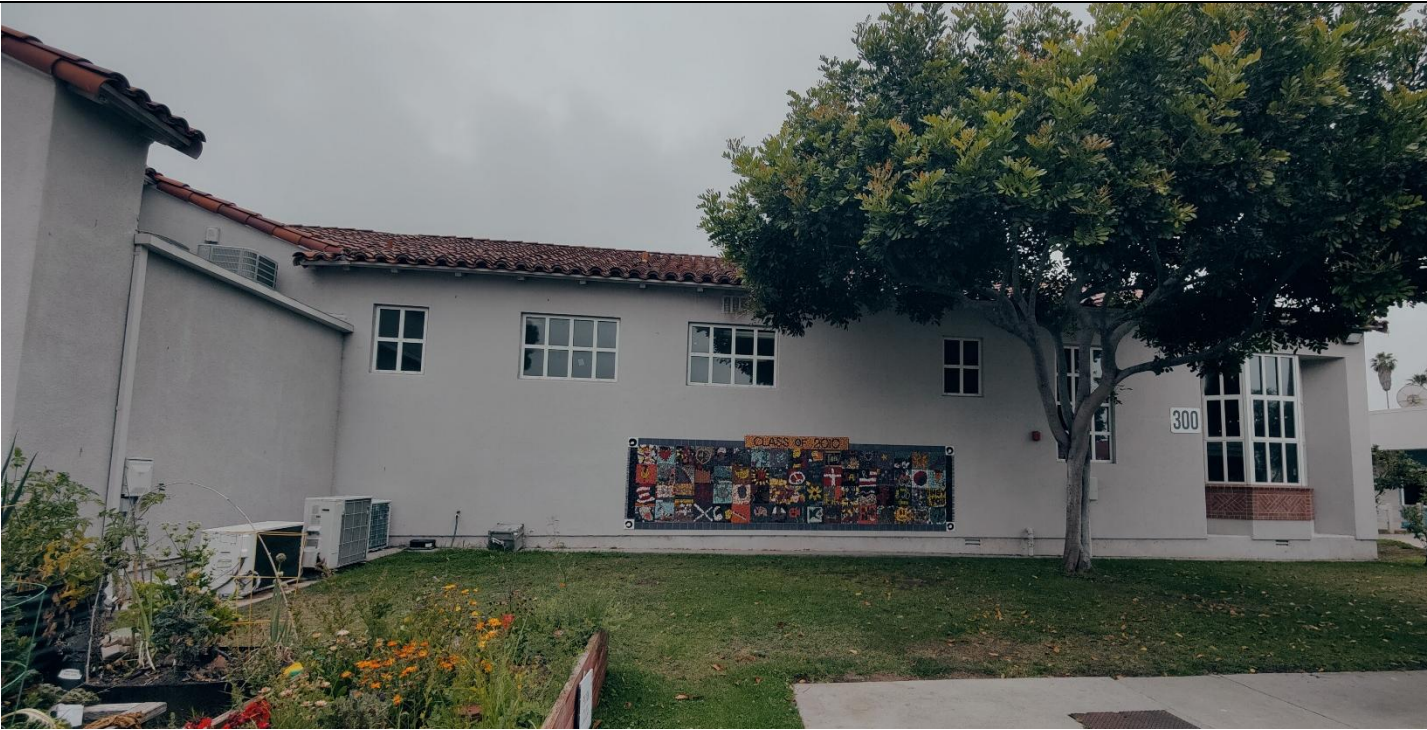
| Location | Feature | Comments | Photograph |
|---|---|---|---|
| West elevation | Window opening configuration at the west elevation | Window at the northernmost end of the west elevation (not captured in this photo) is not original to the building design. | |

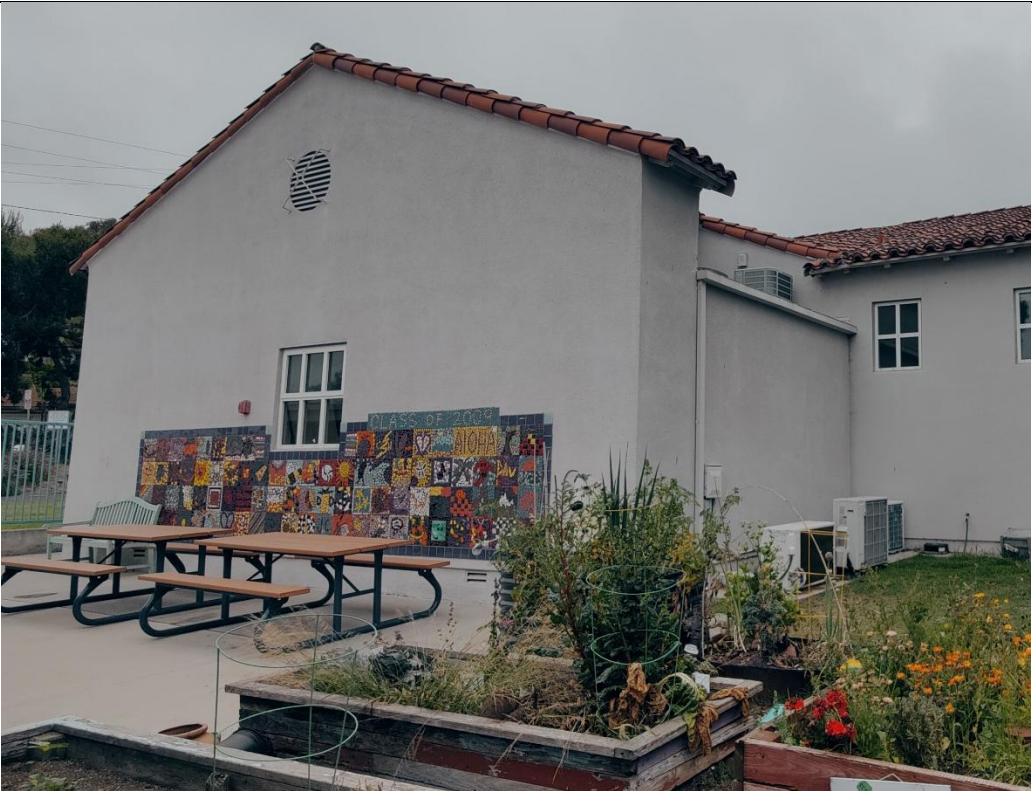
| Location | Feature | Comments | Photograph |
|---|---|---|---|
| Northern end of west elevation | Round louvered vent above it at the gabled eave level and two small rectangular floor vents | Window and mosaic are not original to the building design nor character defining features. | |

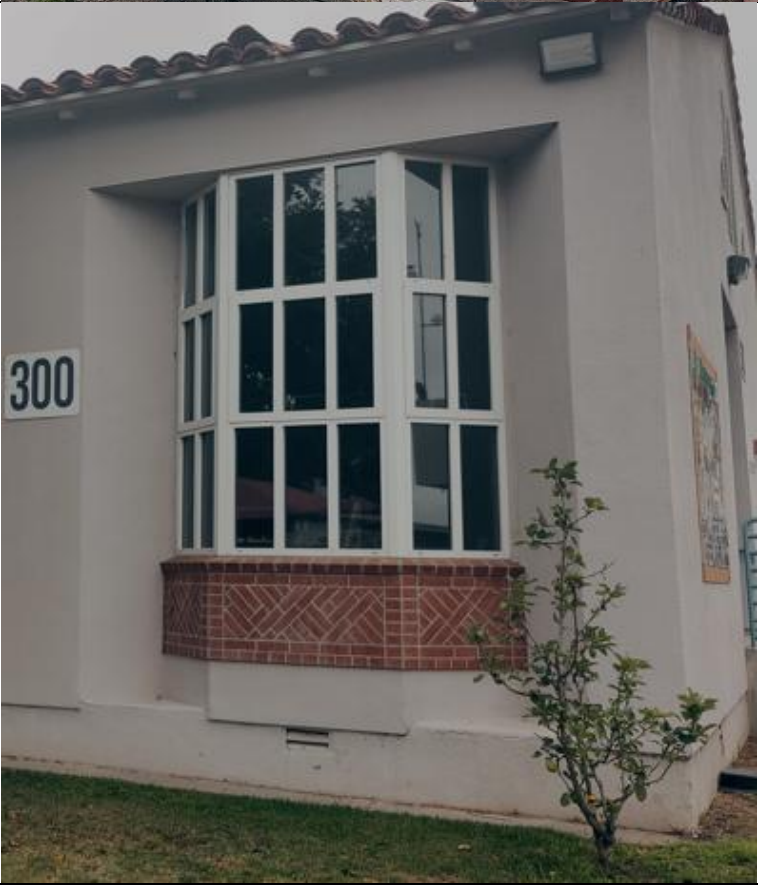
| Location | Feature | Comments | Photograph |
|---|---|---|---|
| South elevation of west elevation | Canted bay window and decorative brick apron | Materials are replacements but maintain the feature's original design. | |

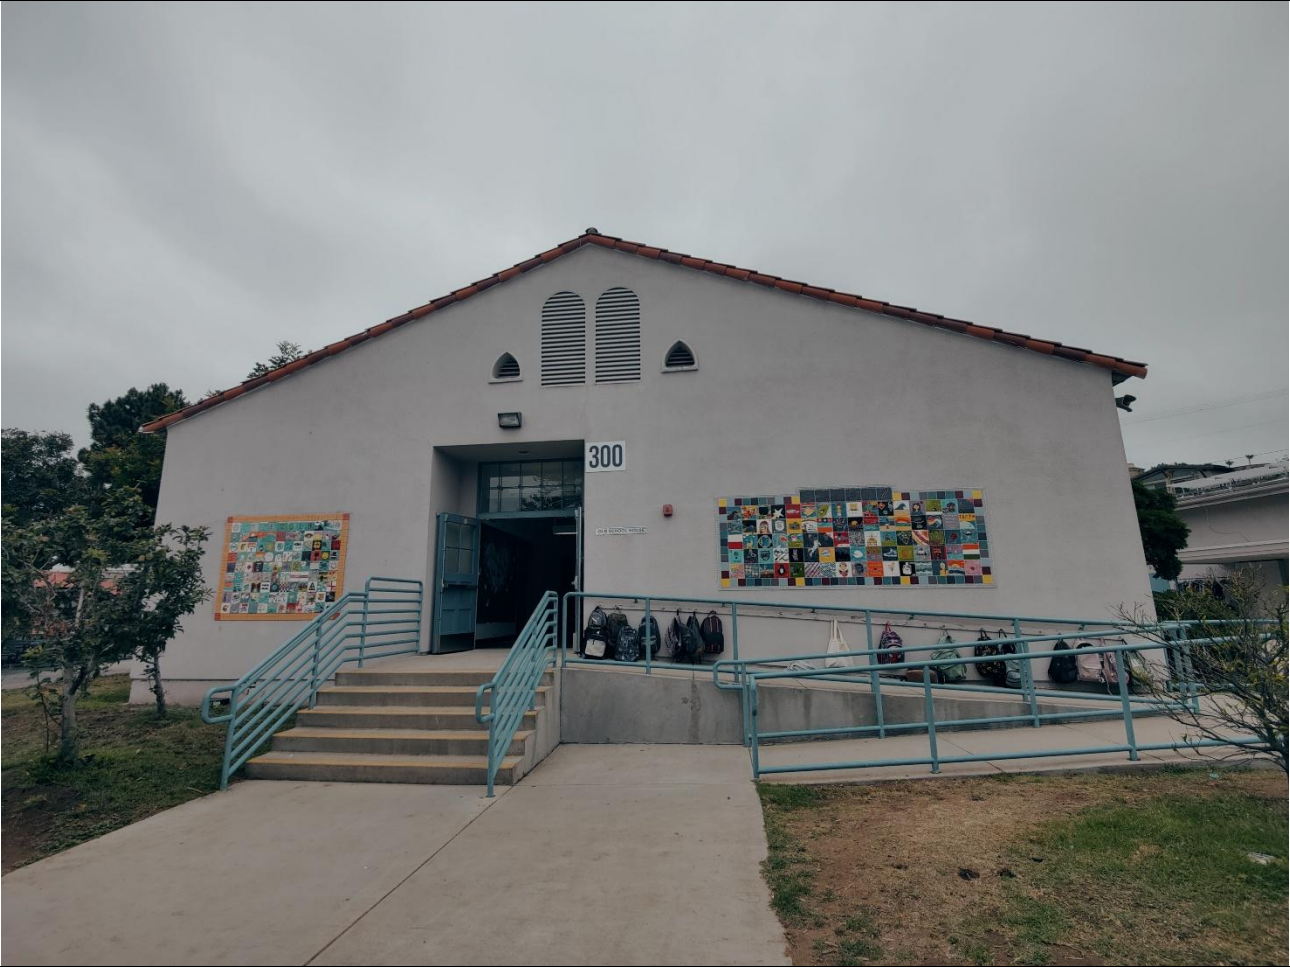
| Location | Feature | Comments | Photograph |
|---|---|---|---|
| South elevation | Configuration of secondary entrance at south elevation | <div>-Recessed entrance.</div> <div>-Double doors and 5-over-5 light transom window with decorative rosettes.</div> <div>Concrete ADA access ramp is not original to the building design and not a character defining feature.</div> | |

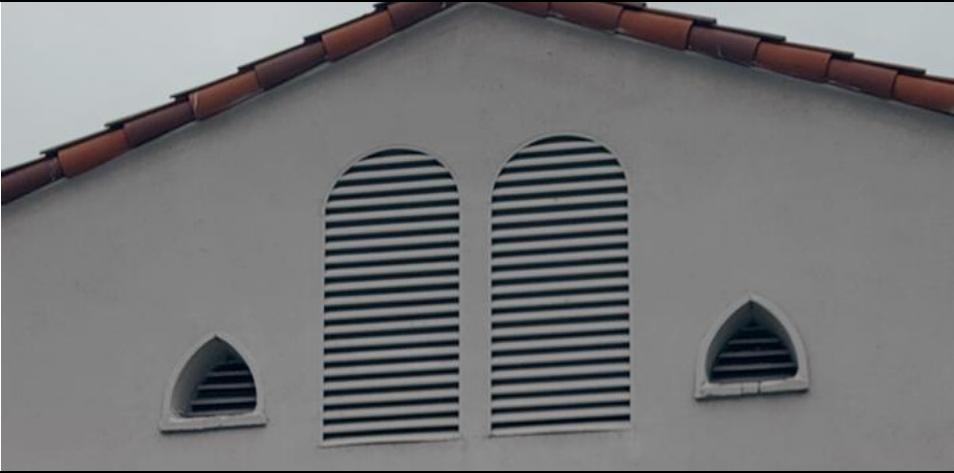
| Location | Feature | Comments | Photograph |
|---|---|---|---|
| South elevation | Louvered gable roof vents | - | |

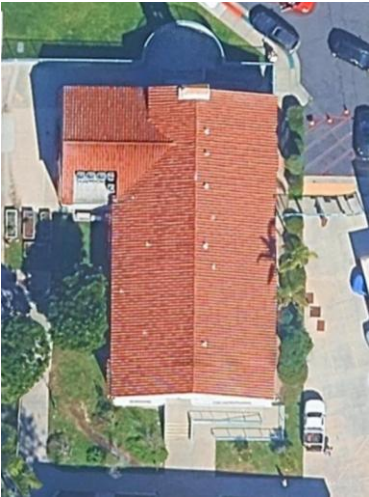
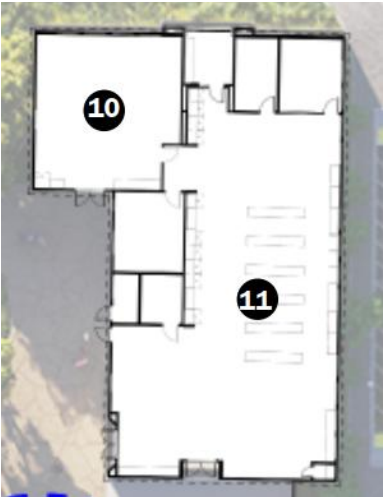
| NO. | LOCATION | FEATURE | DLRGroup 2025 DESIGN PLAN | COMPATIBILITY WITH SOI STANDARDS | IMAGE(S) |
|---|---|---|---|---|---|
| 1. | Exterior | Building Footprint | The building’s existing footprint will remain intact and not expanded. | <b>Yes.</b> The building’s current footprint is consistent with the building’s original design and will not be expanded as part of this Project. | <div></div> <div>1932 USDA aerial photograph.<span>Current aerial (Google Maps).</span><span>Proposed Footprint.</span></div> |

- The building's overall architectural style (Mission Revival style) will not be changed as the Project will maintain key features such as the building's footprint, red tile roof (will be replaced with like materials), stucco exterior, bell tower, and bell.
