# **APPENDIX 3.3-3**

## **SECRETARY OF THE INTERIOR (SOI)**

### **COMPATIBILITY ASSESSMENT FOR THE OLD**

### **SCHOOLHOUSE**

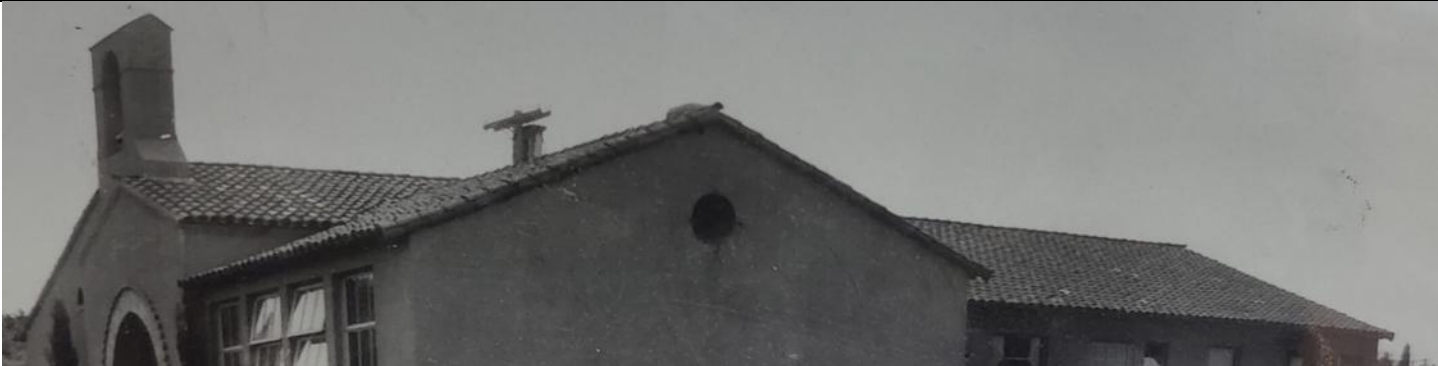
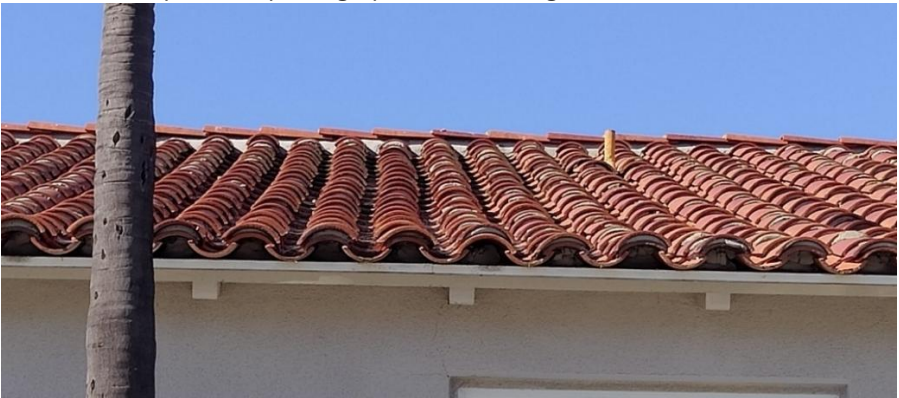
| NO. | LOCATION | FEATURE | DLRGroup 2025 DESIGN PLAN | COMPATIBILITY WITH SOI STANDARDS | IMAGE(S) |
|---|---|---|---|---|---|
| 2. | Exterior | Roof | Replacement of terracotta tile roof with like material, no exposed mortar as exists now. | <p><b>Yes.</b> The Project proposes replacing the current tiles (replacements as of ca. 1999) with like materials. A review of a 1932 photograph of the building shows the original tiles are consistent with style and materials of the existing replacement tiles. The 1932 photograph also shows the original tiles were flush with no visible exposed mortar. Therefore, the decision to remove the exposed mortar as part of the Project would be congruous with the building’s original design.</p> <p>The decision to remove the exposed mortar is to reduce overall weight as the existing roof structure is not rated for the current weight load.</p> | <div></div> <div>April 1932 photograph of roof configuration and tiles.<span>October 2025 roof tile configuration and materials.</span></div> |

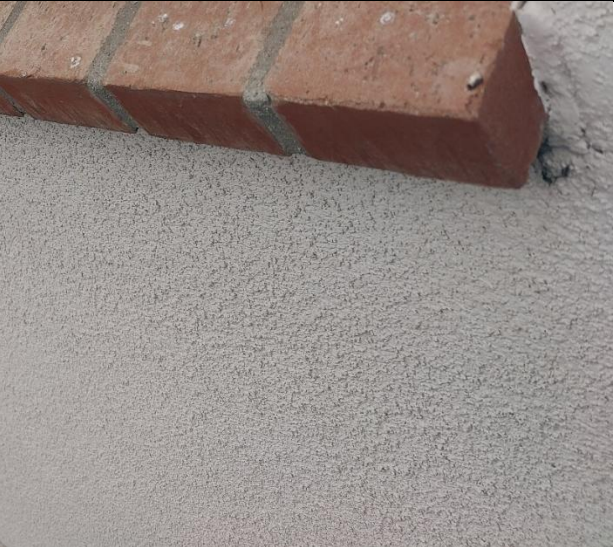
| NO. | LOCATION | FEATURE | DLRGroup 2025 DESIGN PLAN | COMPATIBILITY WITH SOI STANDARDS | IMAGE(S) |
|---|---|---|---|---|---|
| 3. | Exterior | Stucco cladding | Stucco cladding to remain. | <b>Yes.</b> The exterior stucco cladding is a character defining feature of this building and retention of this feature is compatible with the building’s original design. | |

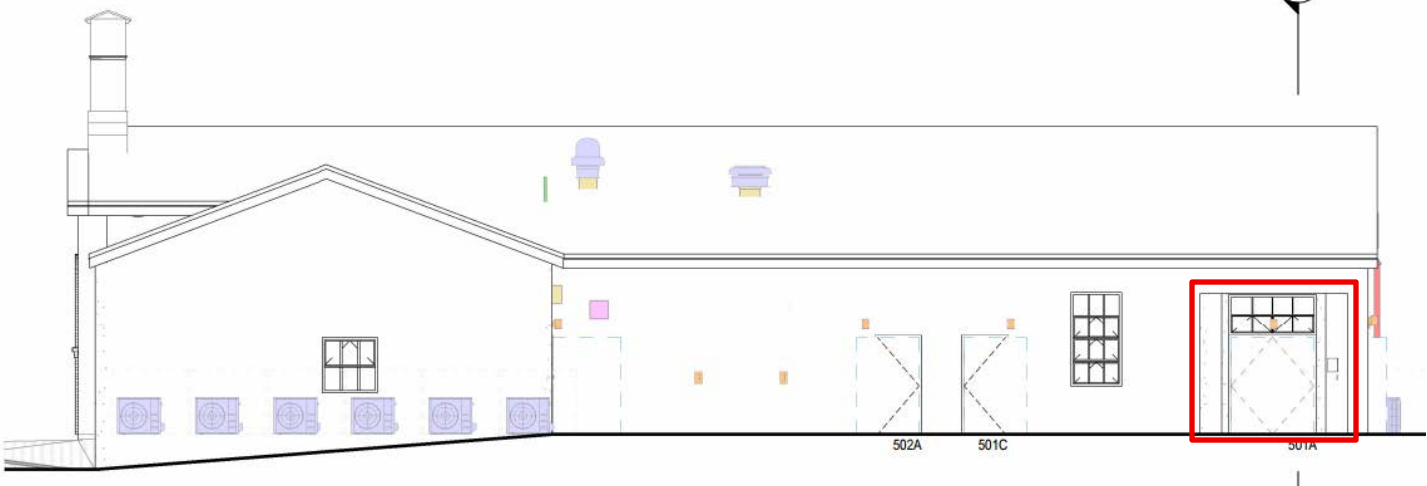
| NO. | LOCATION | FEATURE | DLRGroup 2025 DESIGN PLAN | COMPATIBILITY WITH SOI STANDARDS | IMAGE(S) |
|---|---|---|---|---|---|
| 5. | Southern end of west elevation | Canted bay window and decorative brick apron | Removal of window and brick apron to be replaced with a double-door and transom window. | <p><b>No.</b> The canted bay window and brick apron is a distinct character defining feature of this building. Removal of this feature would have a significant adverse impact on the building’s historic design, workmanship, and feeling.</p> <p>This alteration is not compatible with the SOI standards for Rehabilitation: #2. <i>The historic character of a property will be retained and preserved. The removal of distinctive materials or alteration of features, spaces and spatial relationships that characterize a property will be avoided.</i>”</p> | <p>Proposed alteration</p> |

- o #5, proposed work: Removal of canted bay window and brick apron to be replaced with a double-door and transom window. The canted bay window and brick apron is a distinct character defining feature of this building.

- #4: The primary entrance of this building is an important character defining feature that is visible to the public and should **not** be removed or altered in such a way that its original intended use is erased.
- #5: The canted bay window and decorative brick apron should be left extant as it is a unique character defining feature.
- #7: An alternative recommendation would be to mount said equipment out of the public's field of view such as in the existing carve-out at the southern facing segment of the roof.

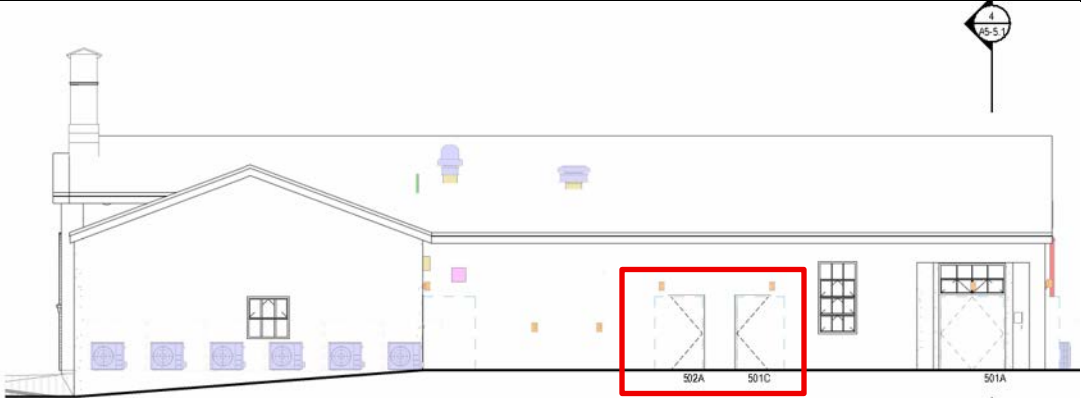
| NO. | LOCATION | FEATURE | DLRGroup 2025 DESIGN PLAN | COMPATIBILITY WITH SOI STANDARDS | IMAGE(S) |
|---|---|---|---|---|---|
| 6. | Western end of (recessed) south elevation and west elevation | Addition of secondary doors | Addition of double doors at western end of (recessed) south elevation and two single doors at west elevation. | <p><b>Acceptable but with conditions.</b> A review of a 1932 photograph (Figure #5) of the schoolhouse depicts a set of narrow double doors (wood frame with glass panes) and transom window near the midpoint of the west elevation (no longer extant). The photograph also depicts a shallow pitched access ramp (no longer extant) along the western end of the south elevation which indicates the presence of a door. A portion of the enclosure (topped with red tile roofed overhang) leading to the basement (no longer extant) is also visible.</p> <p>The 1998 reconstruction plans (Appendix C; Leidenfrost/Horowitz &amp; Associates 1998) for “Building 3” depicts double doors at the western end of the south elevation which were removed and filled in as a result of that project. Therefore, the 2025 proposed plan to install double doors in that exact location would restore a lost feature of the building’s original plan. This would be considered a positive to the building’s integrity of design.</p> <p>The 1998 reconstruction plans removed and filled in the openings for the original narrow pedestrian door and basement door (with access steps). Access to the basement was filled in with dirt and gravel to align with adjacent landscaping. The proposed 2025 Project plans will install two single pedestrian doors near the location of the building’s original (though no longer extant) doors. This installment will not restore the missing</p> | <p>2025 Proposed Project</p> <p>Basement access</p> <p>1998 Building 3 reconstruction plan. Doors were removed and openings filled in as part of Project. Basement access was also filled in with dirt and gravel.</p> |

| NO. | LOCATION | FEATURE | DLRGroup 2025 DESIGN PLAN | COMPATIBILITY WITH SOI STANDARDS | IMAGE(S) |
|---|---|---|---|---|---|
| | | | | architectural features but will reflect an architectural precedent seen in the original design. <b>However, the installation of these doors must not result in the removal of the existing window openings on this segment of elevation as those openings are most likely part of the building’s original design (according to review of historic photographs and the 1998 reconstruction plans) and are considered a character defining feature.</b> | <p>Proposed doors</p> |

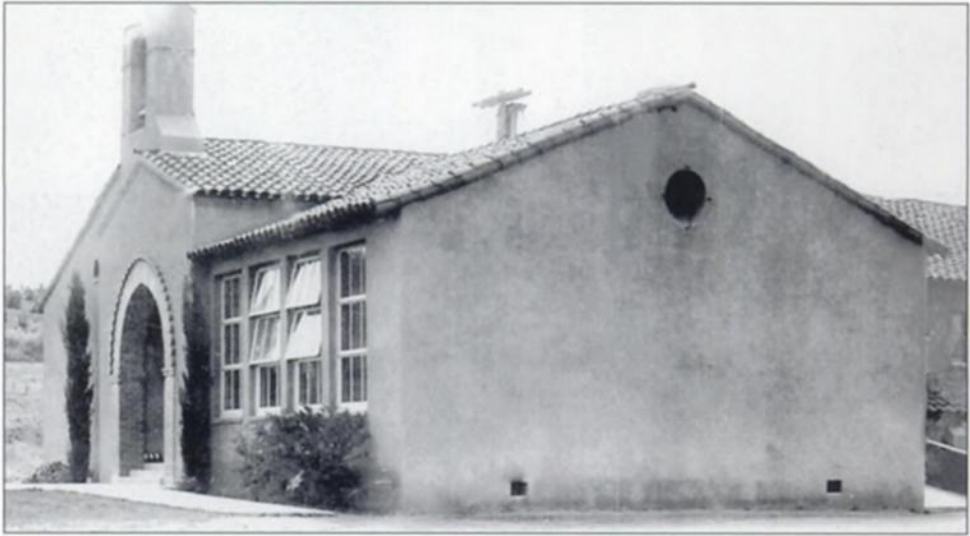
| NO. | LOCATION | FEATURE | DLRGroup 2025 DESIGN PLAN | COMPATIBILITY WITH SOI STANDARDS | IMAGE(S) |
|---|---|---|---|---|---|
| 7. | Northern end of west elevation | Exterior wall <ul style="list-style-type: none"><li>• Removal of mosaic murals, patch and repair finish.</li><li>• Installation of HVAC units/mechanical equipment at the lower portion of the exterior wall.</li></ul> | | <p><b>Yes.</b> The mosaic is not a contributing character defining feature of this building. Removal of the mosaic mural would have no adverse impact on the significance of the building. This action would also remove a non-historic visual element from this segment of wall which was originally unadorned.</p> <p><b>Not recommended.</b> A review of a 1932 photograph of the building shows this segment of the west elevation originally consisted of a round gable roof vent and two small rectangular ground level vents. While these three features remain extant, a small window has been added (date unknown) as well as the existing mosaic (added ca. 2009). The removal of the mosaic would restore a portion of the wall’s original “bare” design; however, the addition of the HVAC units/mechanical equipment would negatively impact the visual character of this portion of the building’s design as seen from the public right of way. An alternative recommendation would be to mount said equipment out of the public’s field of view such as in the existing carve-out at the southern facing segment of the roof.</p> | <p>Proposed alteration</p> <p>1932 photograph of northern end of west elevation.</p> |

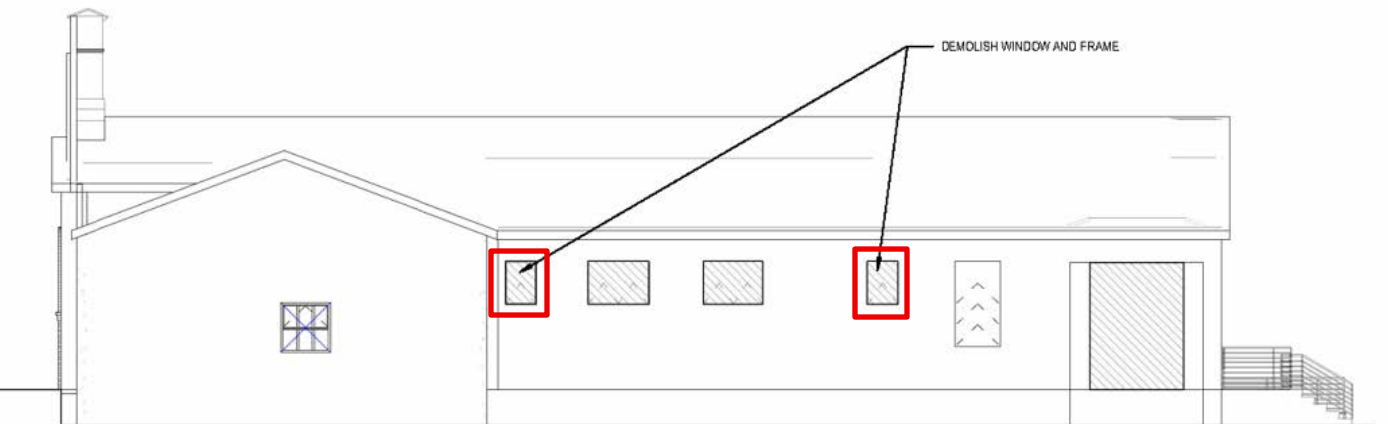
| NO. | LOCATION | FEATURE | DLRGroup 2025 DESIGN PLAN | COMPATIBILITY WITH SOI STANDARDS | IMAGE(S) |
|---|---|---|---|---|---|
| 8. | West elevation | Small windows at west elevation | Removal of window and infill of window openings | <b>No.</b> According to a review of the 1932 historic photograph and 1998 reconstruction plans of this elevation, these window openings are most likely part of the building's original fenestration design and their removal would have an adverse impact of the building's integrity of design. (Note: the window materials are replacements and not original to the building). | <p>2025 Proposed Plan</p> |

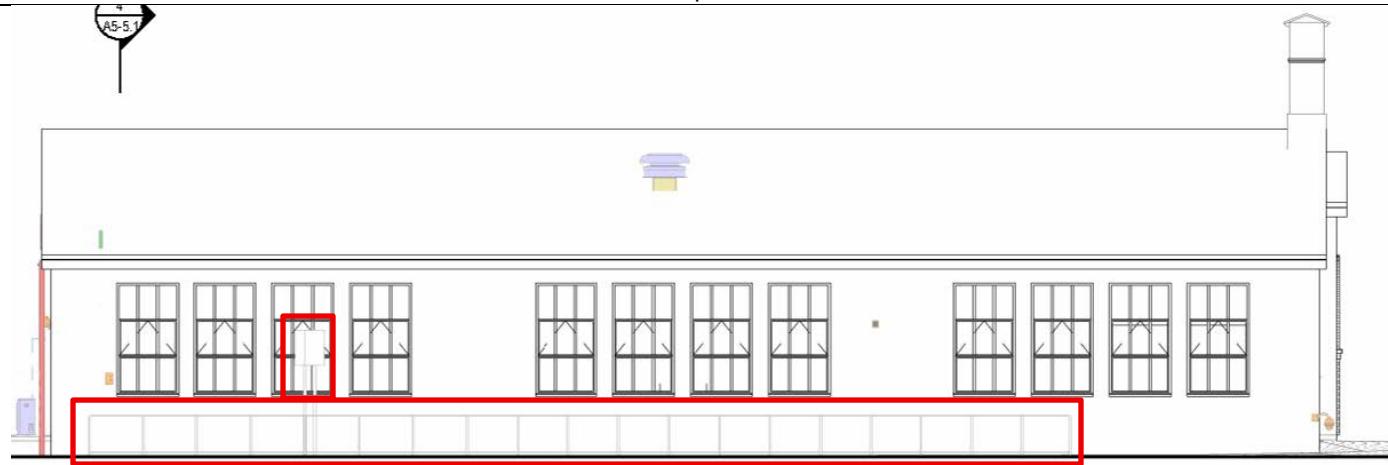
| NO. | LOCATION | FEATURE | DLRGroup 2025 DESIGN PLAN | COMPATIBILITY WITH SOI STANDARDS | IMAGE(S) |
|---|---|---|---|---|---|
| 9. | East elevation | Mechanical equipment | Addition of mechanical equipment along ground level of elevation and raised electrical box at southern end of elevation | <b>Acceptable.</b> Equipment will be primarily ground level at the exterior of the elevation and largely obscured from public view. It is recommended that vegetation be maintained in this area to help obscure view of the equipment. | <p>2025 Proposed Plan</p> |

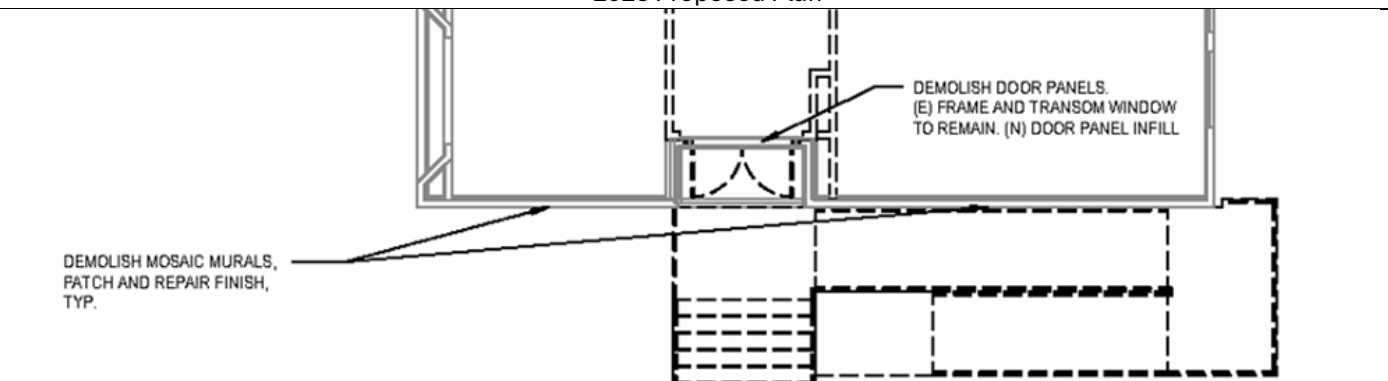
| NO. | LOCATION | FEATURE | DLRGroup 2025 DESIGN PLAN | COMPATIBILITY WITH SOI STANDARDS | IMAGE(S) |
|---|---|---|---|---|---|
| 10. | Exterior, south elevation | Double doors, stairs and ramp | Replacement of door panels and removal of existing stairs and ramp. Frame and transom window to remain. | <b>Acceptable with recommendation.</b> While the original door design is not known (though likely composed of wood as common for the time period) it is unlikely the existing doors are original to the building (likely replacements installed in 1998). Therefore, their replacement would not have a significant adverse impact on the historic integrity of the overall building. It is recommended that the replacement door panels have a similar design to their predecessor as the half glass design is harmonious with the overhead transom window's design.<br><br>Removal of the existing stairs and ramp is compatible with the SOI standards as they are neither historic in age nor a character defining feature. | |

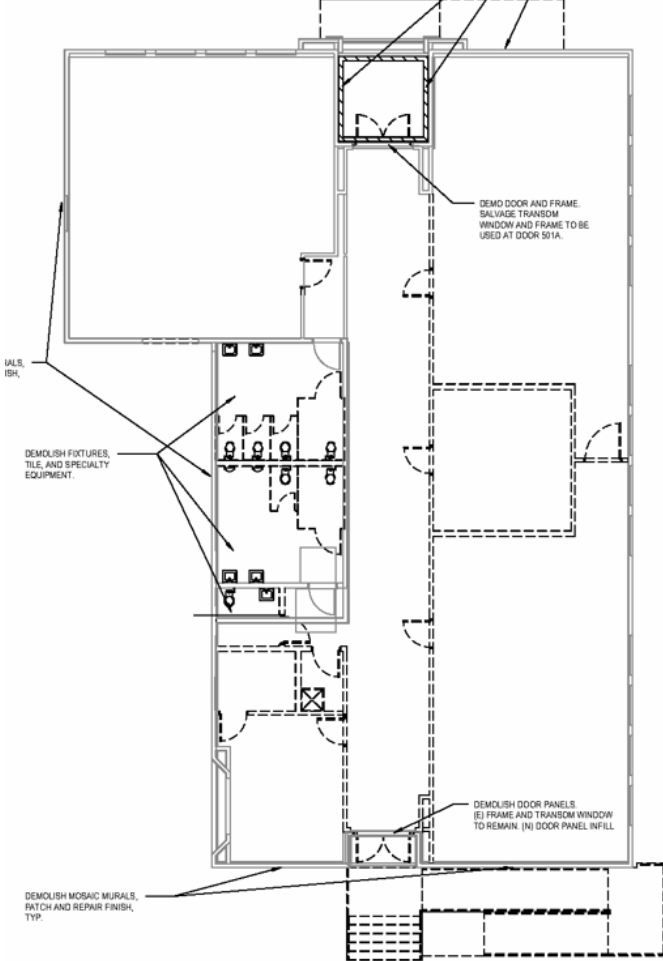
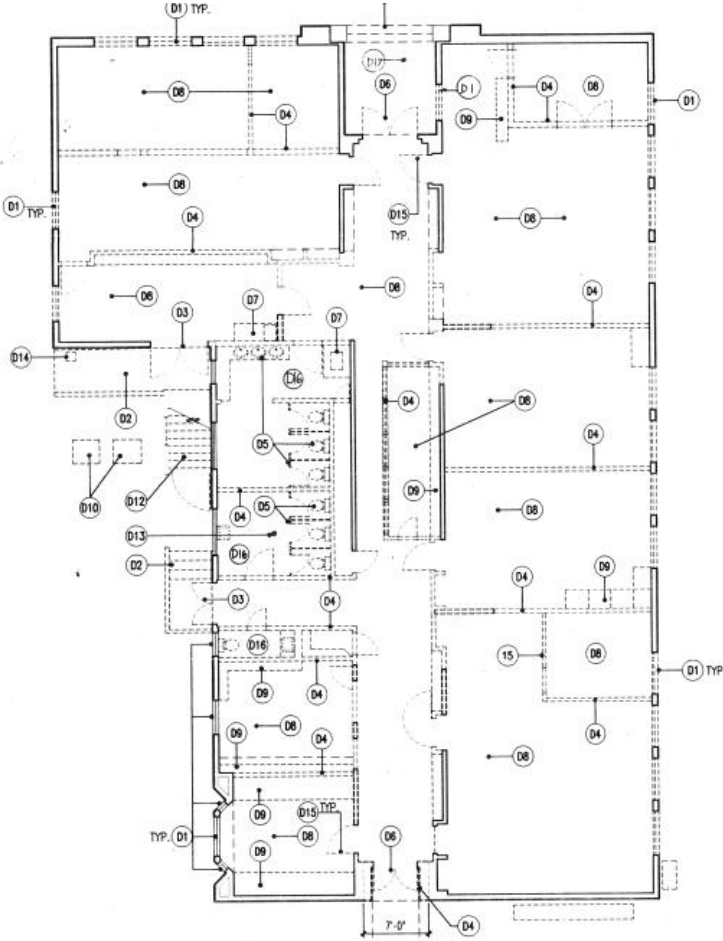
| NO. | LOCATION | FEATURE | DLRGroup 2025 DESIGN PLAN | COMPATIBILITY WITH SOI STANDARDS | IMAGE(S) |
|---|---|---|---|---|---|
| 11. | Interior | Classrooms | <p>Demolition of walls dividing Classroom 22, Room 25, Classroom 21, Classroom 24, and Custodian closet</p> | <p><b>Acceptable.</b> Despite in depth research attempts, and coordination with the EUSD, information depicting the original interior layout of the Old School House could not be located. The 1998 Building 3 Reconstruction plan indicated substantial demolition of previously existing room partitions but it is not clear if those rooms were part of the building’s original floor plan.</p> <p>The Project will convert the new open space for use as a library which is congruous with the schoolhouse’s historic use as an educational building. The space at the northwest corner of the building will continue its use as a private classroom portioned off from the rest of the building. The rooms used for restrooms will remain; however, use will be converted to other purposes such as storage. Additional, smaller, secondary spaces will be added at the northeast portion of the building’s interior, including the proposed reading nook in the building’s primary entrance way (impacts addressed in No. 4), storage room, and multipurpose room.</p> <p>As the original floor plan of the building is not known, it is unclear if the proposed demolition of partitioned spaces will have an adverse or non-adverse impact on the building’s integrity of interior design. With the exception of the proposed reading nook, these alterations in general will not have an adverse impact on the exterior of the building and will not negatively impact the building’s eligibility for historic listing.</p> | <div><p>2025 Proposed Project floor plan (with proposed demolition).</p></div> <div><p>1998 reconstruction floor plan (with proposed demolition and wall construction)</p></div> |

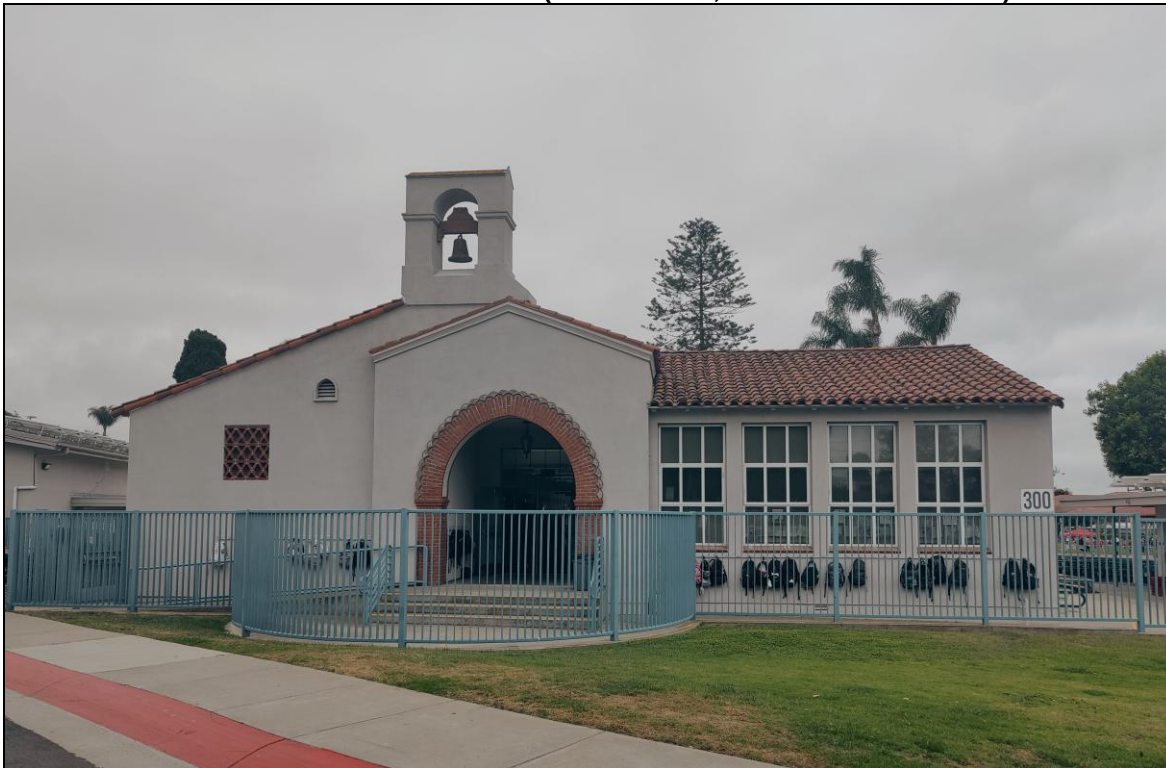
**Building #3: north elevation, facing south.**

Windows at the north façade are large, awning type, nine-glass panes each (replacements), organized in sets of seven which allow ample natural light. At the eave level of the south elevation (rear of the building) are horizontal rectangular windows, three-panes each with false muntins (replacements), organized in sets of seven. Also at the south elevation is a wide eaved porch overhang that spans the entirety of the elevation and is supported by steel poles. While this building's windows are all replacements, their style and size match the originals as seen in the 1947 design plans. The original wood paneled doors and wood paneled doors with wire framed plate glass windows have been replaced with contemporary heavy doors with narrow horizontal glass windows.

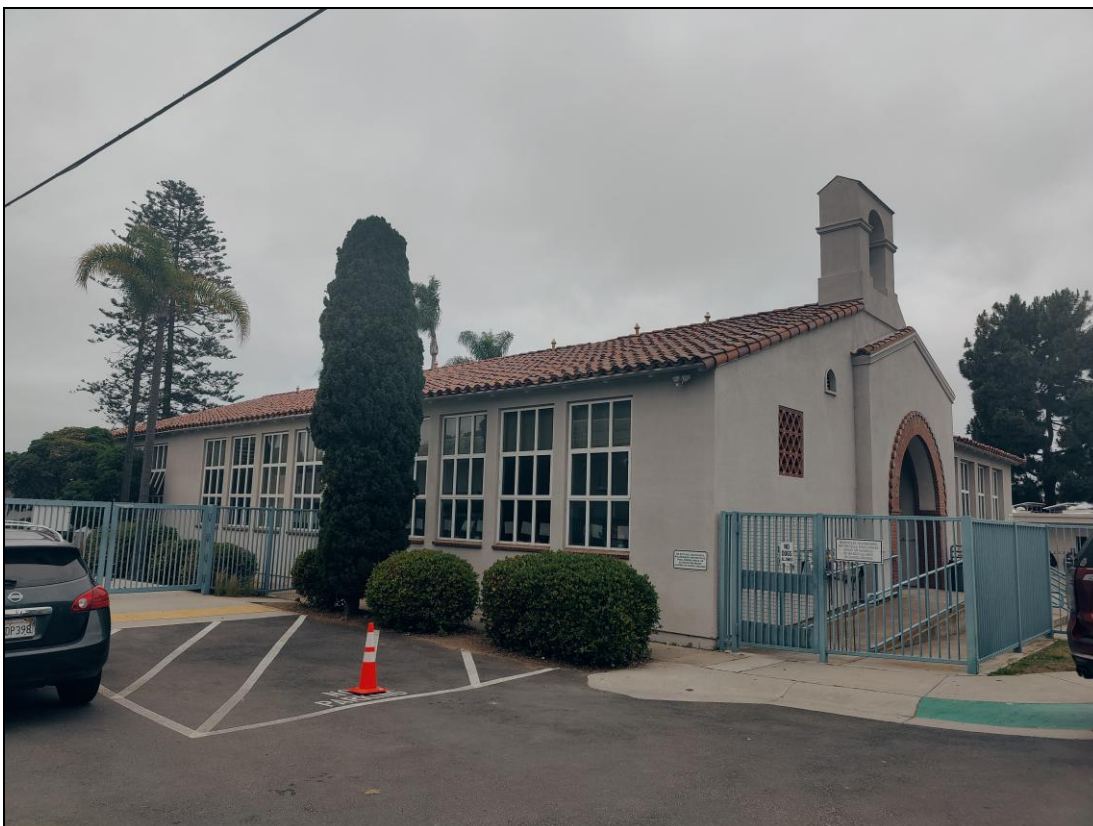
**Building #3: east elevation (left) and north façade (right), facing southwest.**

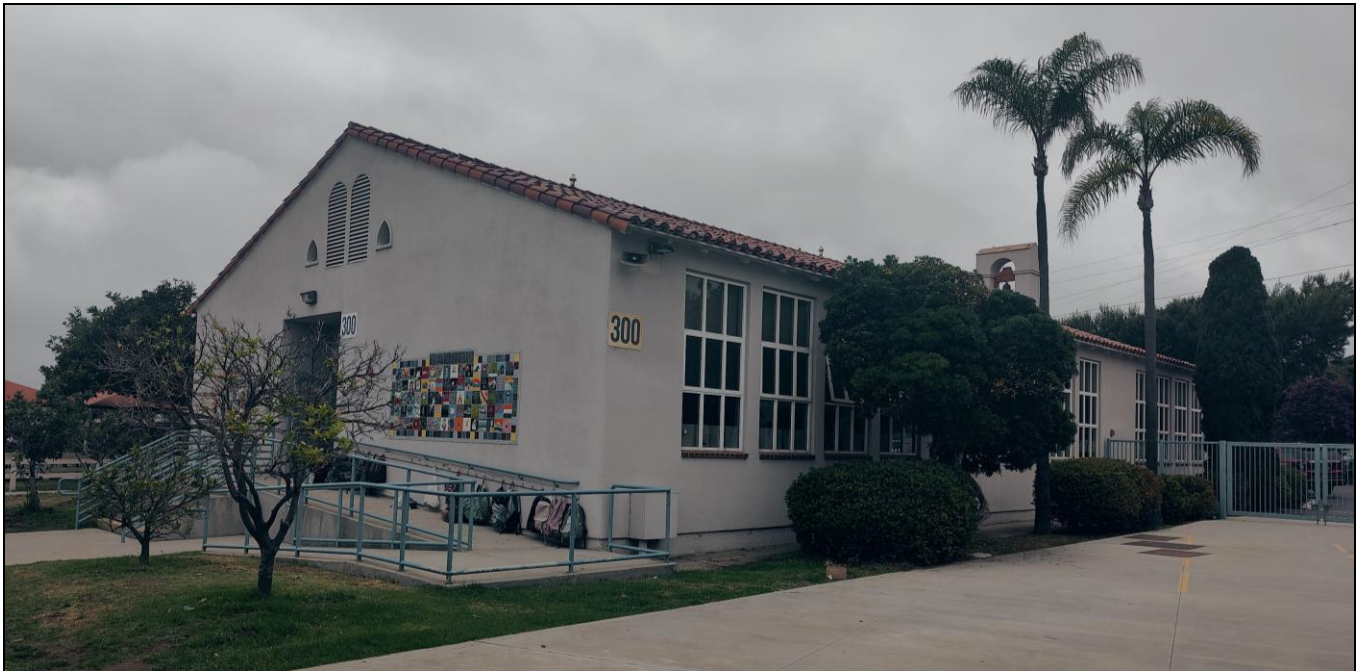
Building #3: south elevation (left) and east elevation (right), facing northwest.

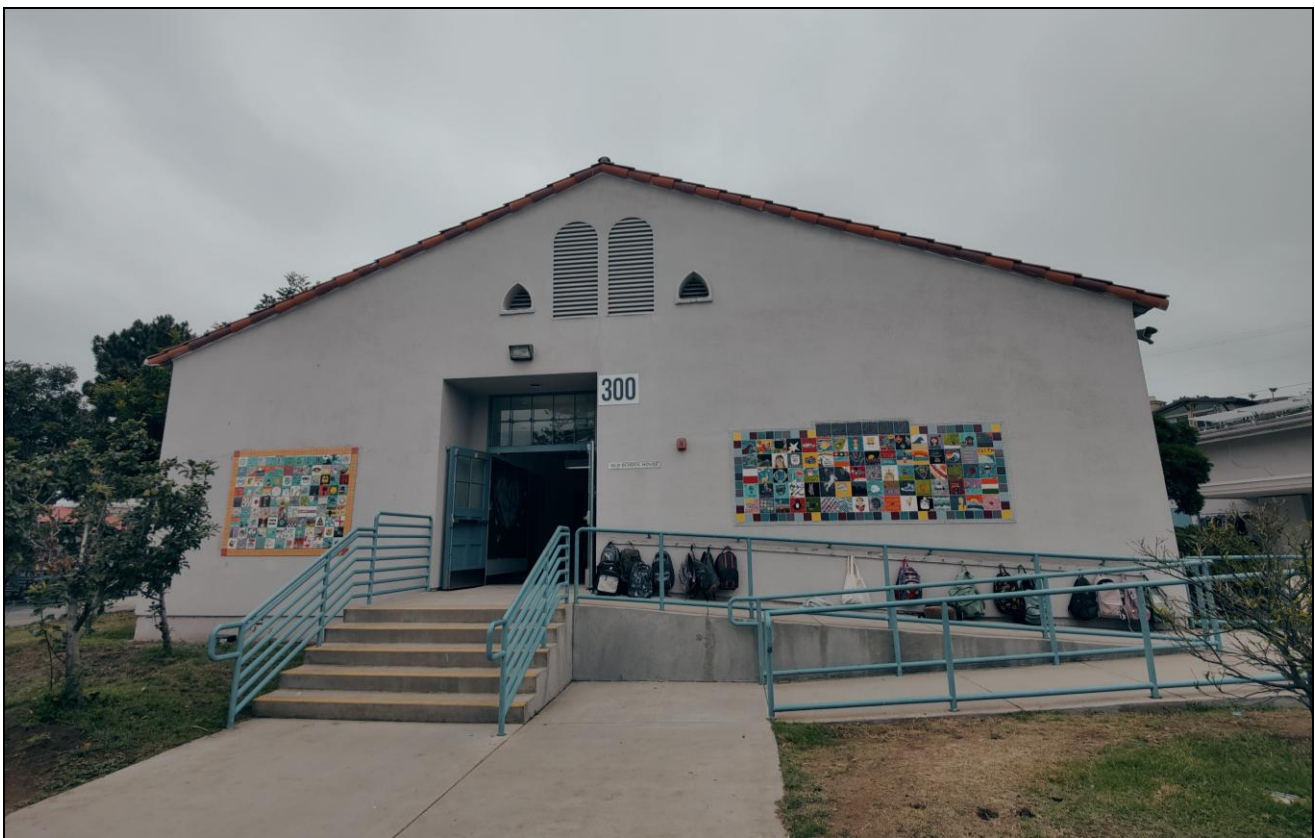
Building #3: south elevation, facing north.

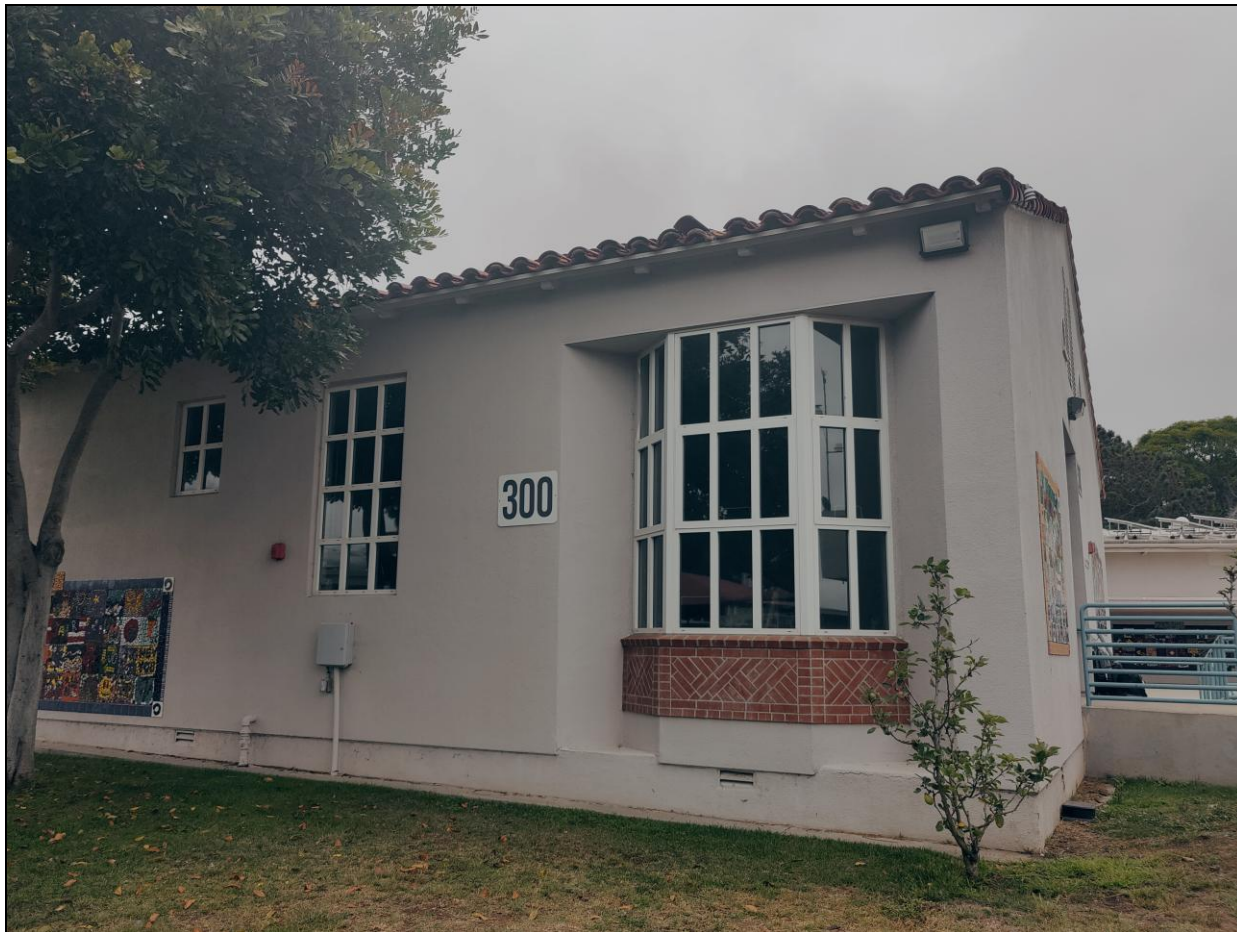
Building #3: southern end of west elevation, facing east.

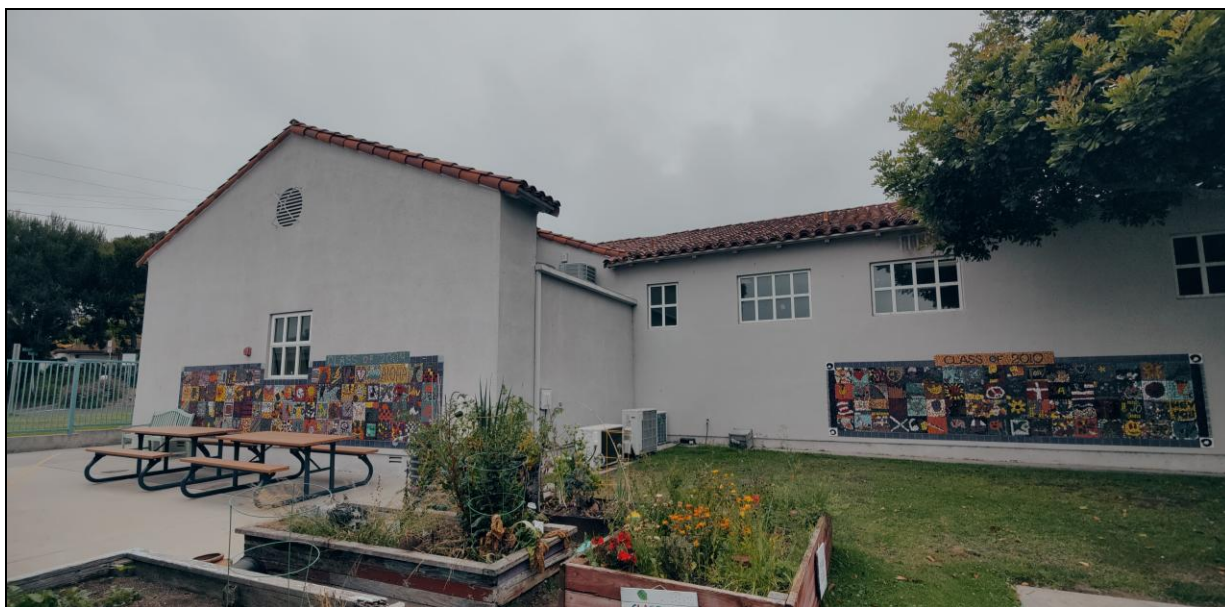
Building #3: northern end of west elevation, facing northeast.

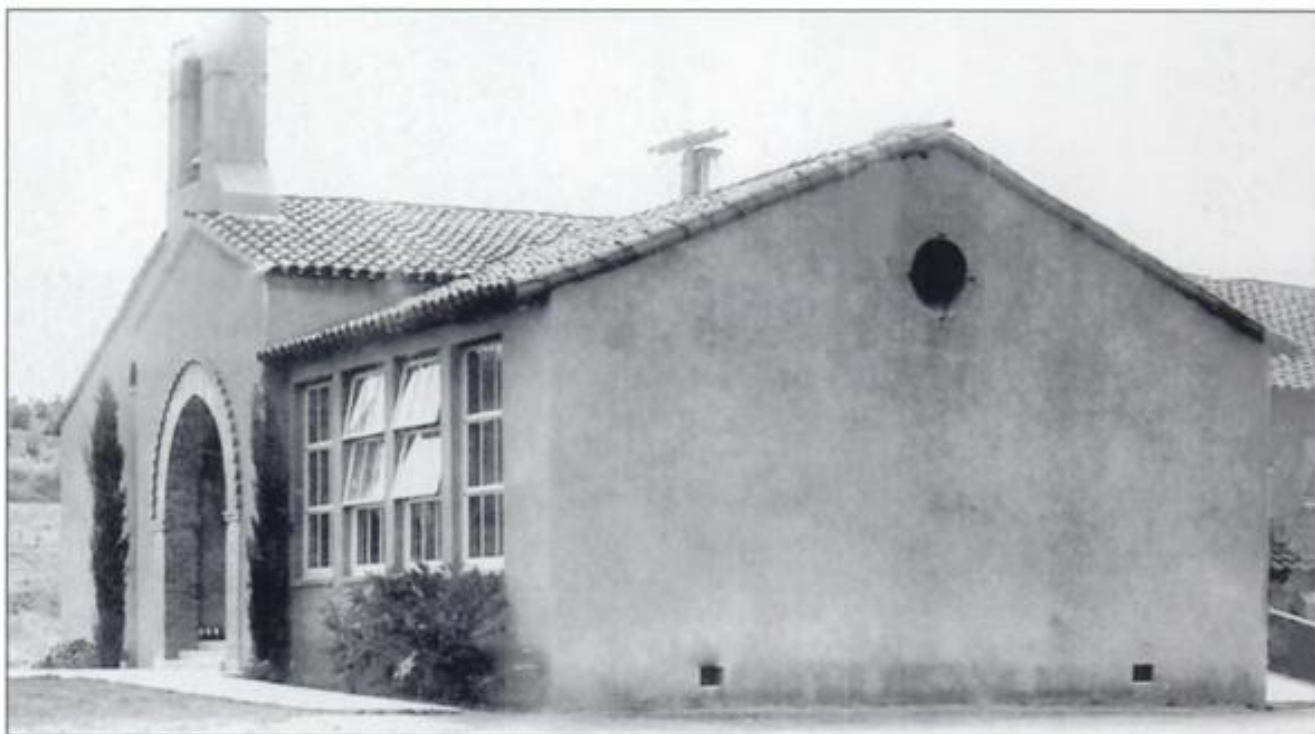
When the Encinitas School District failed to obtain a majority of votes to fund new buildings in 1927, a bond was passed that resulted in Central Elementary School being constructed by the fall of 1929. This 1932 photograph shows details of the school that is still located on Union Street in Leucadia, now known as Paul Ecke Central School in memory of Paul Ecke Sr. (Courtesy of Jimmy and Betty Brass.)

1932 photograph of north façade (left) and west elevation (right) (Holtzclaw 2006).

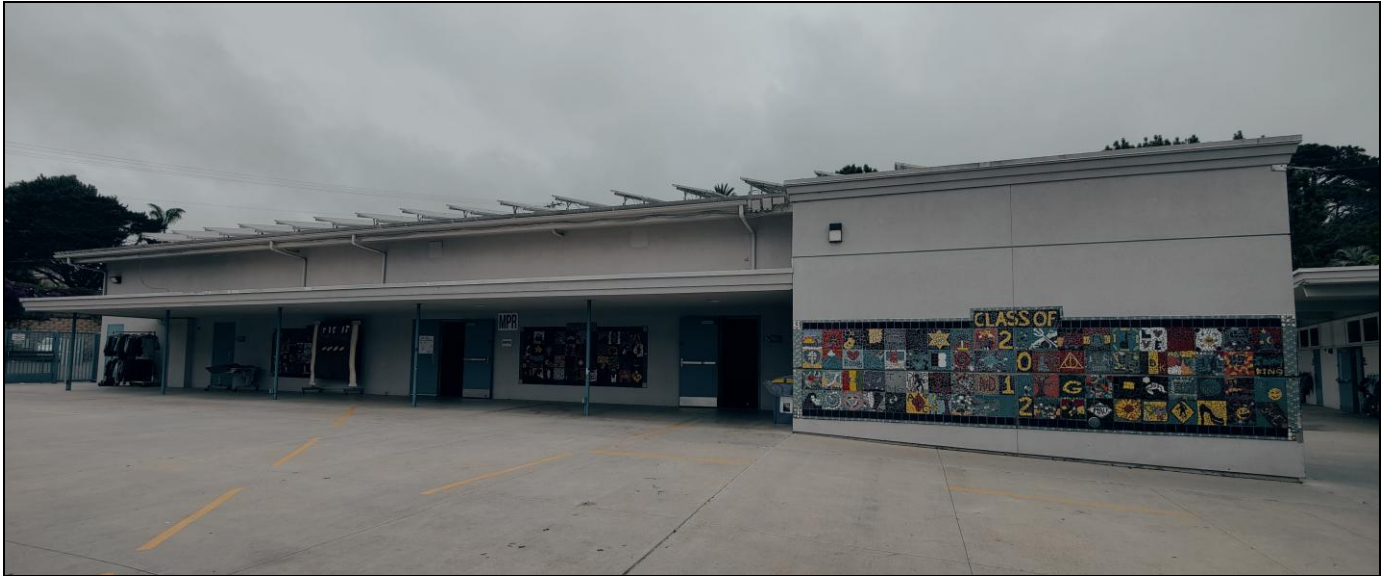
Building #4: southwest elevation (classrooms), facing northeast.

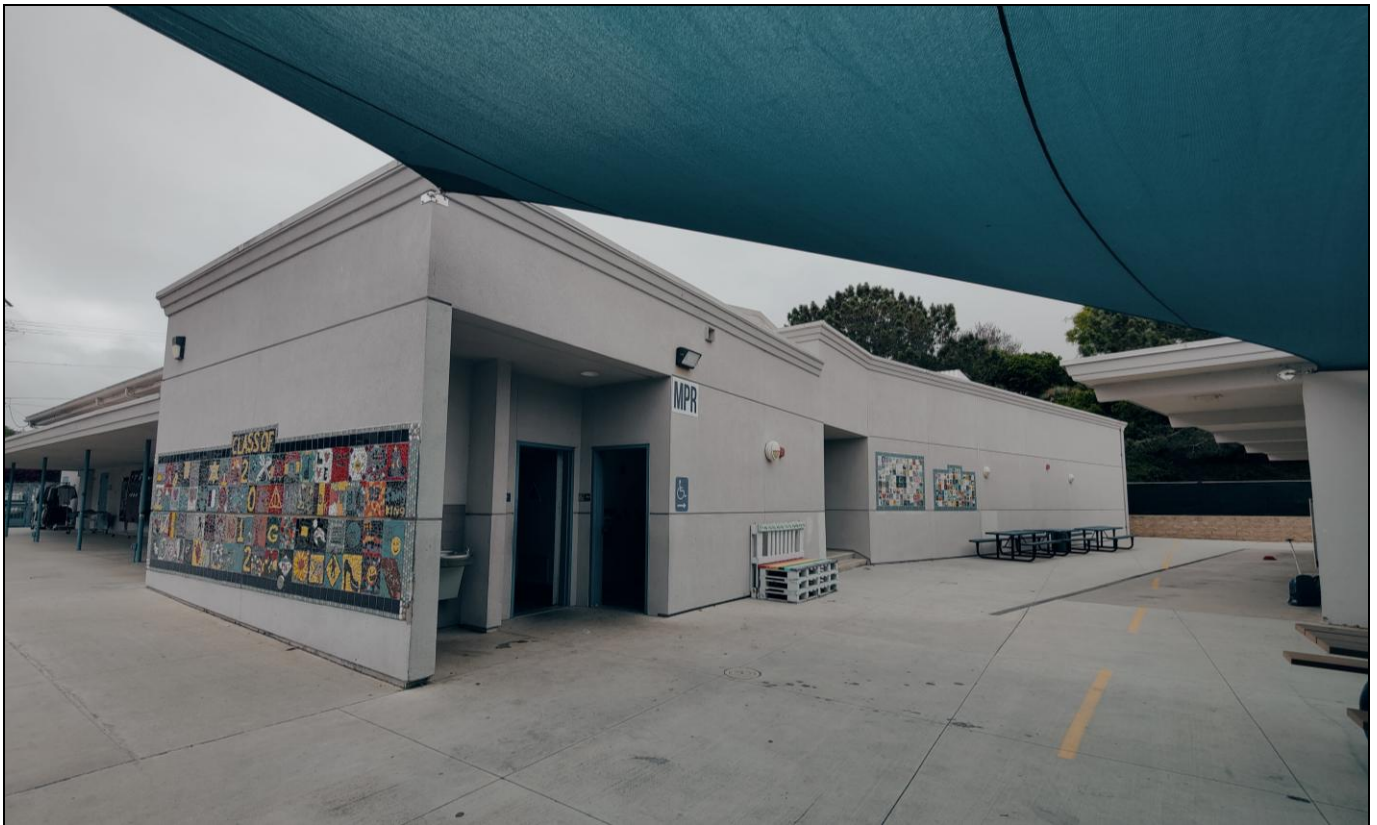
Building #4: south elevation (Multi-Purpose Room), facing northeast.

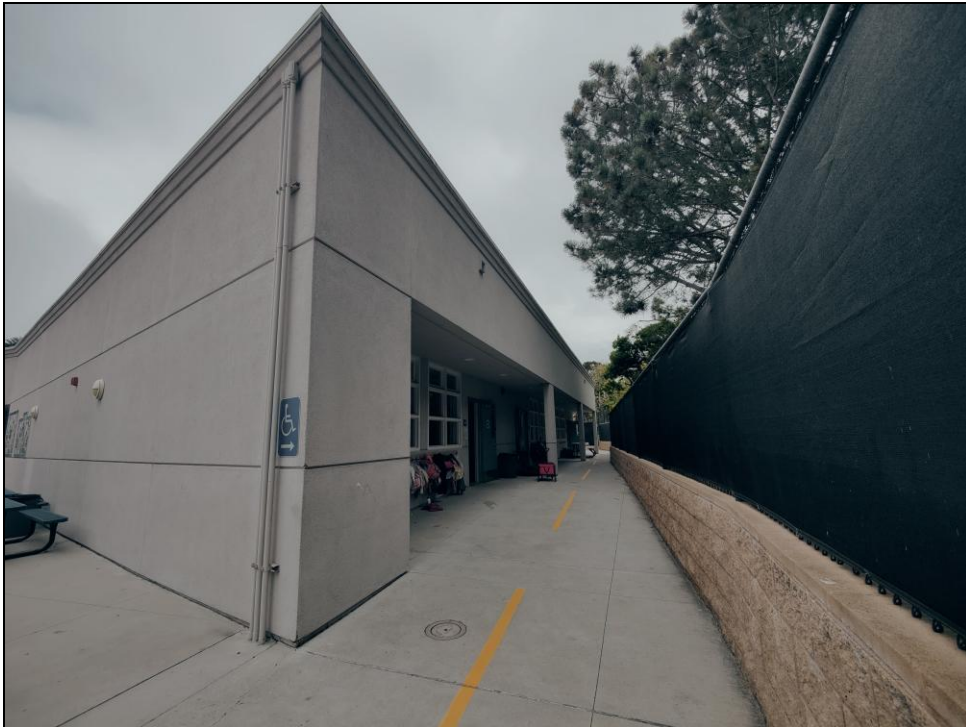
Building #4: south elevation (left) and southern end of east elevation (right), facing northwest.

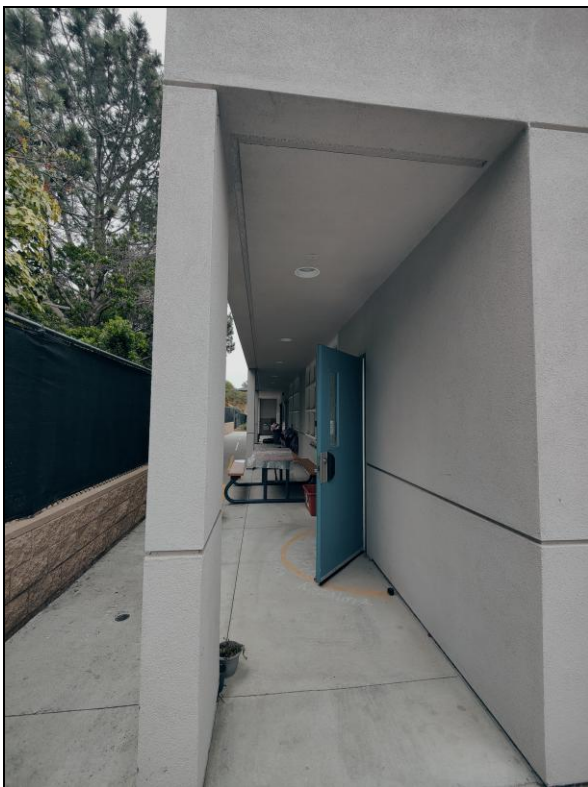
Building #4: east elevation, facing southeast.

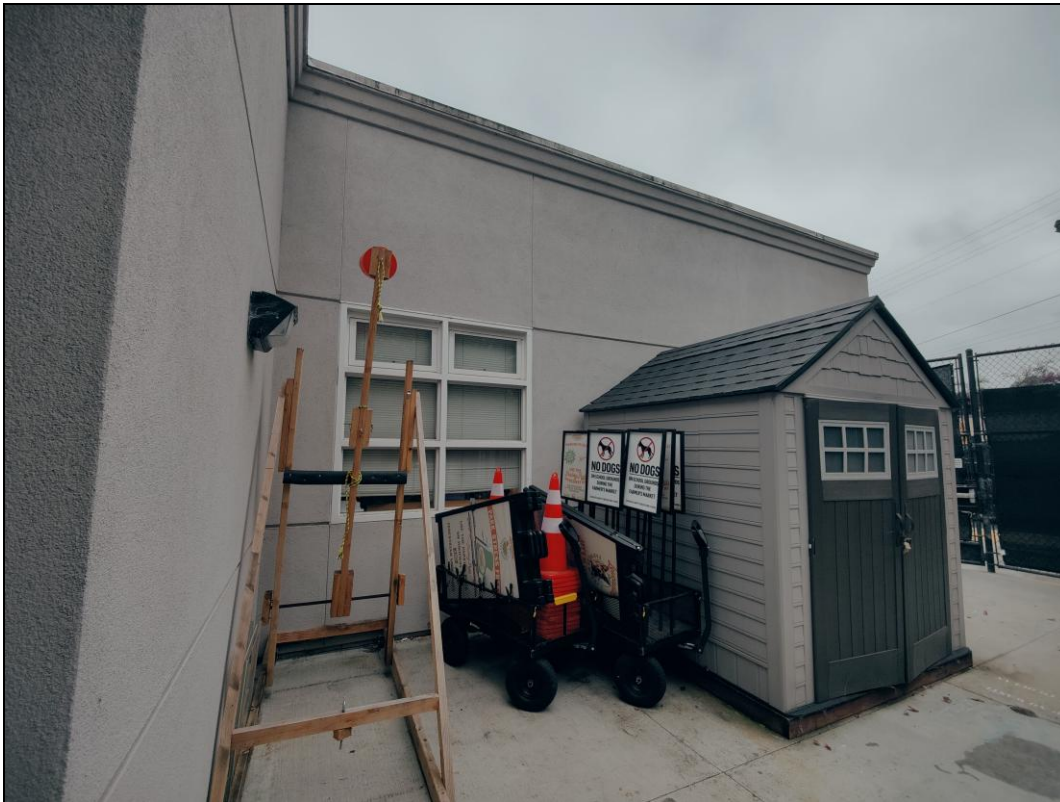
Building #4: northern end of east elevation, facing west.

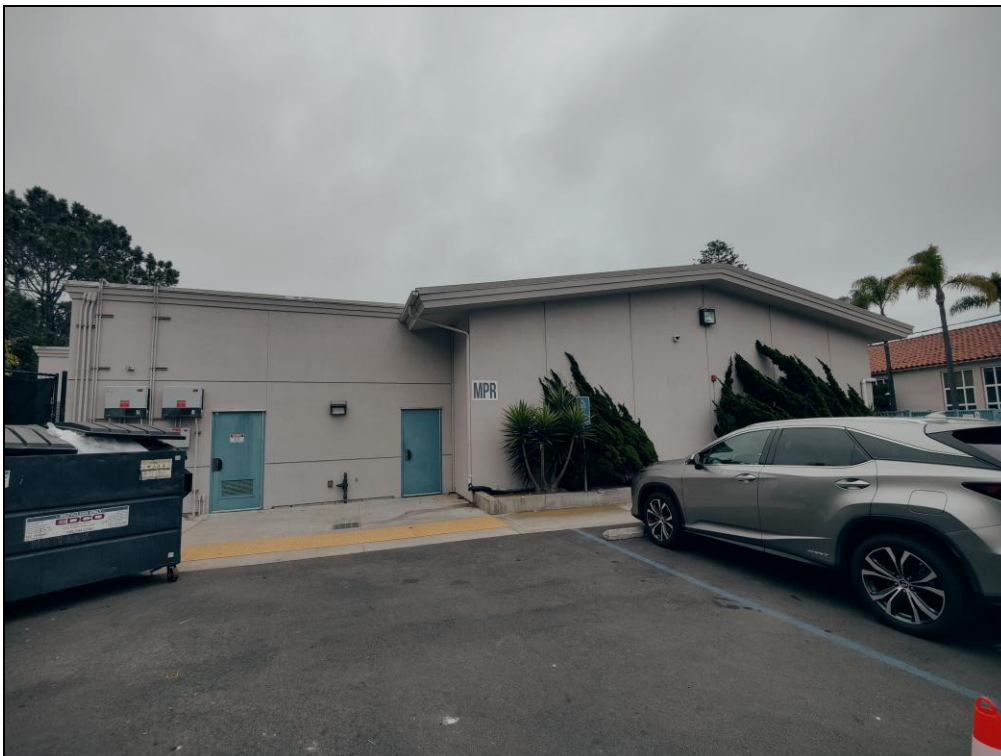
Building #4: northwest elevation, facing southeast.

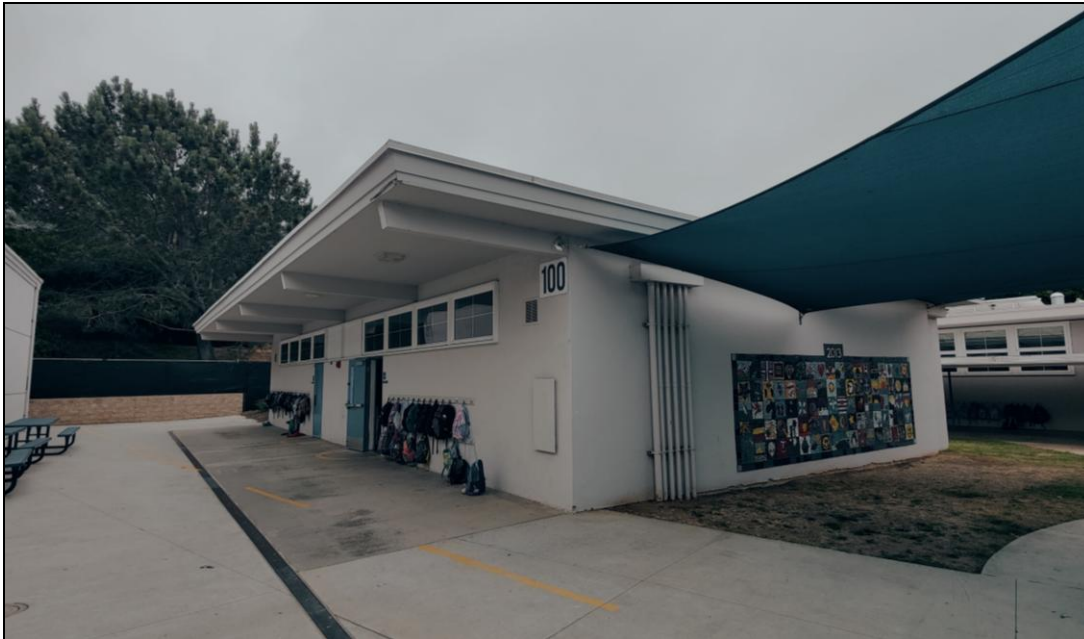
Building #6: north elevation (left) and west elevation (right), facing southeast.

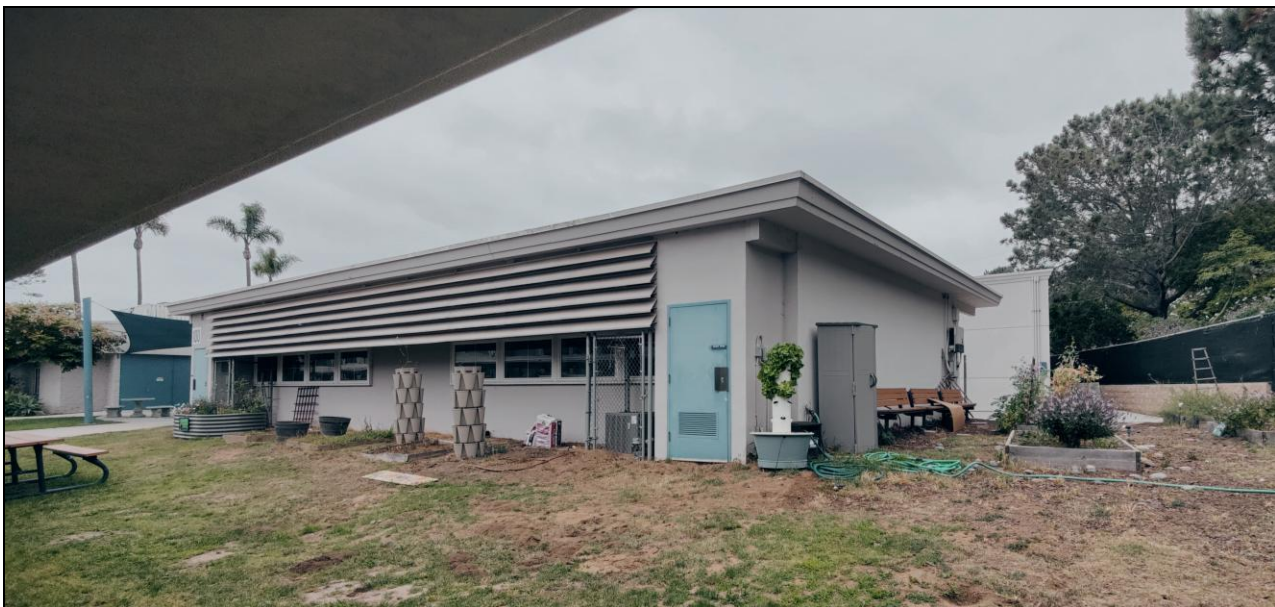
Building #6: south elevation (left) and east elevation (right), facing northwest.
