# **APPENDIX 3.3-3**

## **SECRETARY OF THE INTERIOR (SOI)**

### **COMPATIBILITY ASSESSMENT FOR THE OLD**

### **SCHOOLHOUSE**

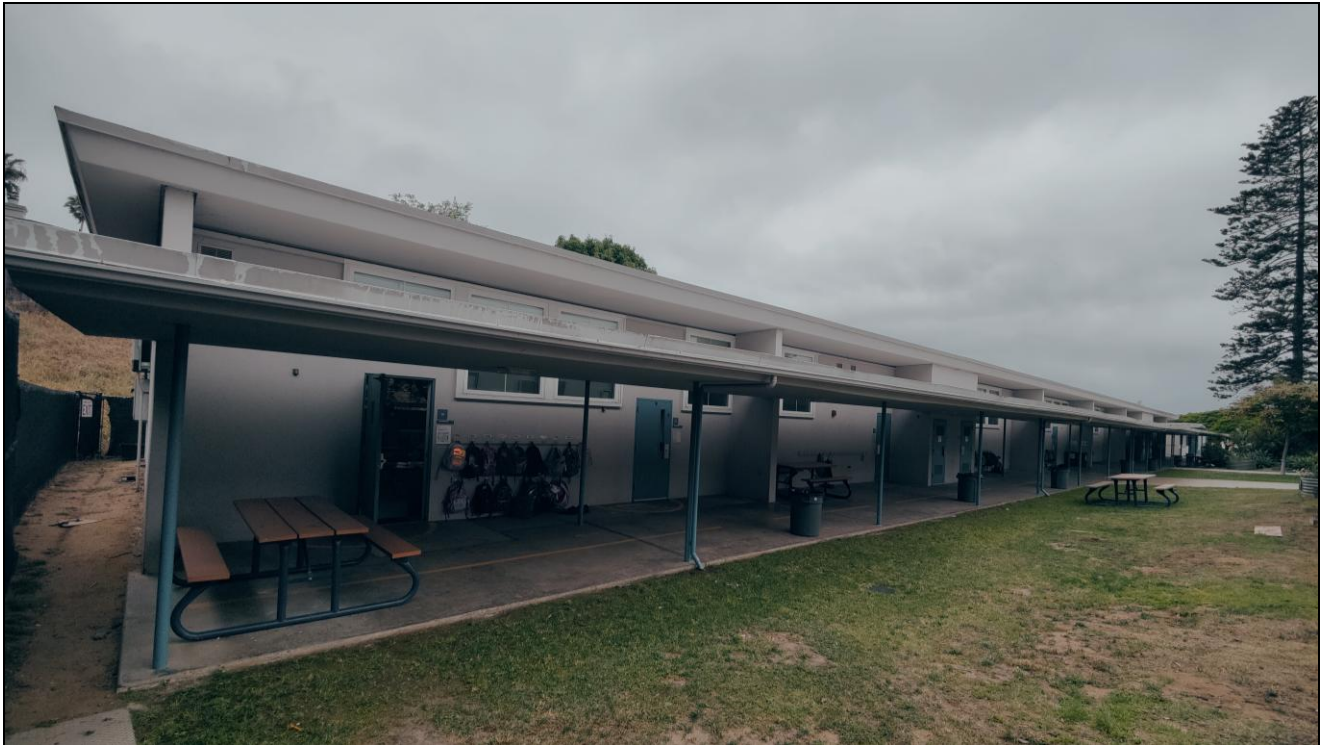
Building #7: north elevation, facing southwest.

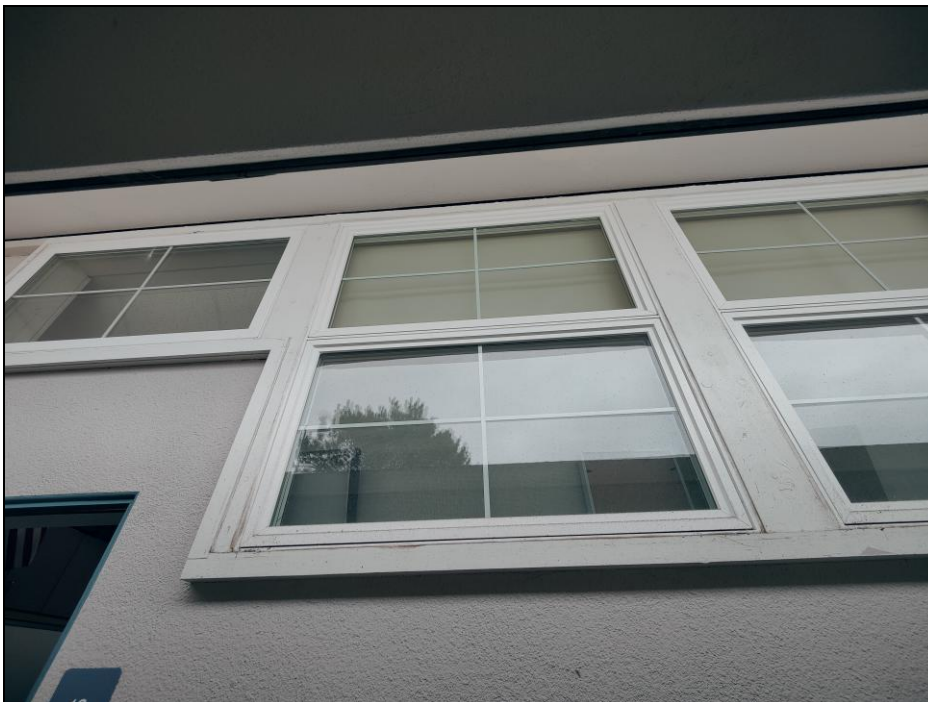
Building #7: close up of fixed windows at eave levels at north façade.

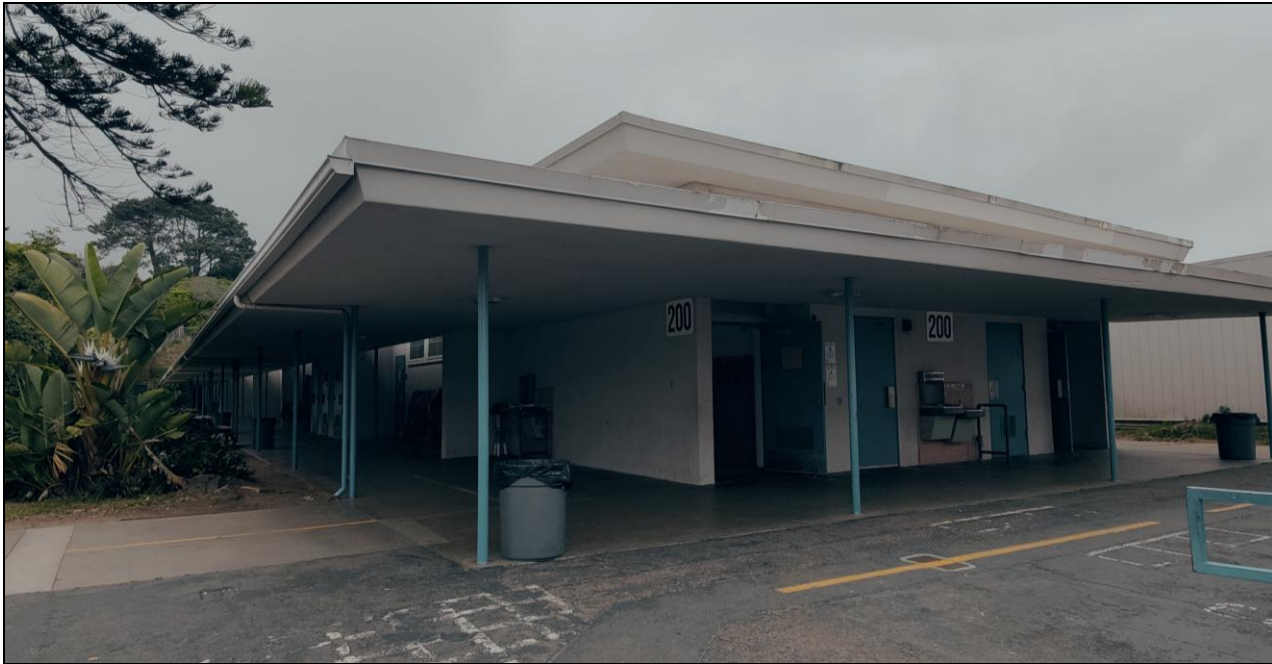
Building #7: north façade (left) and west elevation (right), facing southeast.

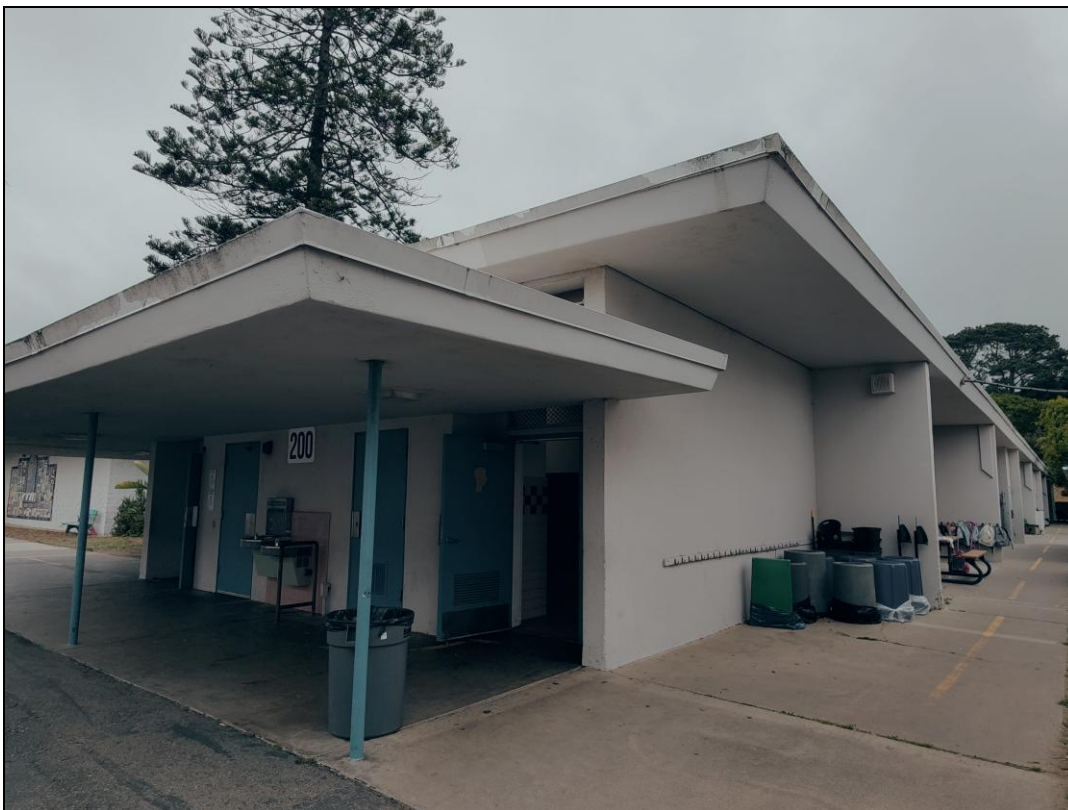
Building #7: west elevation (left) and western end of south elevation (right), facing northeast.

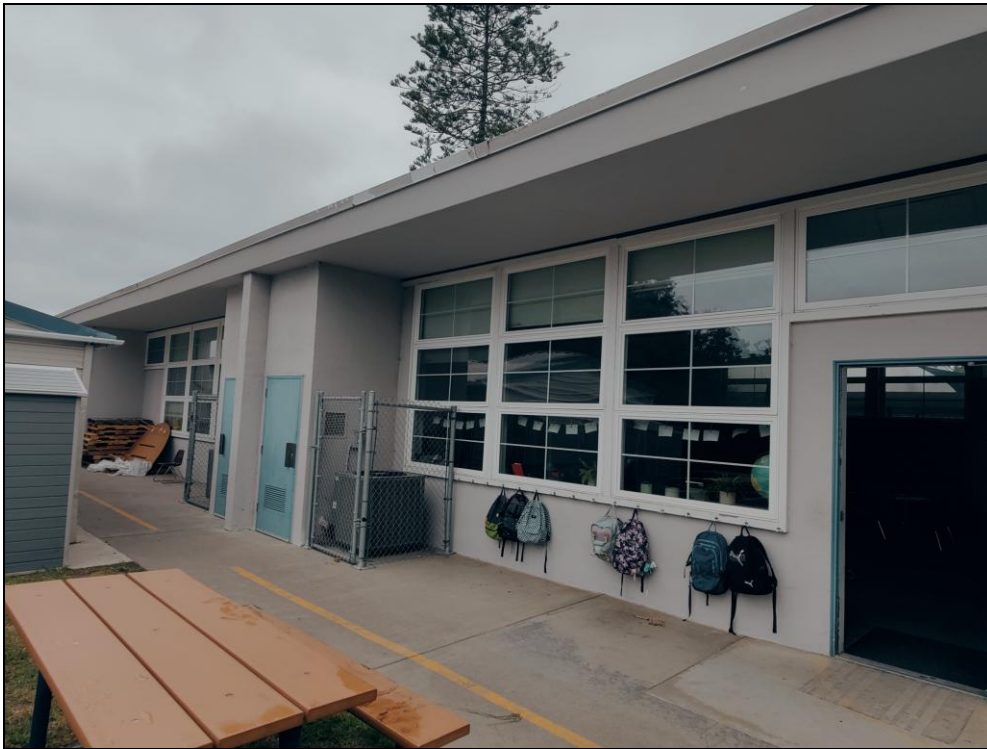
Building #7: western end of south elevation, facing northwest.

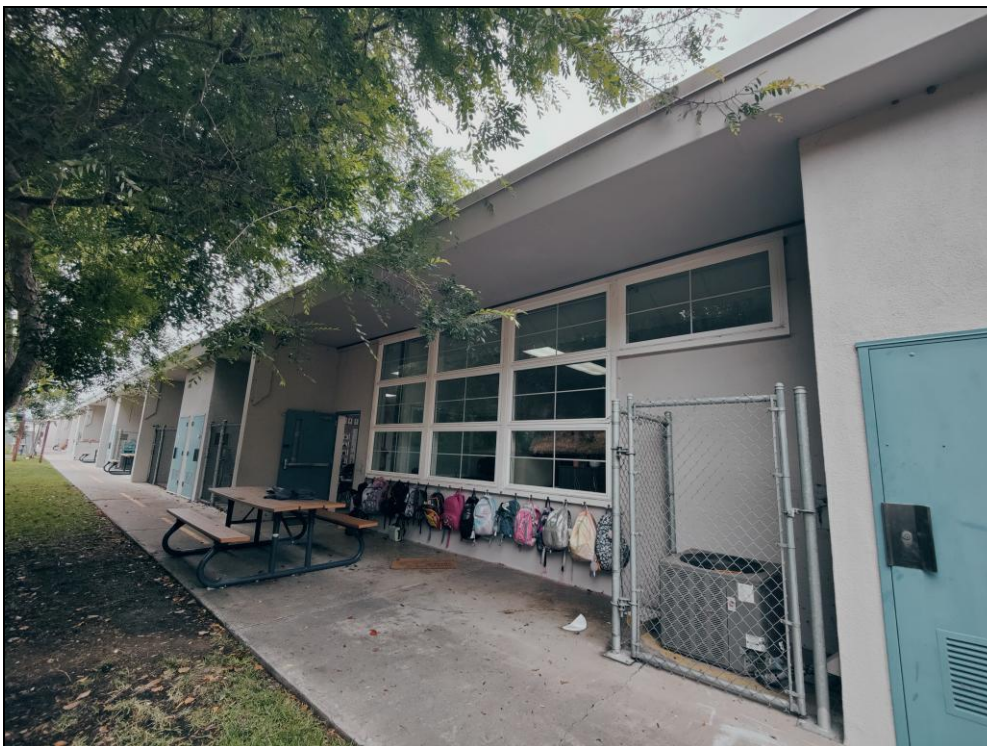
Building #7: overview of south elevation, facing northwest.

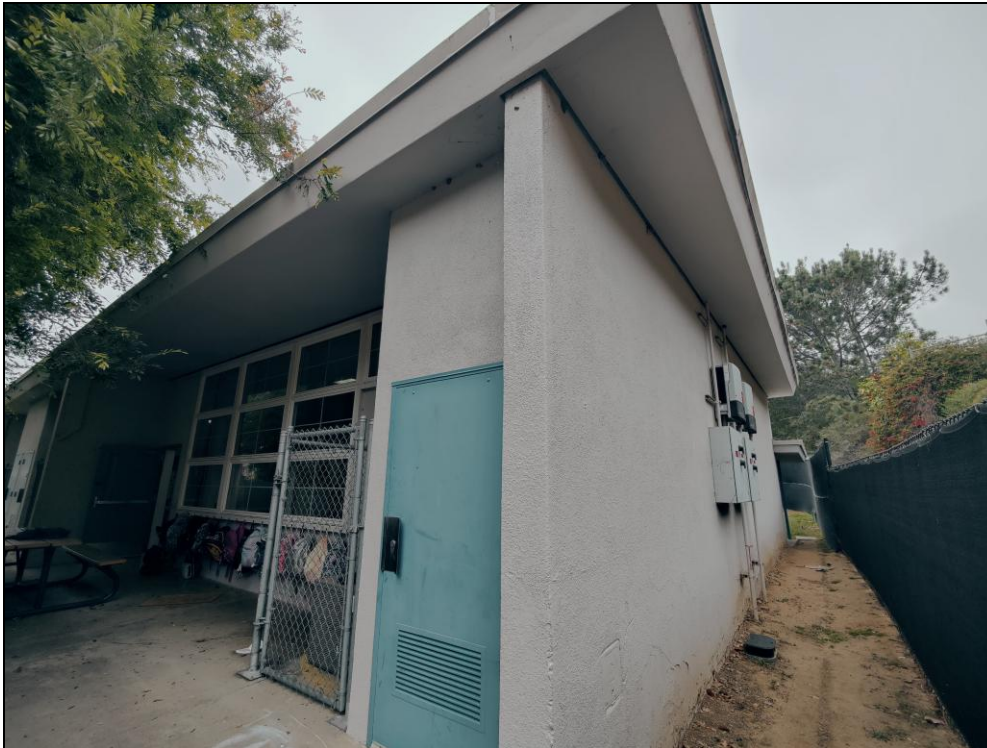
Building #7: eastern end of south elevation (left) and east elevation (right), facing northwest.

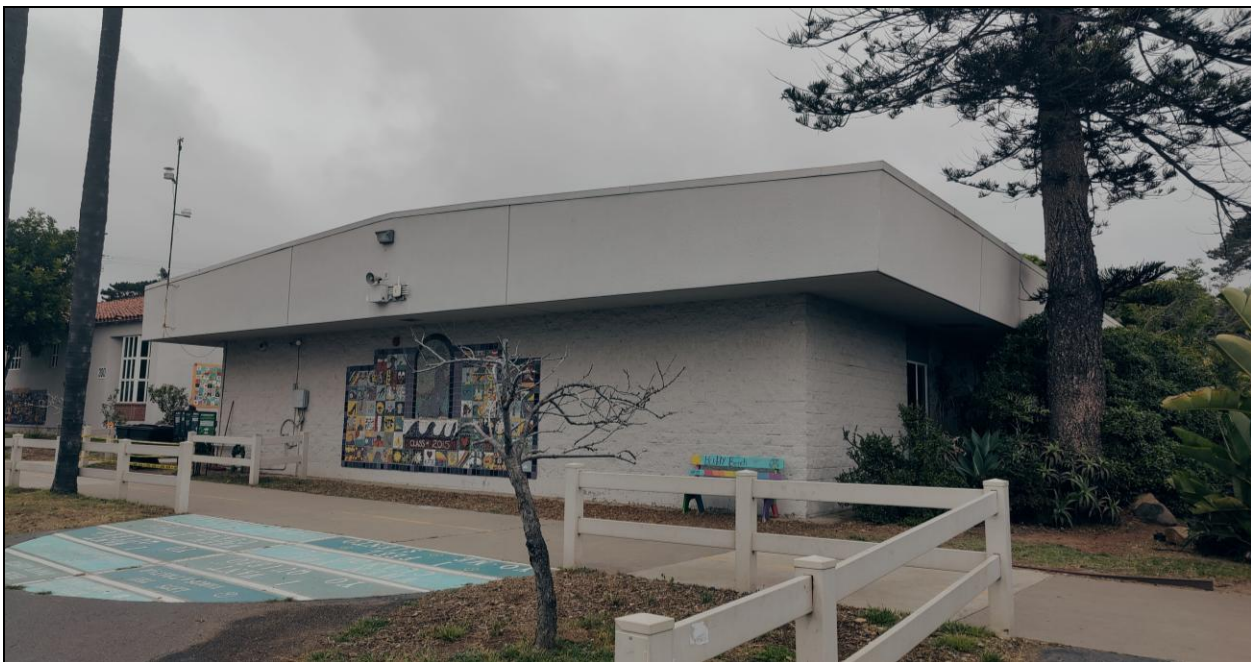
Building #8: west elevation and partial view of south elevation, facing northeast.

- **Building #6:** Built in 1968. Classrooms (2). Modern style.
- **Building #8:** Built in 1974. Multi-Media Center. Modern Style. The only notable alterations to the exterior of the building are the window replacements on north and south elevations and the addition of a large tile mosaic at the west elevation in 2015.

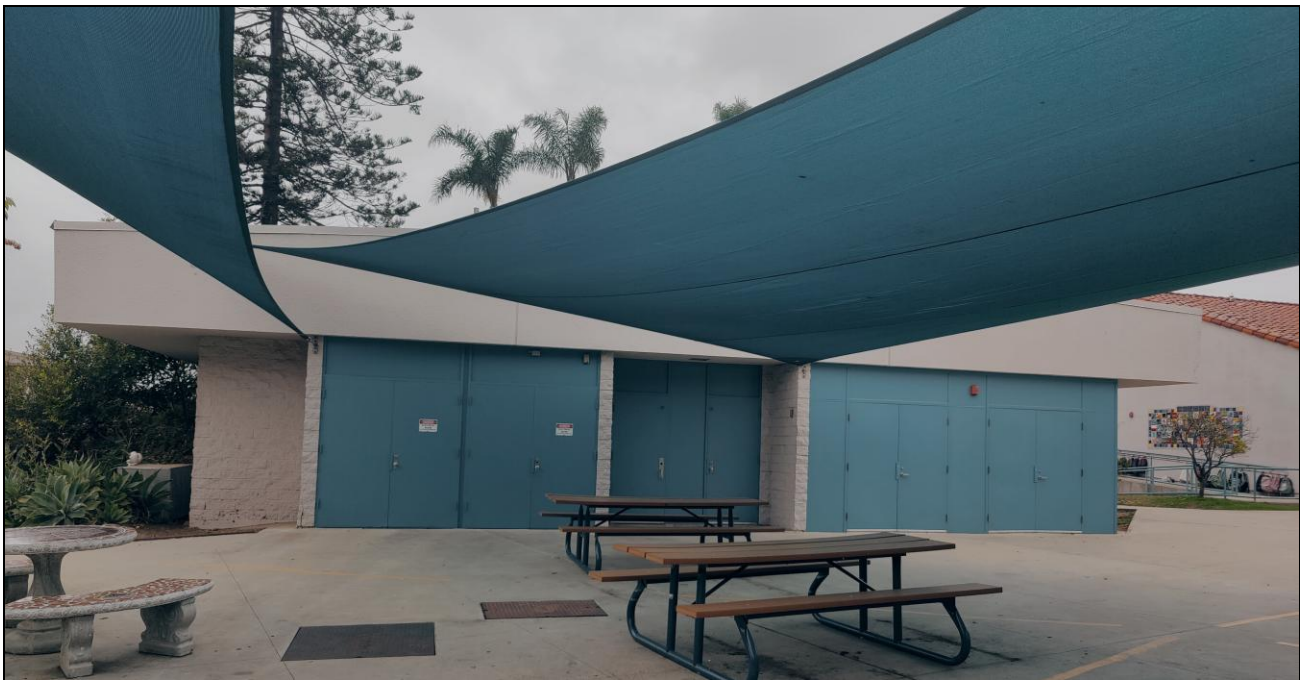
Building #8: east elevation, facing west.

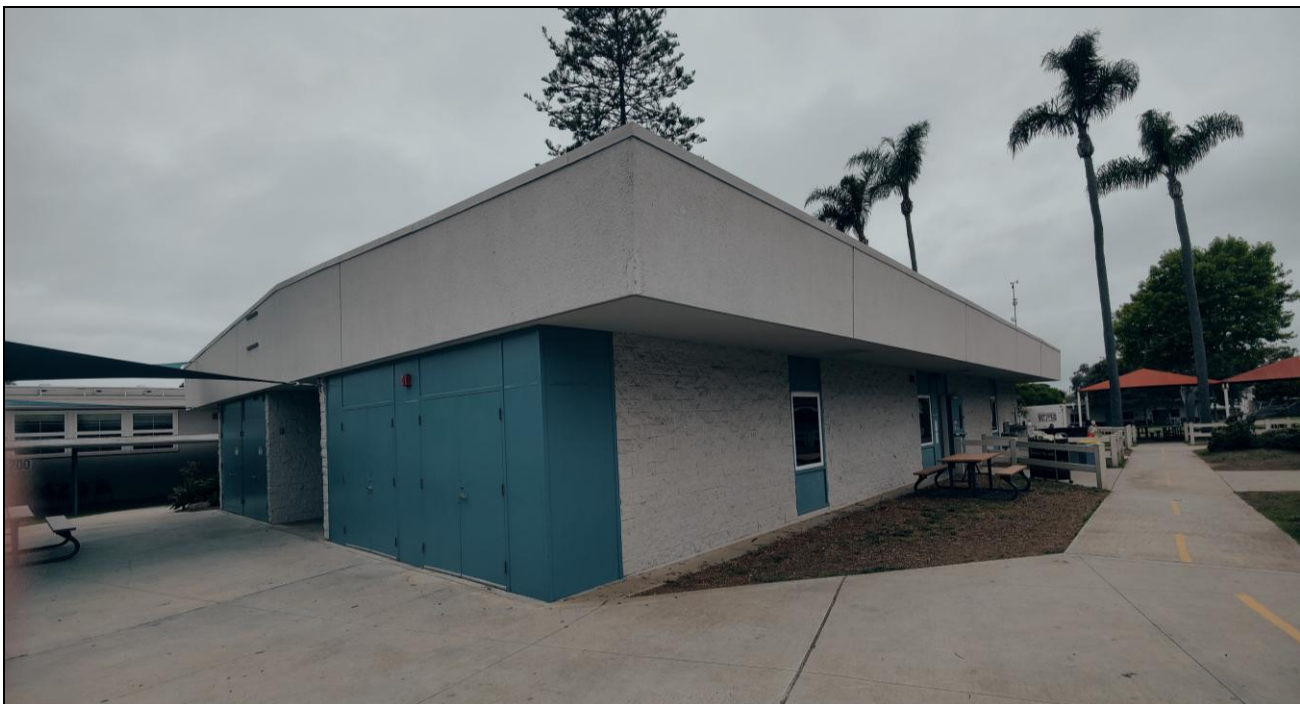
Building #8: east elevation (left) and north façade (right), facing southwest.

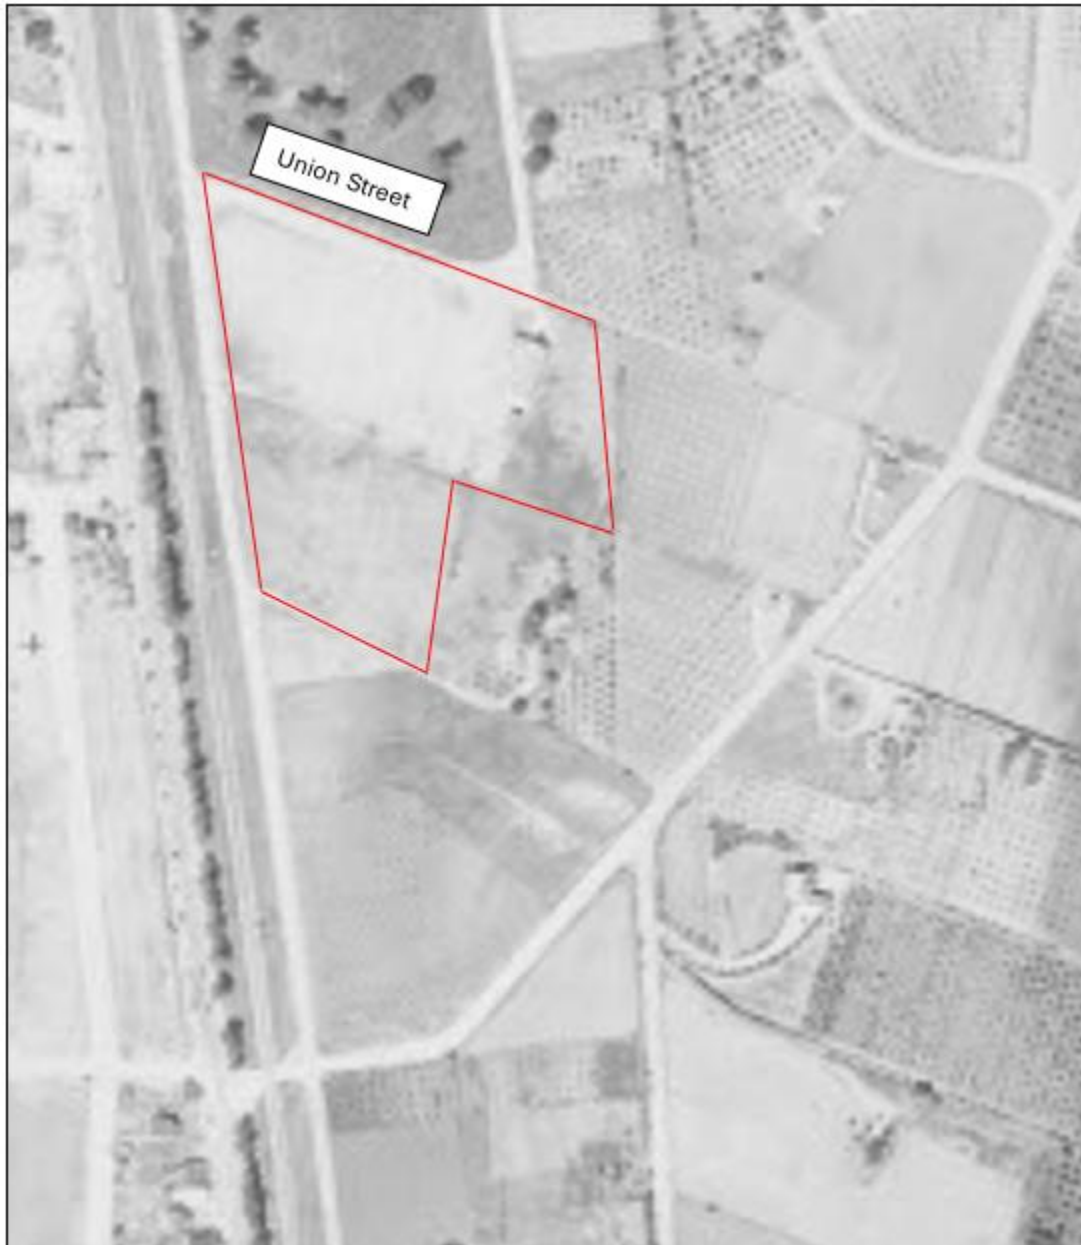
1932 USDA aerial photograph of Ecinitas Central Elementary School (FrameFinder 1932).

Despite a search of the school district's archives, primary and secondary sources, the associated architect and original building plans for this structure are unknown. While the original building plans cannot be located, USDA aerial photographs from 1932, 1939, and 1964 show the original footprint was twice as long as the current building. Sometime between 1964 and 1980, the southern half of the building (the cafeteria building) was demolished. In 1998-1999, a large renovation project impacted the building's interior and exterior (Leidenfrost/ Horowitz & Associates 1998). Major alterations include, but are not limited to:

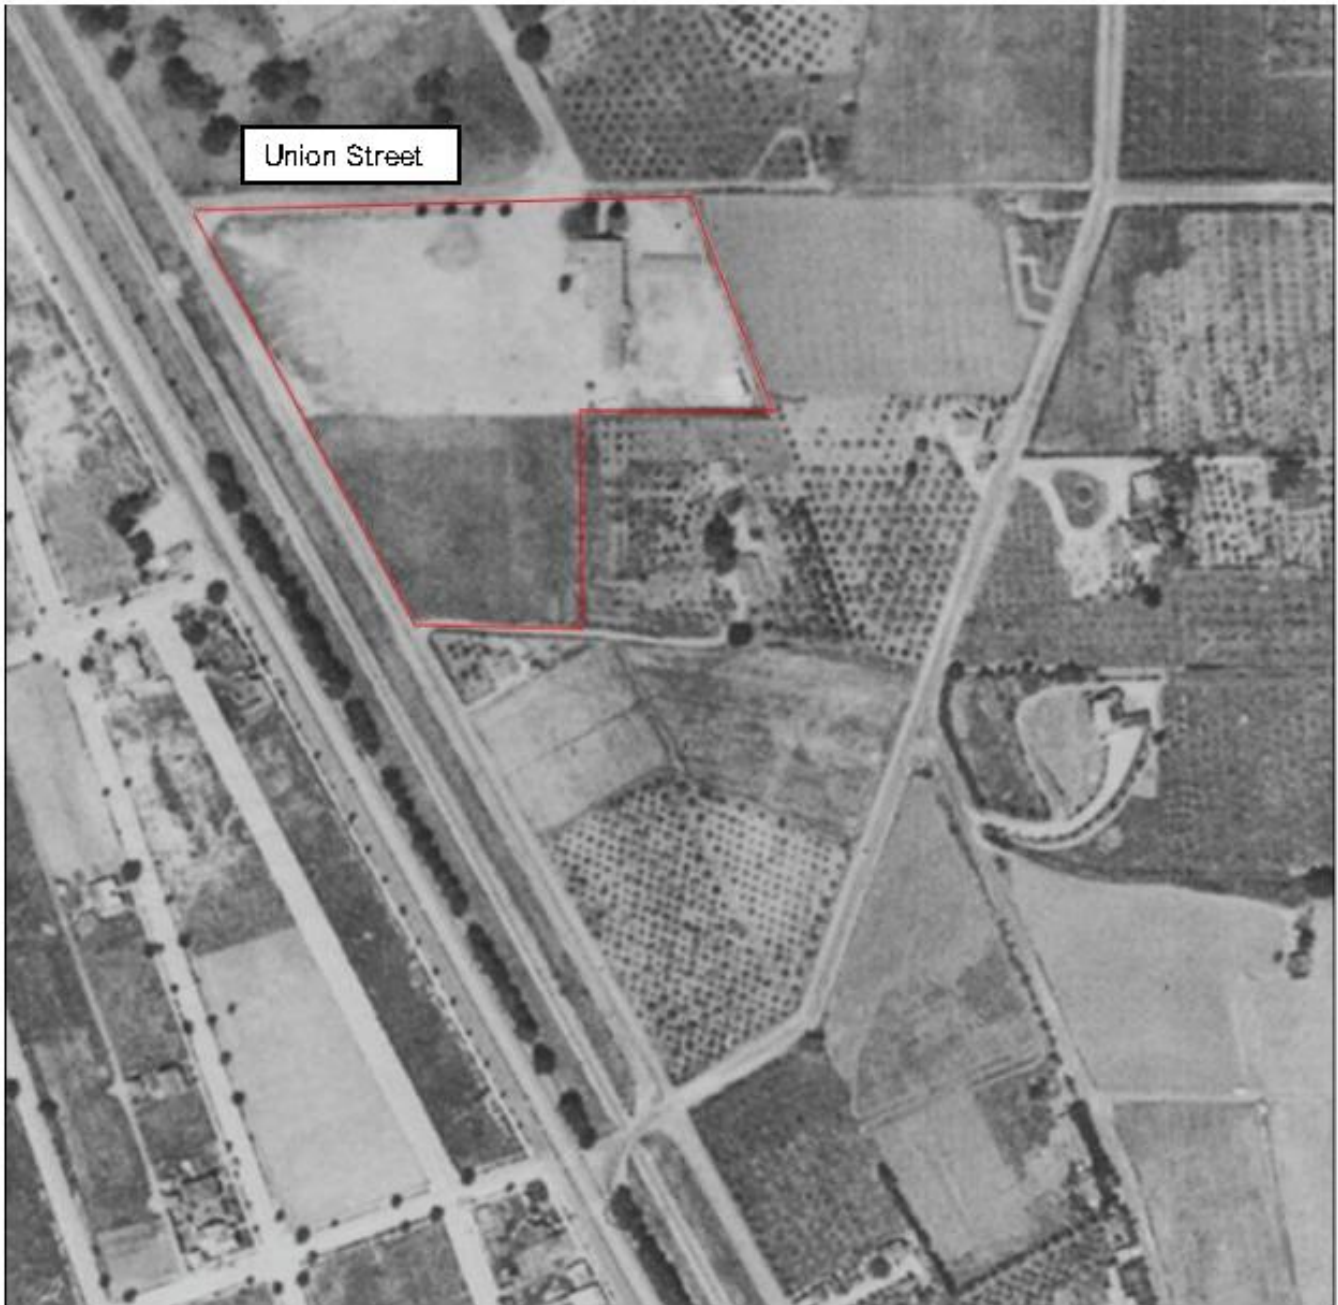
1939 USDA aerial photograph of Encinitas Elementary School (FrameFinder 1939).

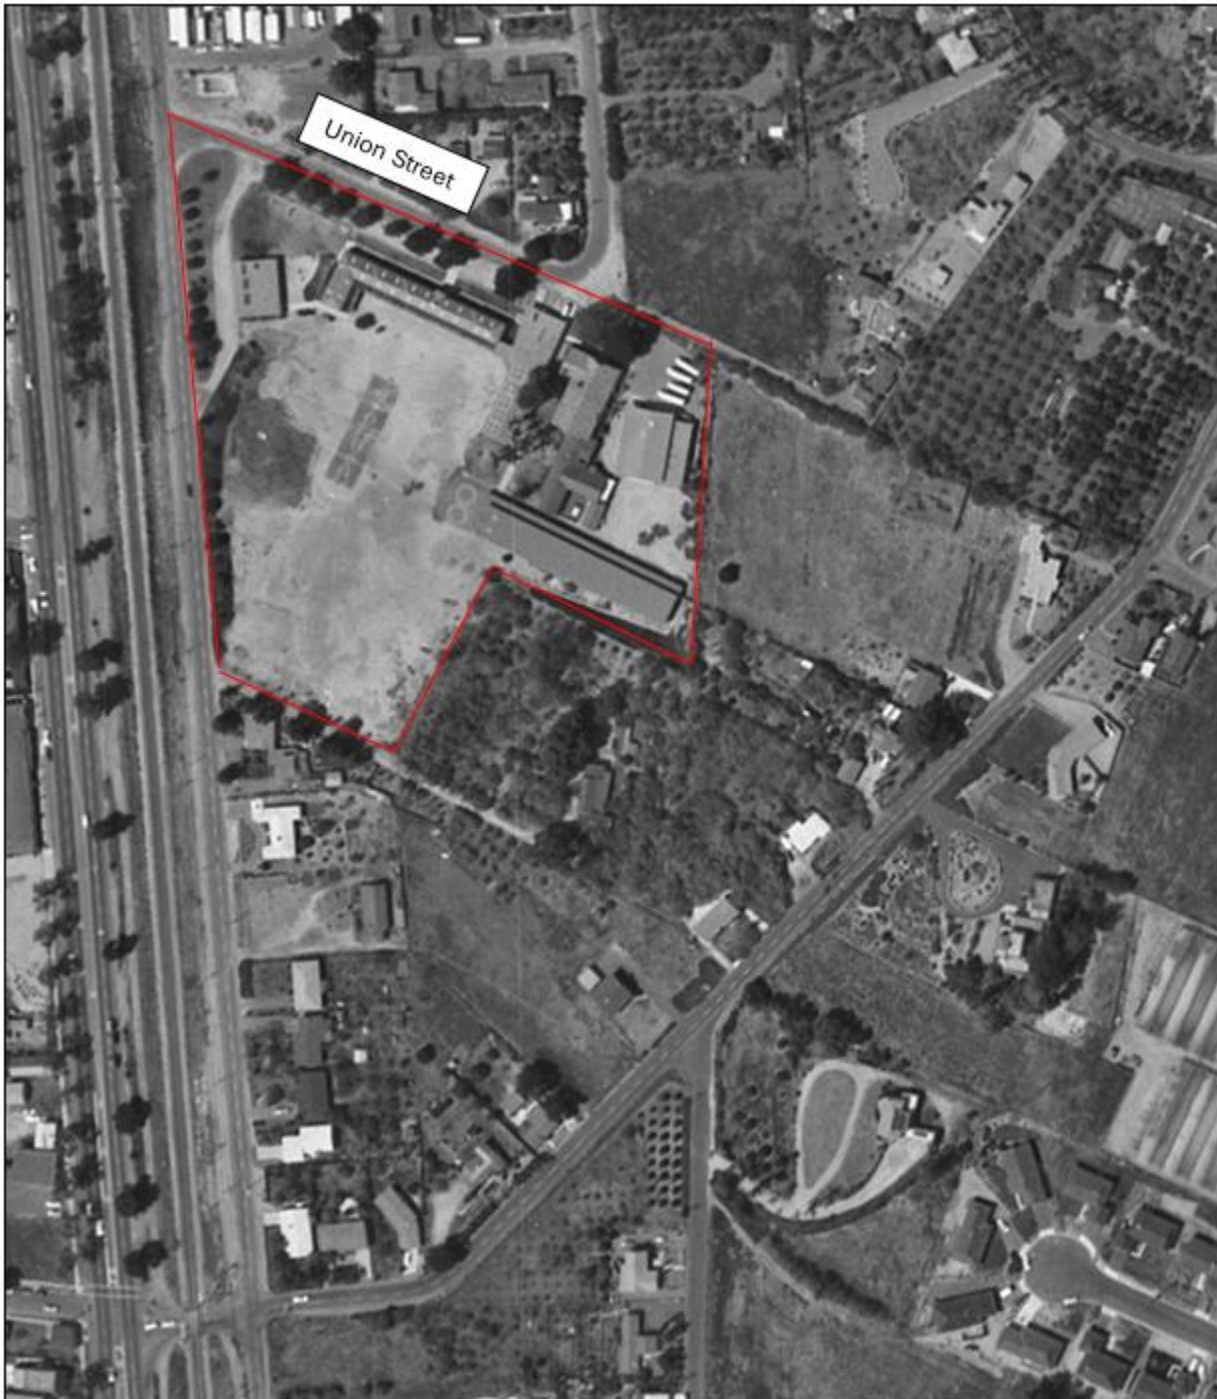
1964 USDA aerial photograph of school (FrameFinder 1964).

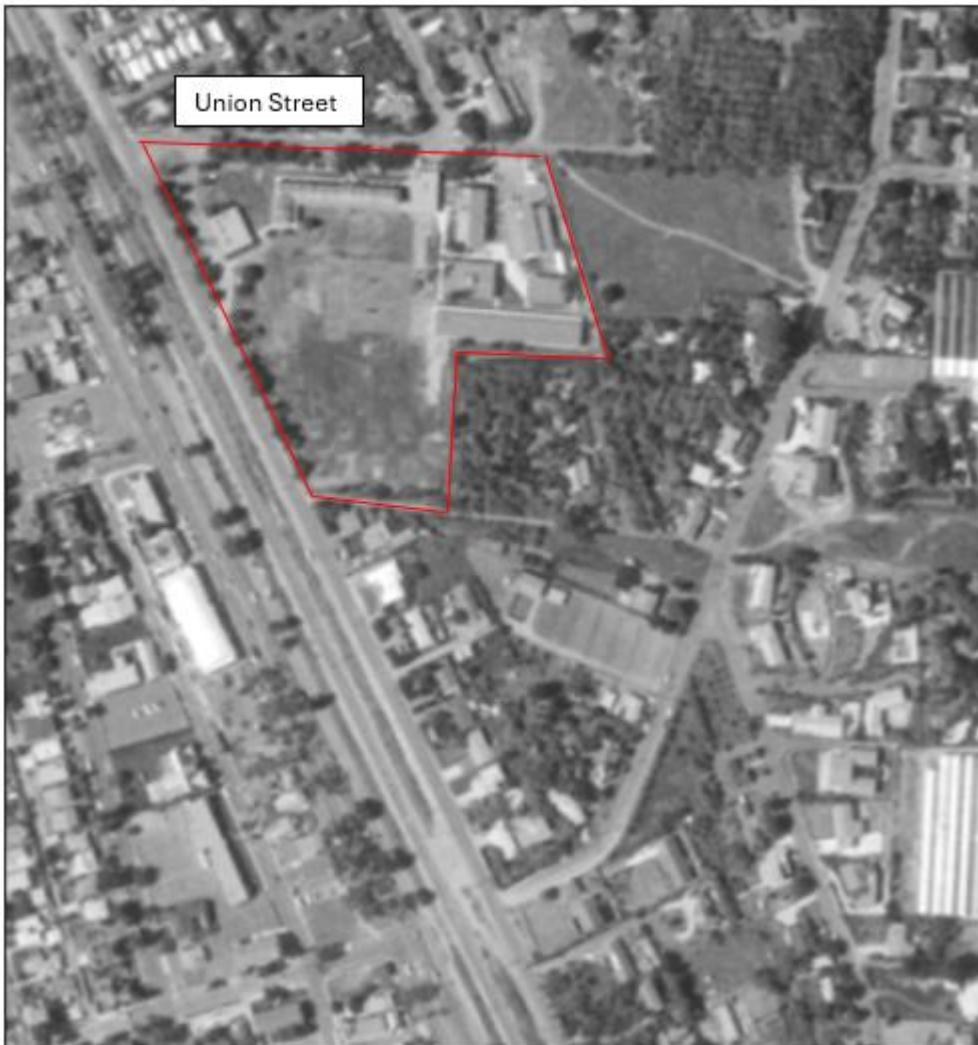
1980 USDA aerial photograph of school (FrameFinder 1980).
