***PRELIMINARY GEOTECHNICAL INVESTIGATION REPORT FOR THE PROPOSED
HAVEN VINEYARD DEVELOPMENT, APN 927-670-009, LOCATED ON CAMINO DEL
VINO, CITY OF TEMECULA, RIVERSIDE COUNTY, CALIFORNIA***

***Dated: June 30, 2022
Project No. D21-1119-10***

Subject: Preliminary Geotechnical Investigation Report for the Proposed Haven Vineyard Development, APN 927-670-009, Located on Camino del Vino, City of Temecula, Riverside County, California.

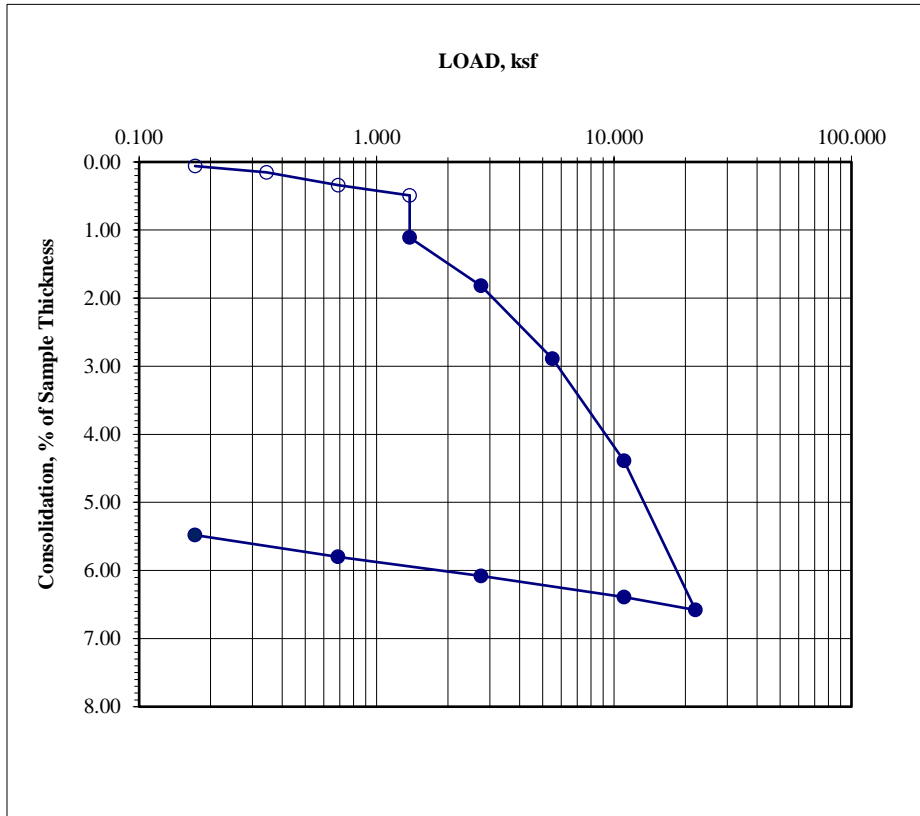
CONSOLIDATION TEST RESULTS

Note: Filled circle denotes readings after sample was submerged in water

<u>In-place</u>	<u>Post Consol</u>
Dry Density, (pcf):	108.3	106.6
Moisture (%):	4.4	16.5
WATER ADDED @ ksf:	1.378	
MAXIMUM LOAD, ksf:	22.040	
SOIL DESCRIPTION:	Silty SAND to SAND	
U.S.C.S.	SM/SP	
% Collapse/Swell (-):	0.62

Consolidation: A consolidation test was performed on a undisturbed sample. (Modified ASTM Test method D2435. The samples (2.42 inches in diameter and 1-inch in height) were placed in a consolidometer and increasing loads were applied. The sample was allowed to consolidate under "double drainage" and total deformation for each loading step was recorded. The percent consolidation for each load stamp was recorded as the ration of the amount of vertical compression to the original sample height. The in progress graphical test results are presented on the following pages.

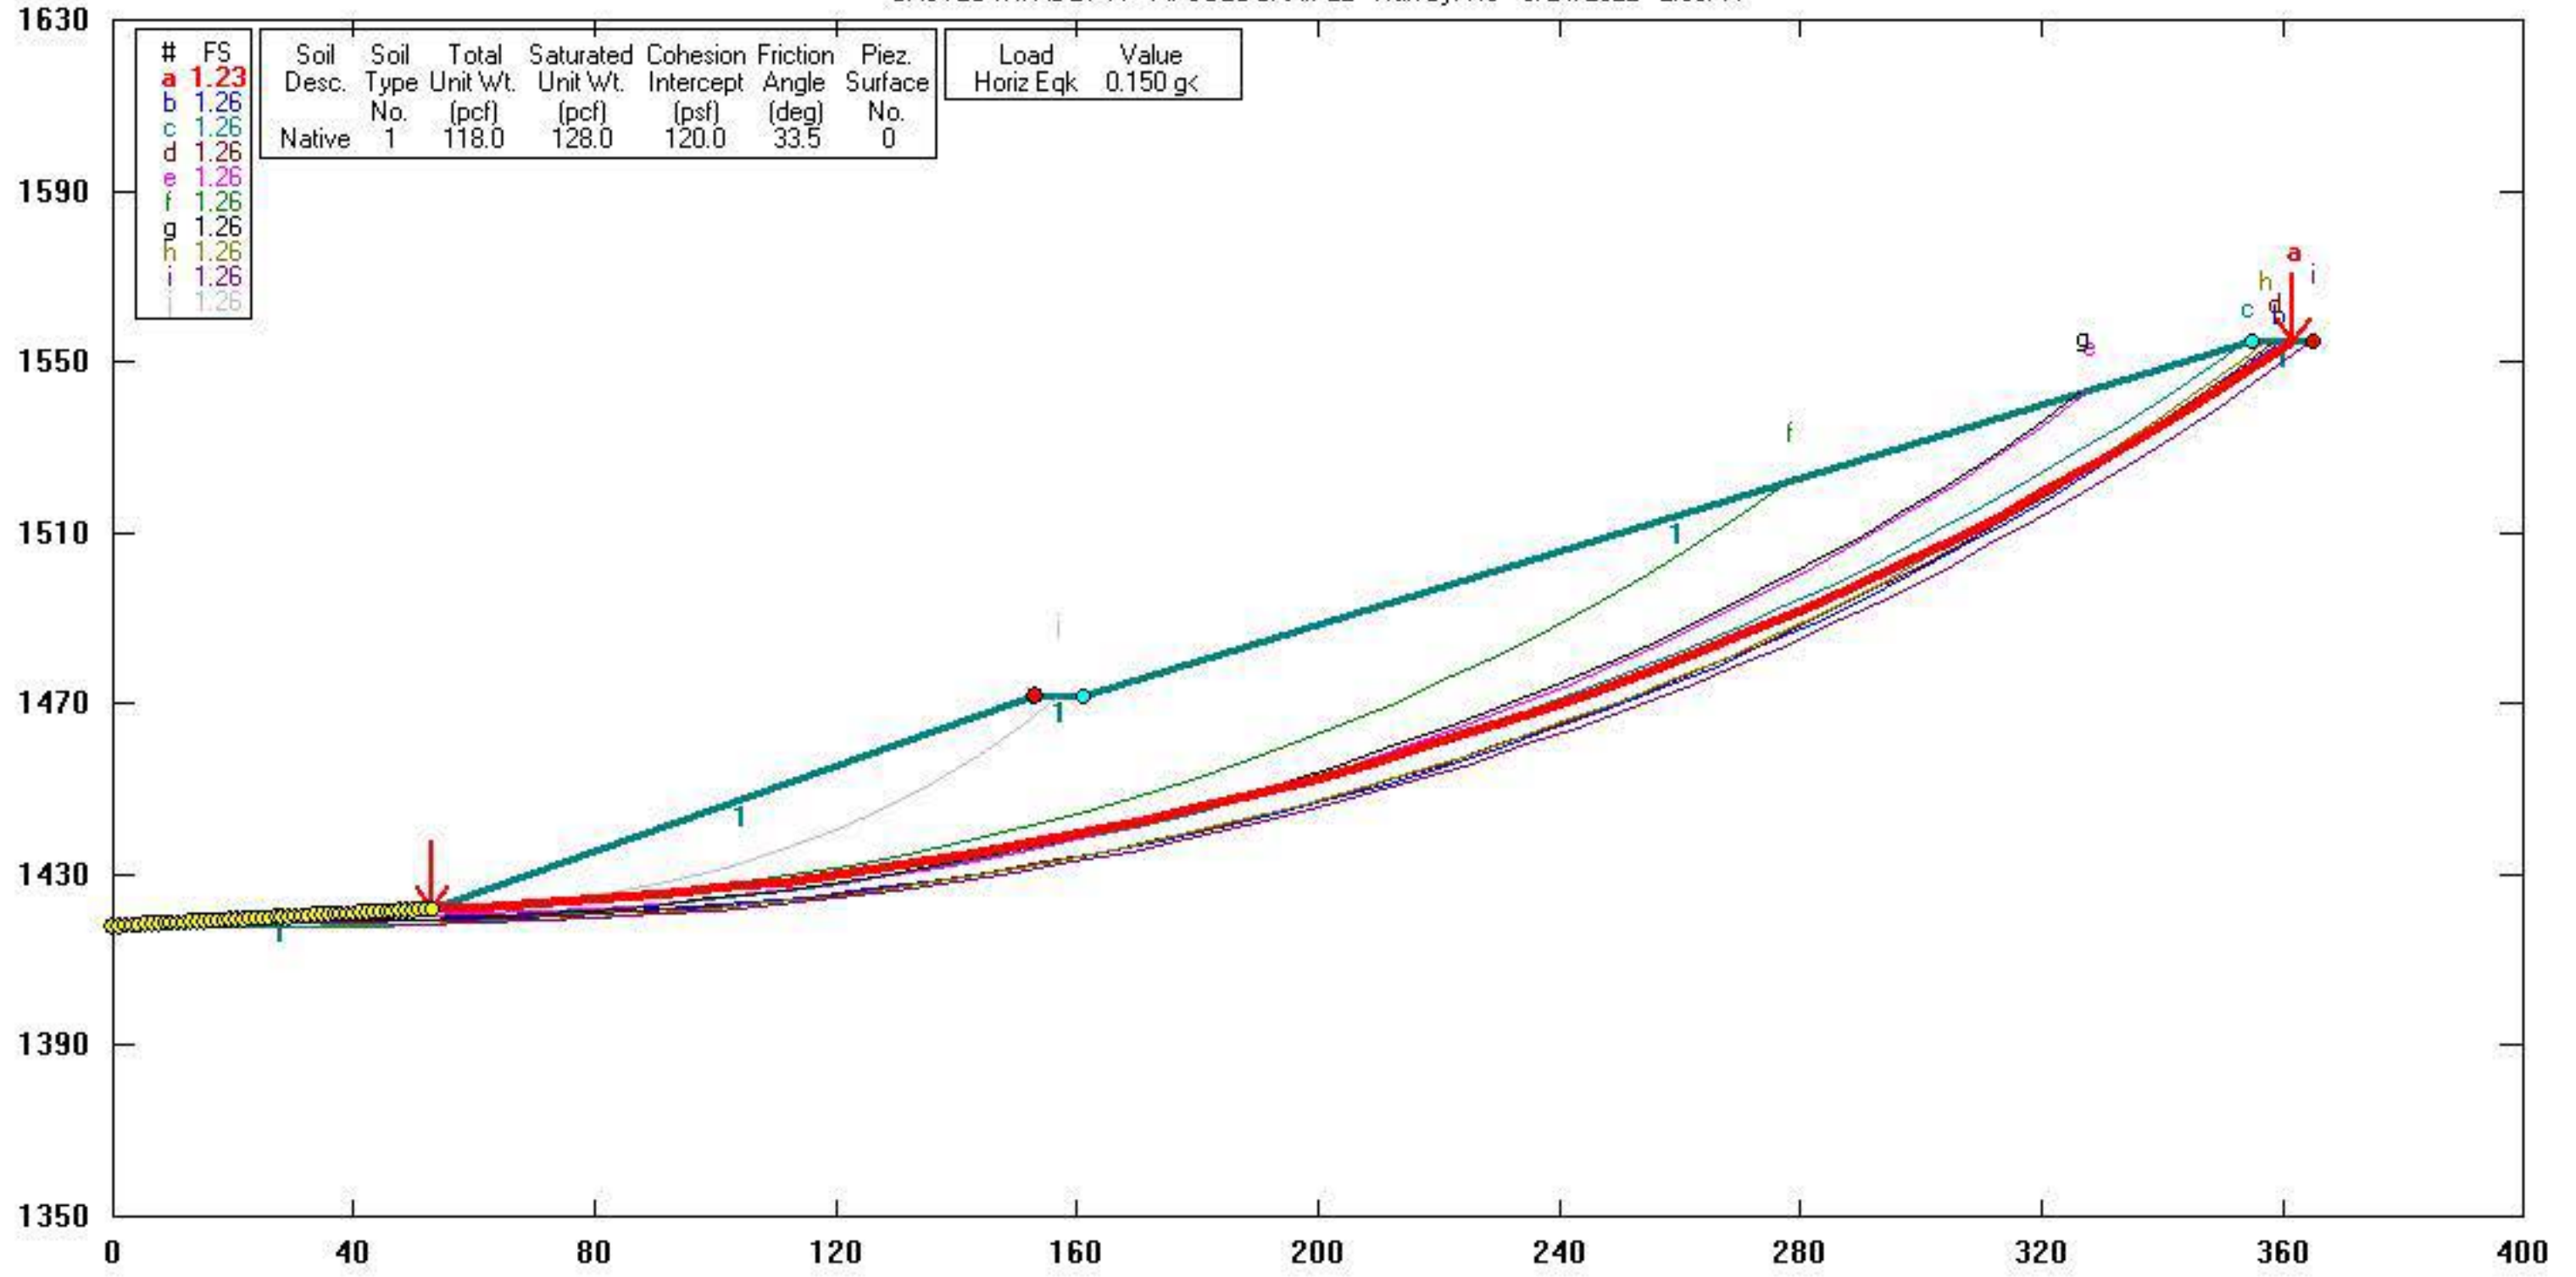
D21-1119-10 Camino Del Vino Haven Winery Crossection A-A' Prop Slope PSUEDO-STATIC

GSTABL7 v.2 FSmin=1.23

Safety Factors Are Calculated By The Modified Bishop Method

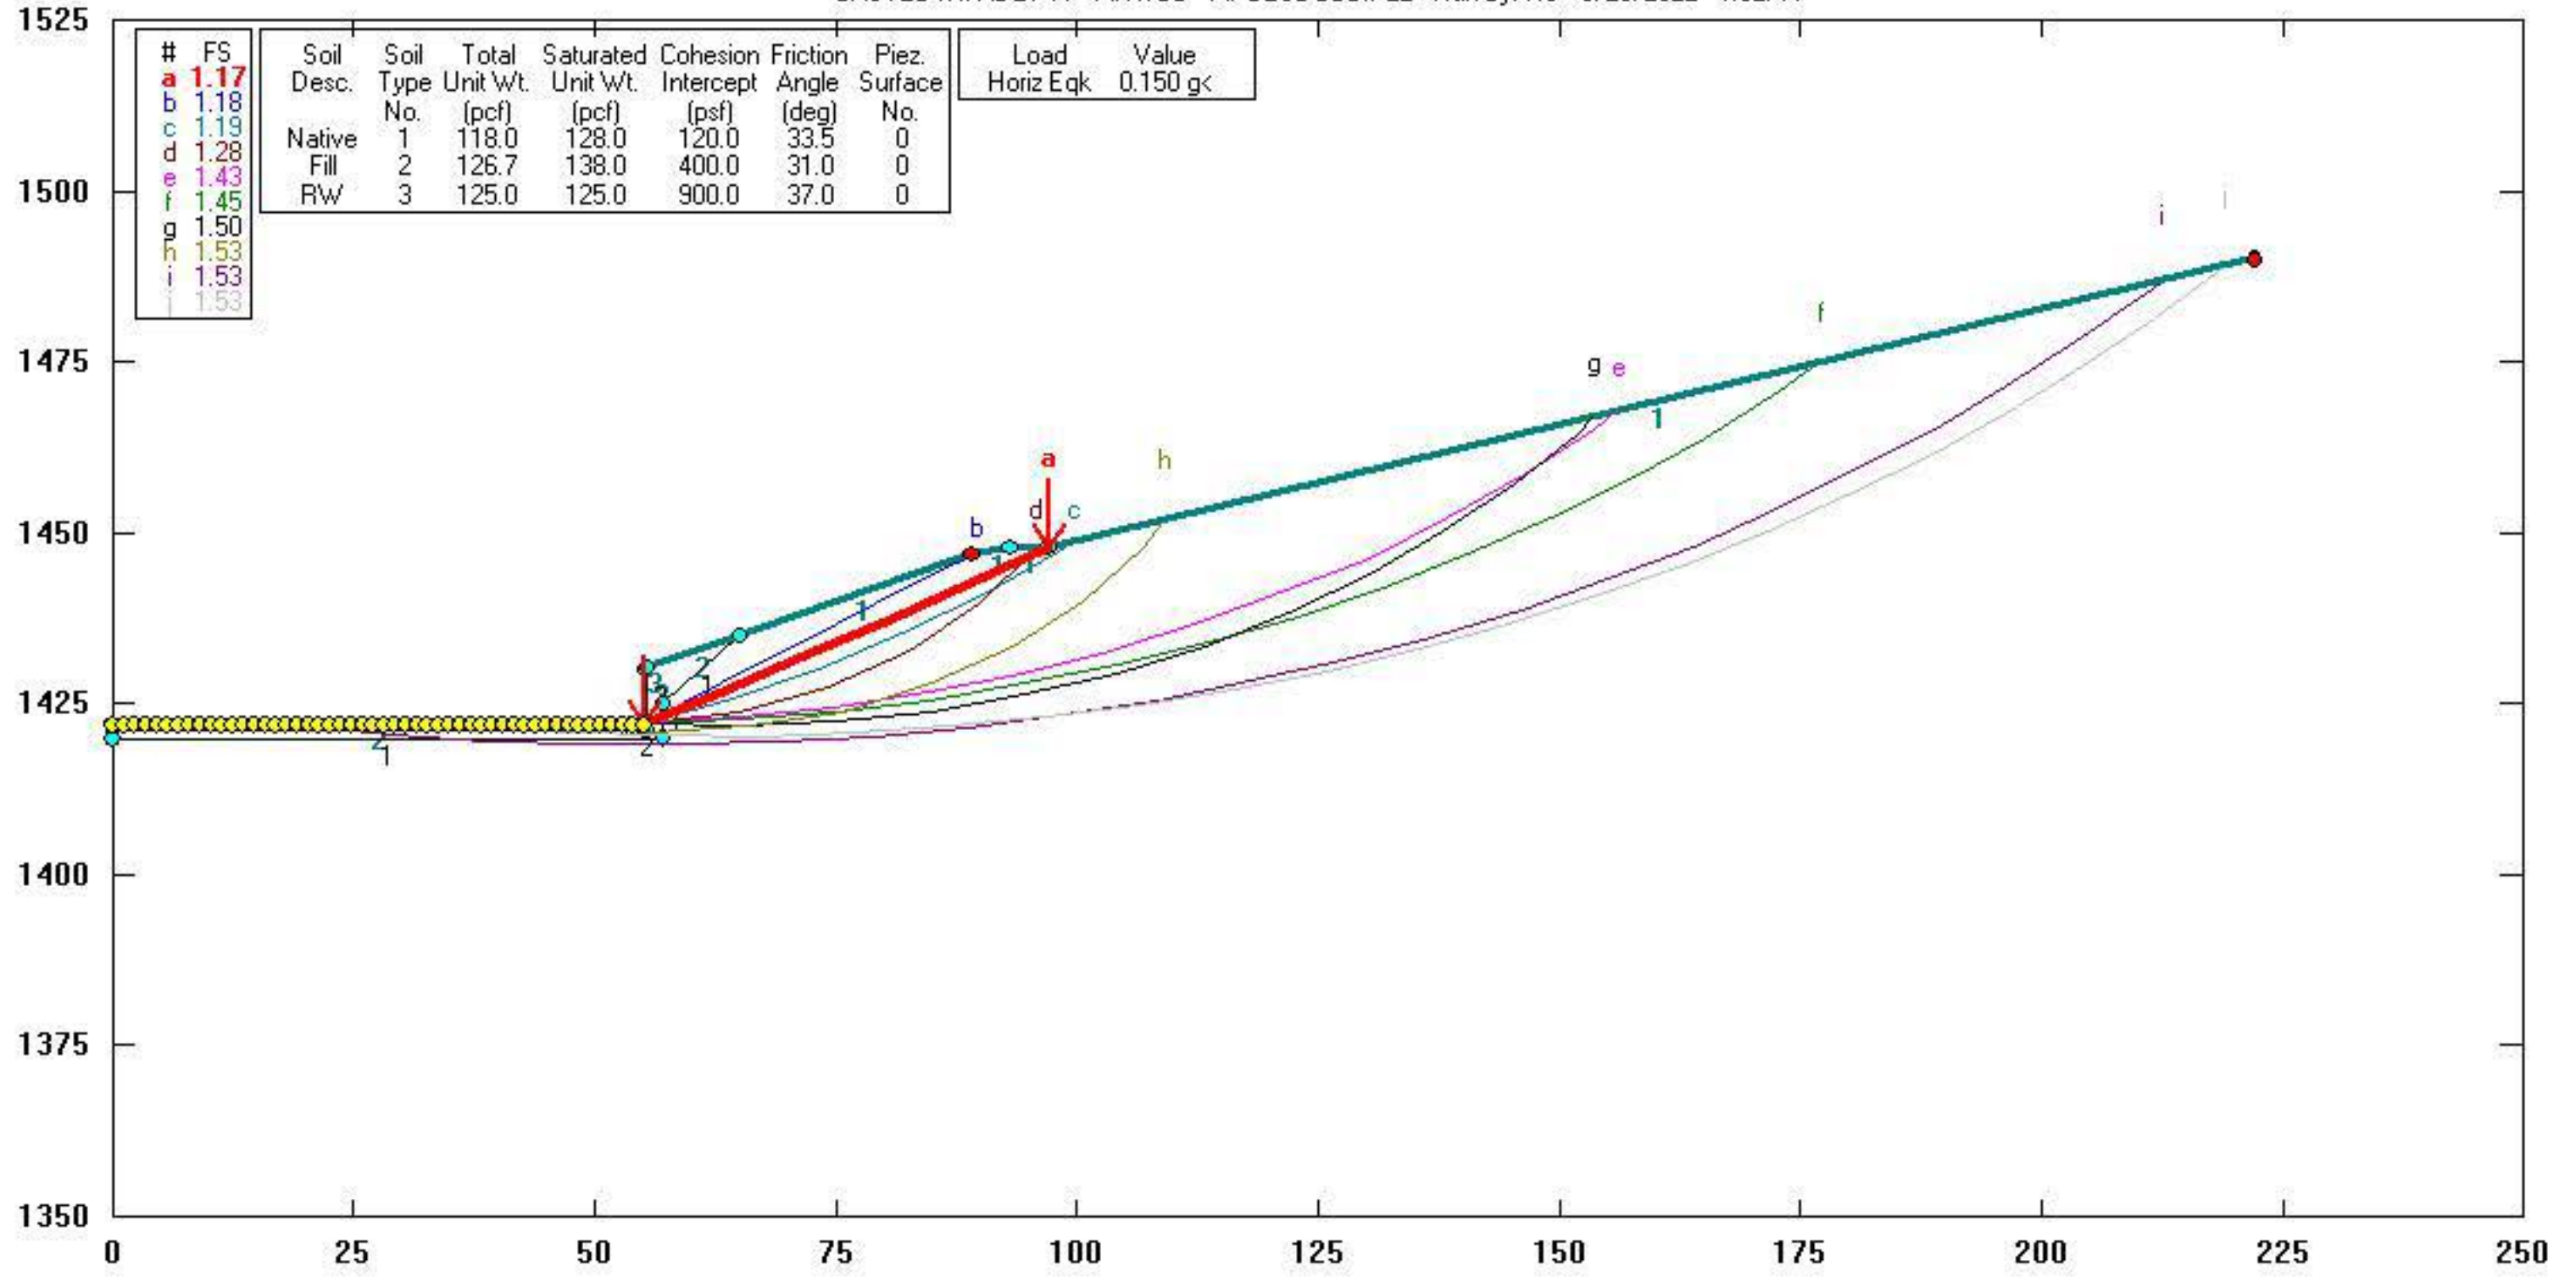
D21-1119-10 Camino Del Vino Haven Winery Crosssection B-B' Prop RW PusedoStatic

GSTABL7 v.2 FSmin=1.17

Safety Factors Are Calculated By The Modified Bishop Method
