# FEBRUARY 13, 2025 CDP\_2024-0004

## **PROJECT BACKGROUND & INFORMATION**

**PROJECT DESCRIPTION:** The proposed development includes (1) the construction of a two thousand (2,000) square foot single-family residence, (2) the creation of a circular berm/knoll and landscaped area surrounding the residence, (3) the creation of a berm between the residence and an existing parking area, (4) a water catchment area, (5) the construction of a seven hundred forty-four (744) square foot "garage-studio" which would be permitted as an Accessory Dwelling Unit (ADU), (6) the construction of a five hundred forty-three (543) square foot storage shed, (7) improvements to an existing driveway, (8) repairing and raising an existing wooden fence, (9) deepening an existing well, (10) a new entry gate, and (11) a new fence near the entrance to the property. The project would also involve after-the-fact permitting of a driveway and mitigation of impacts to wetlands due to the development of the unpermitted driveway.

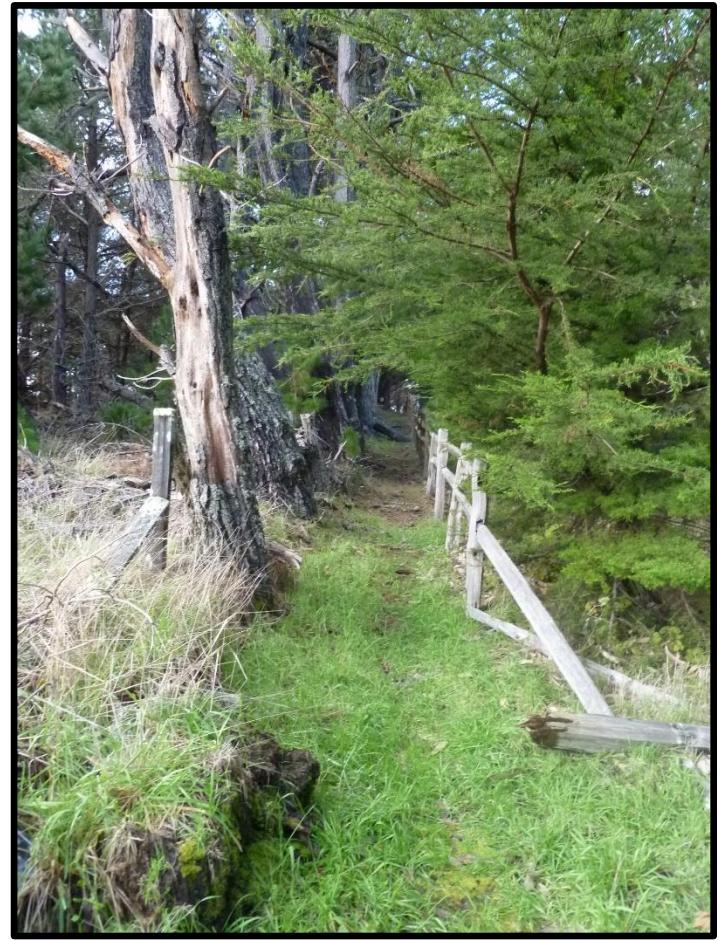
Fig 2. View of the existing vertical access easement along the southern property boundary looking west.

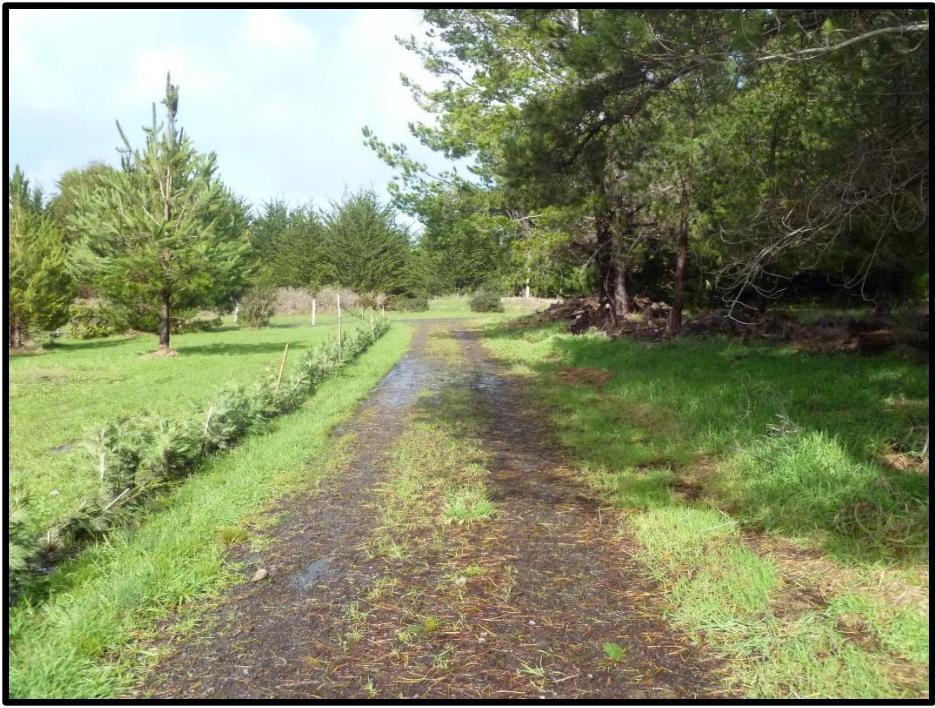
Fig 3. View of the existing driveway looking north.

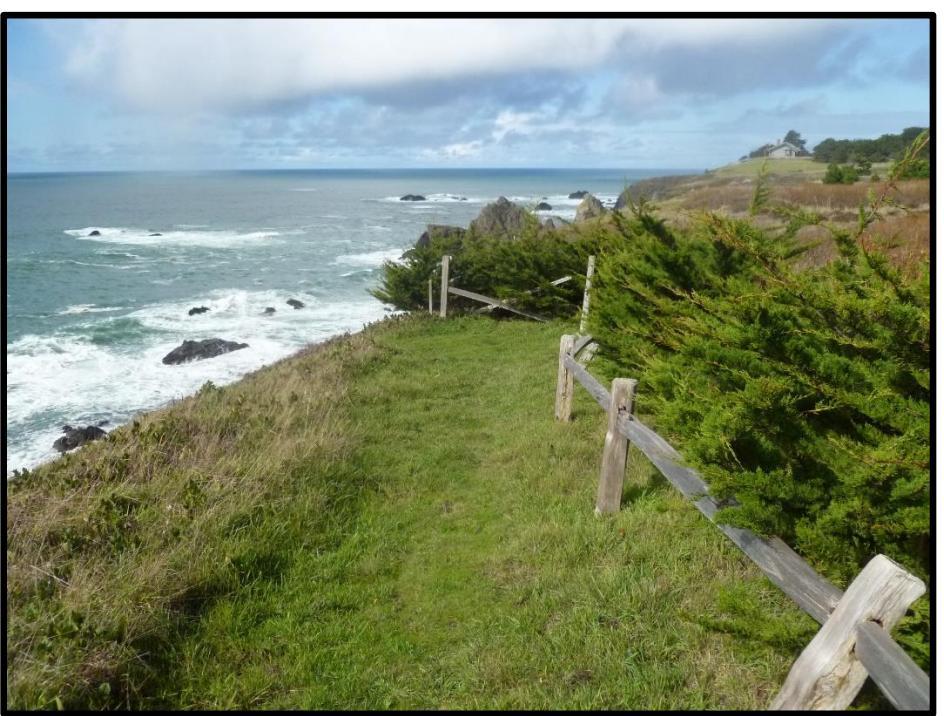
Fig 4. Terminus of the lateral access easement along the western edge of the property.

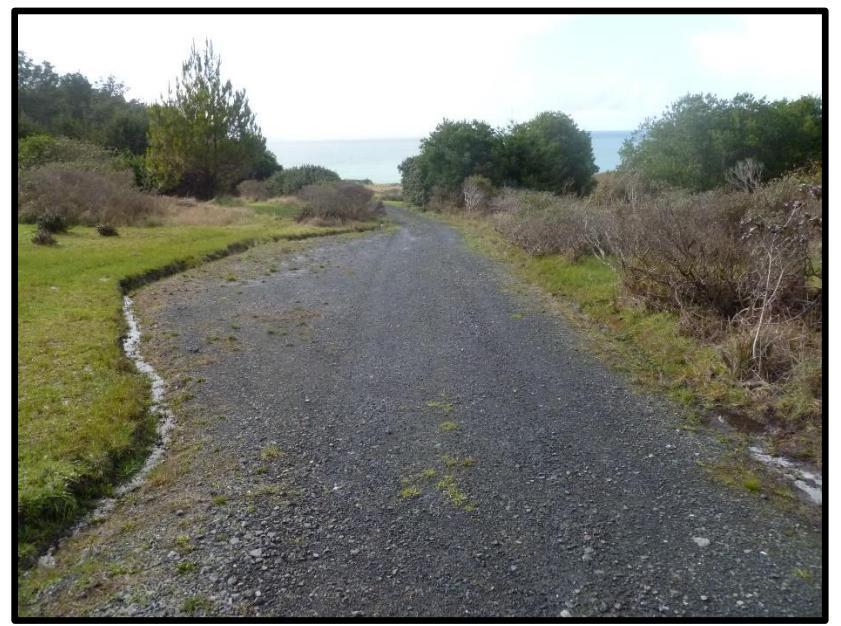
Fig 5. View of unpermitted driveway looking west near where it intersects with the identified wetland.

Subsequently, a wetland delineation, biological survey, and botanical survey was conducted on the property (see attached *Biological Scoping Survey, Wetland Delineations, & Botanical Surveys*). According to the report, no special-status plant species or plant communities were observed during the surveys. The wetland delineation revealed a one and one tenth (1.1) acre wetland on the property. No special-status animals were observed during the surveys. A one hundred (100) foot buffer was established around the identified wetland. The proposed single-family residence, berm/knoll, ADU, and storage shed would be located entirely outside of the one hundred (100) foot buffer. However, portions of the water catchment area, portions of the existing driveway, portions of the existing wooden fence, existing eastern well, new entry gate, and new fence would either be located directly within the wetland or the wetland buffer area. These features are not permitted within the wetland ESHA or wetland ESHA buffer area because they are accessory structures associated with residential development, which is not a permitted use within wetlands.

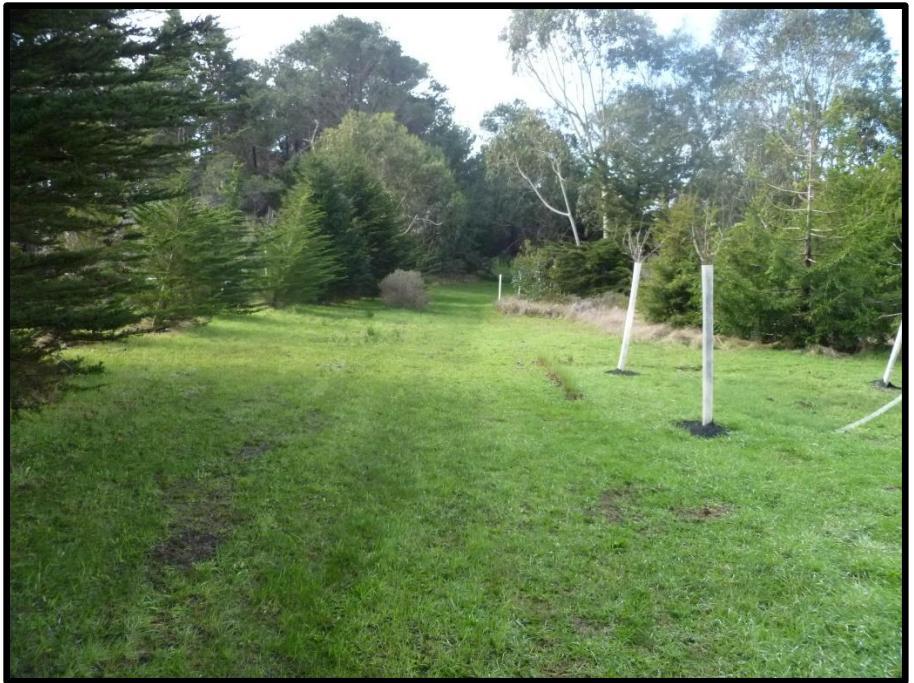
Fig 6. Looking west at a portion of the proposed driveway authorized by CDP 1-81-85.

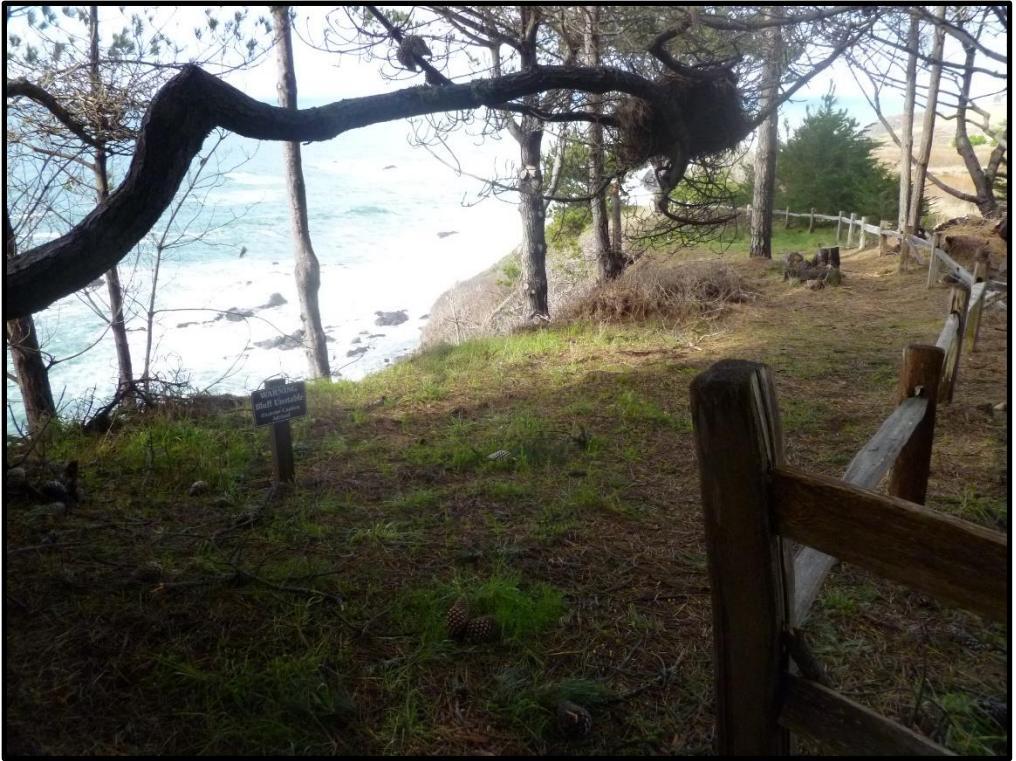
Fig 7. View of vertical/lateral access easement, including installed signage.

**Public Access:** Per MCC Section 20.528.010, 20.528.015, and Coastal Element Policies 3.6-9 and 3.6-28, an existing vertical and lateral access easement exists along the southern and western boundaries of the property, which is managed by the Mendocino Land Trust. Provision of new access is unnecessary. The proposed development would not interfere with existing access because development would not occur within the access easement or between the easement and the bluff face.

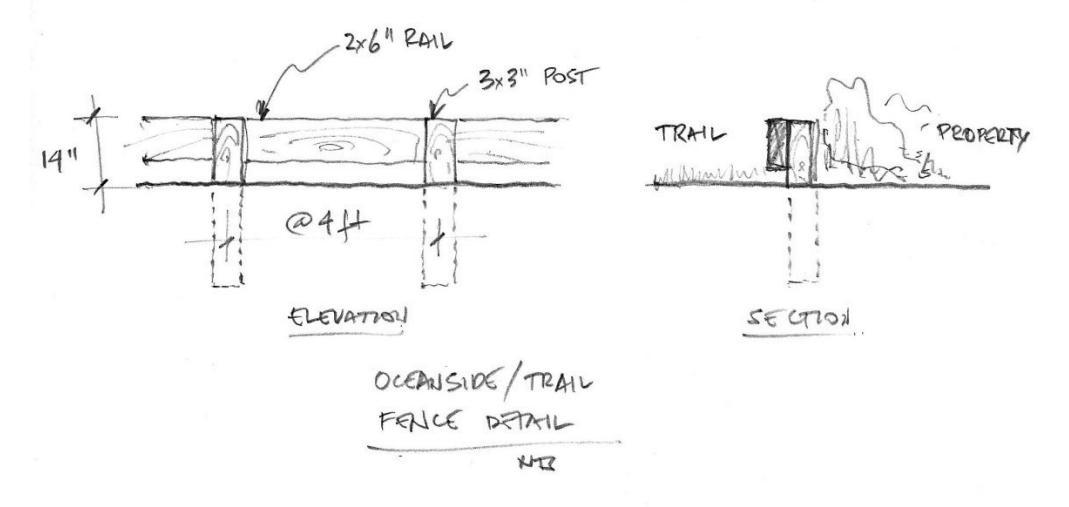
1. Between points A and B in plan, there is an existing fence that defines the bluff trail separating it from the rest of the property. The proposal considers repairing and lowering this fence to approximately 12-14" to reduce the blocking of views towards the ocean.

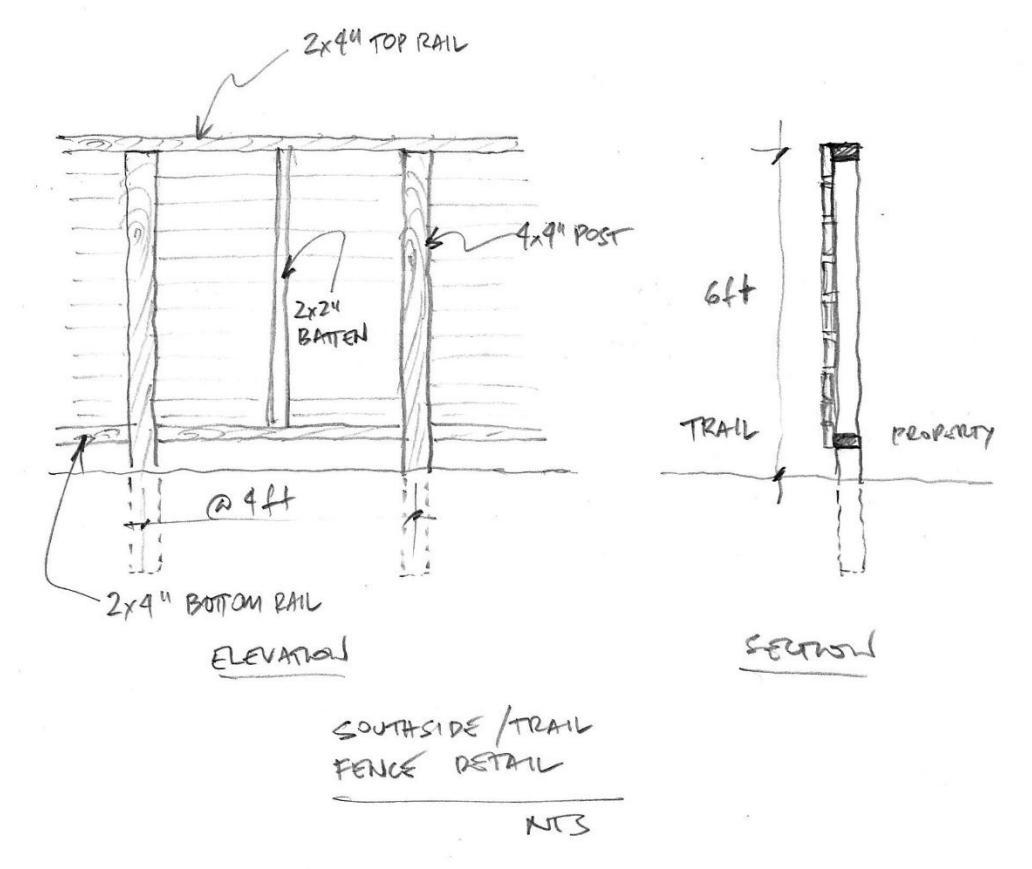
2. Between points B and C in plan, the fence separates the property from the trail along the neighboring plot. The proposal considers repairing and raising this fence to 6ft, to provide privacy to the main residence.

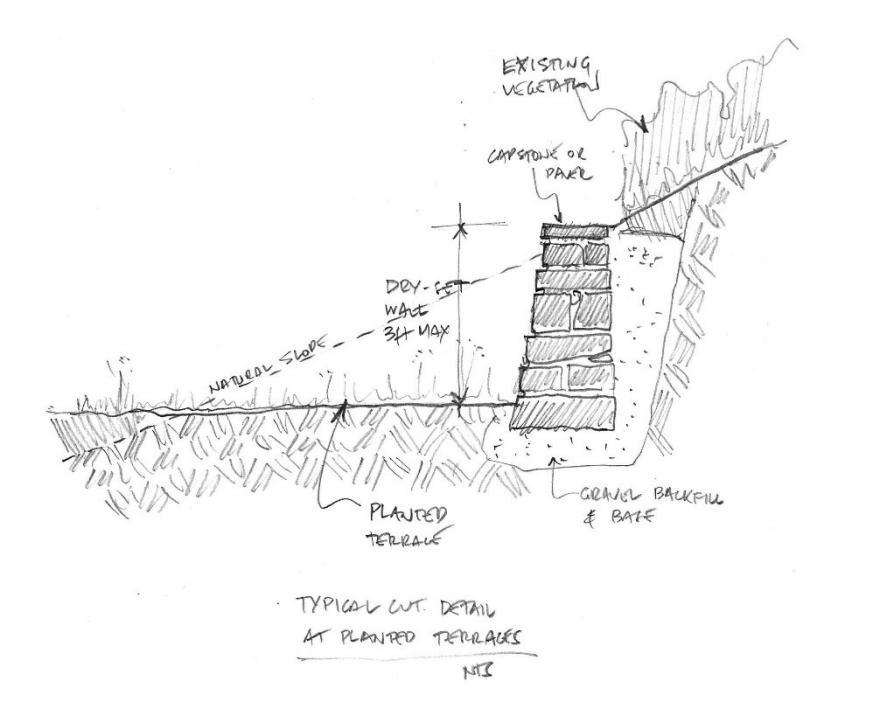
Towards the south and southeast side, the terrace is cut not exceeding 4ft in height. These cuts allow to create a natural berm effect and hide part of the house façade. The top of the cut is planted with native vegetation to blend with what is already naturally growing on the site.

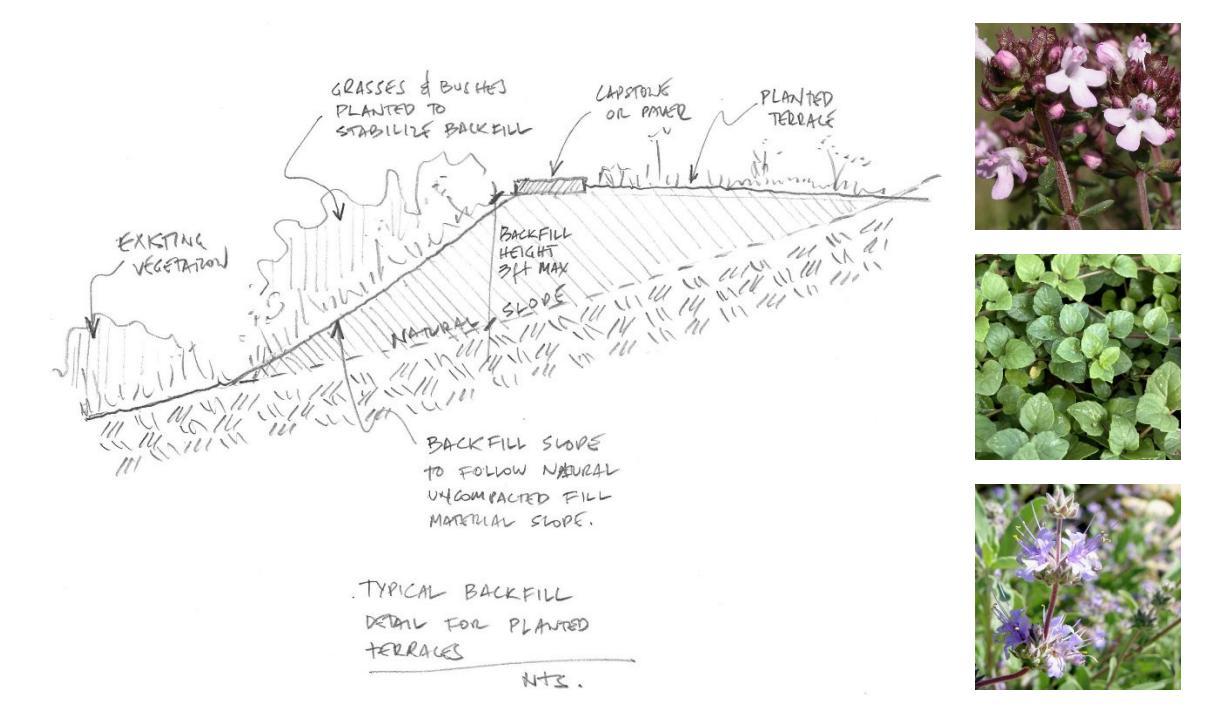
Towards the north and northwest, the terraces meet the natural terrain with a back fill not exceeding 3ft in height. The back fill slope follows the natural slope of the fill material and is stabilized with planting of species already growing on the site so that it blends more naturally.

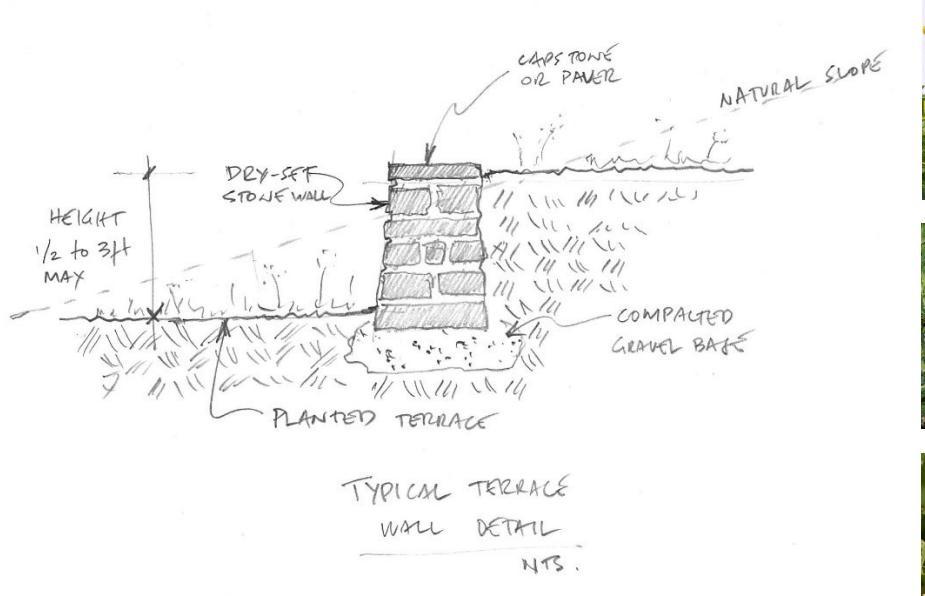
The interior terraces are made from dry-set stone walls and are limited and vary in height, from half foot to 3 feet, hence not requiring any structural foundation. The flat terraces are planted with drought-tolerant grasses and ground cover.

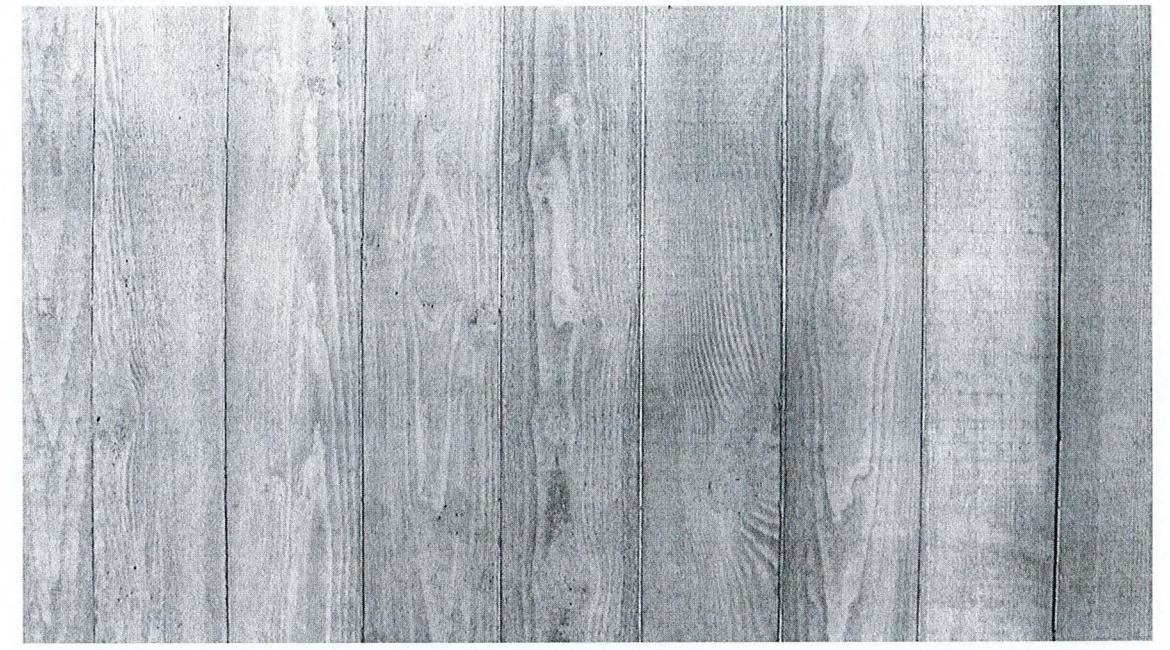
The image below shows the result of this type of formwork construction in a previous project designed by ELEMENTAL. In addition to the texture provided by saw cut and wood grain, the concrete achieves different tonalities giving it a more natural look compared to synthetic or painted siding boards.

Rough-saw board form work concrete in a project by ELEMENTAL.

In addition to the texture of the concrete, surfaces formed in this way will promote the growth of lichen on many of them because the imperfection of the texture will hold very small amounts of moisture. This phenomenon will further promote the contextualization of the material in the Mendocino microclimate as lichen is prevalent on wood left to age outside in many locations in the area as well as rock used in construction and naturally occurring.

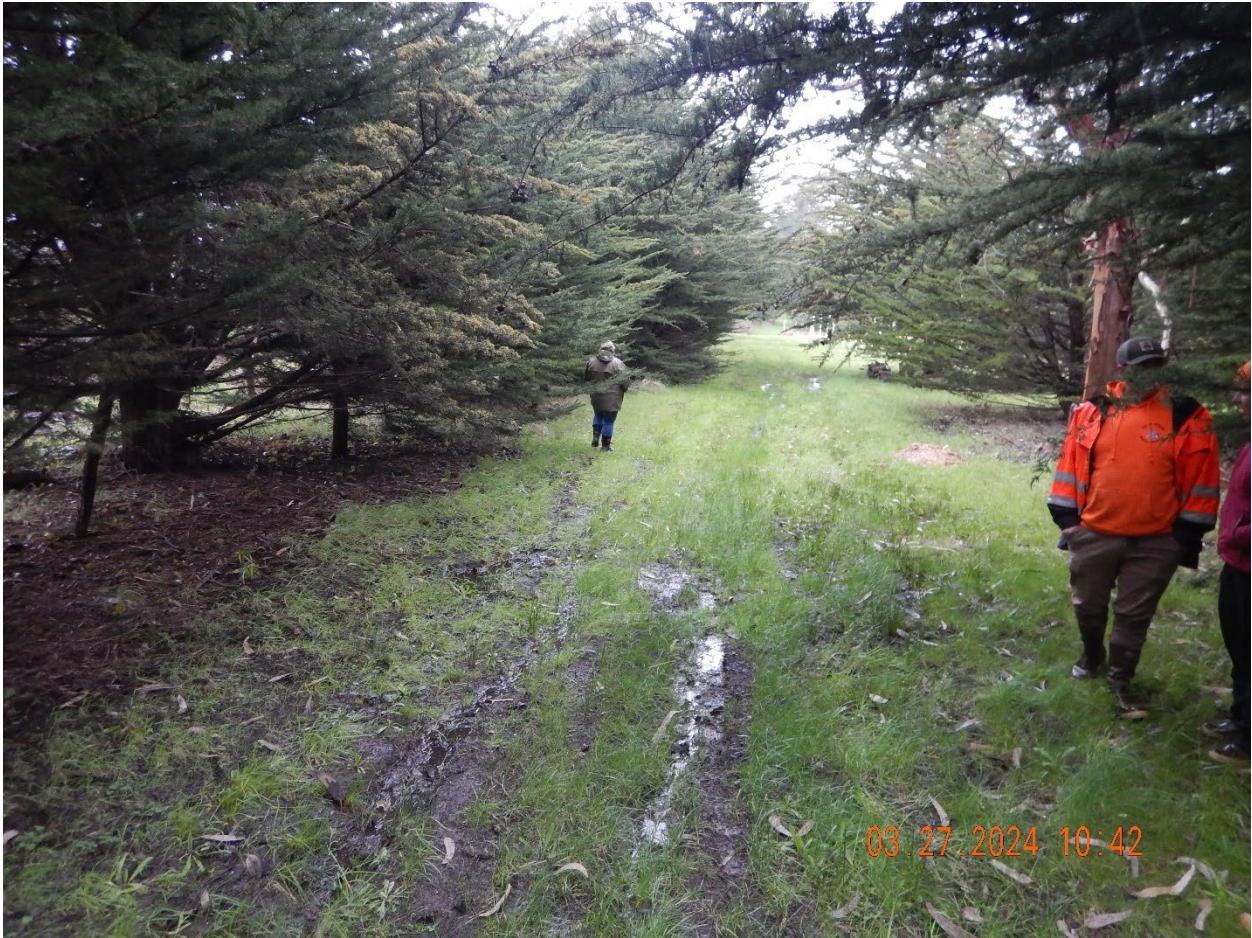
Photo 1: Facing west, walking along the southern border of the property with the public trail located to the left of the trees. Surface water and wetland vegetation are seen in the center of the photo.

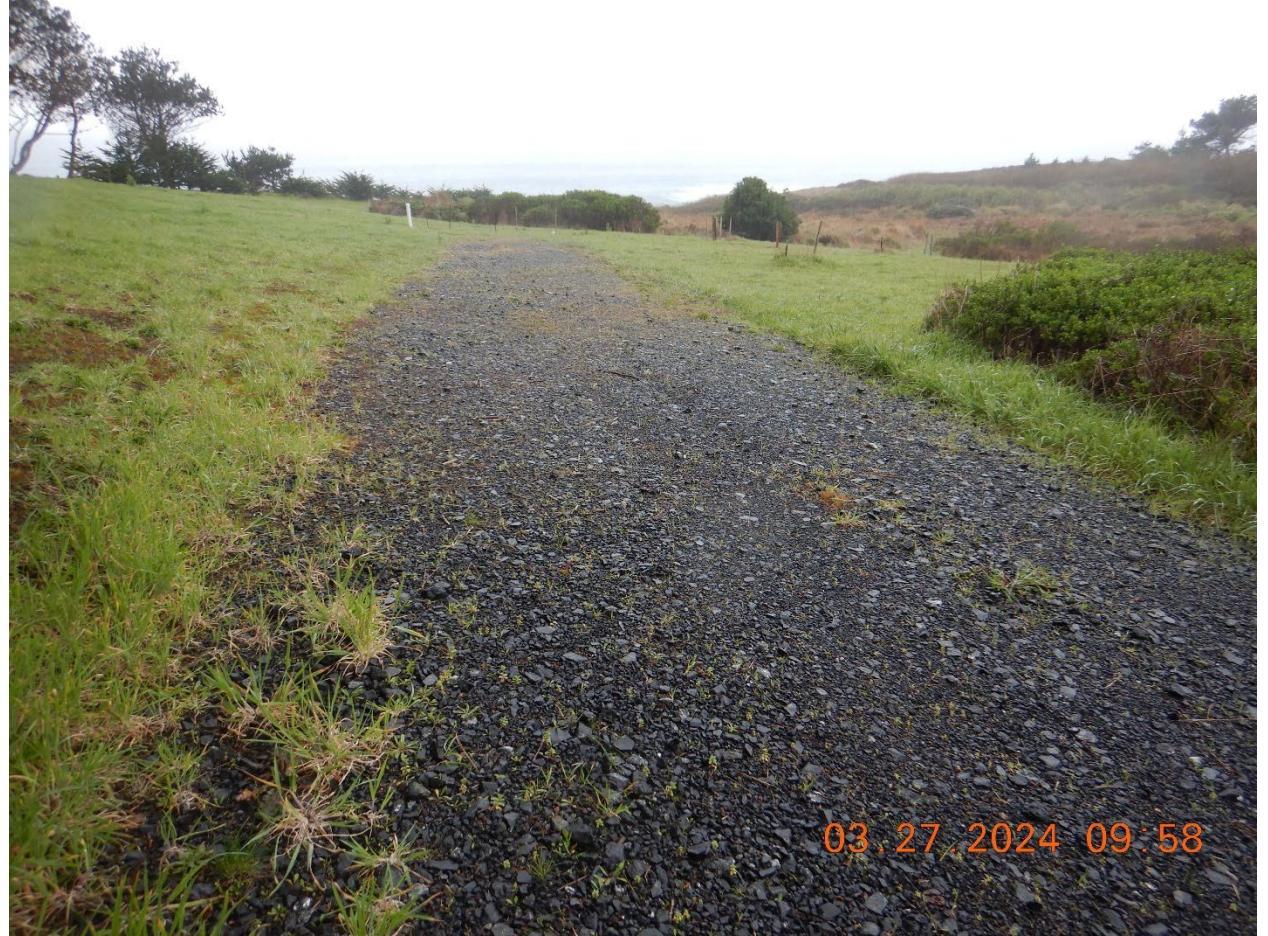
Photo 3: Facing west, the end of the gravel driveway is visible.

We approached the gravel driveway on the western section of the property (see Photo 3) and Sarah Bradley, the property owner's representative, commented on the location of the septic system being west of the end of the gravel driveway. At this location, we expressed concern with a septic system potentially being placed without an appropriate buffer from the wetlands that could cause excess nutrients to infiltrate and impact the wetlands. After this site inspection, in a video call meeting with the property owner on April 10, 2024, we were informed that the septic system utilizes aerobic treatment and does not leach toward the wetlands.

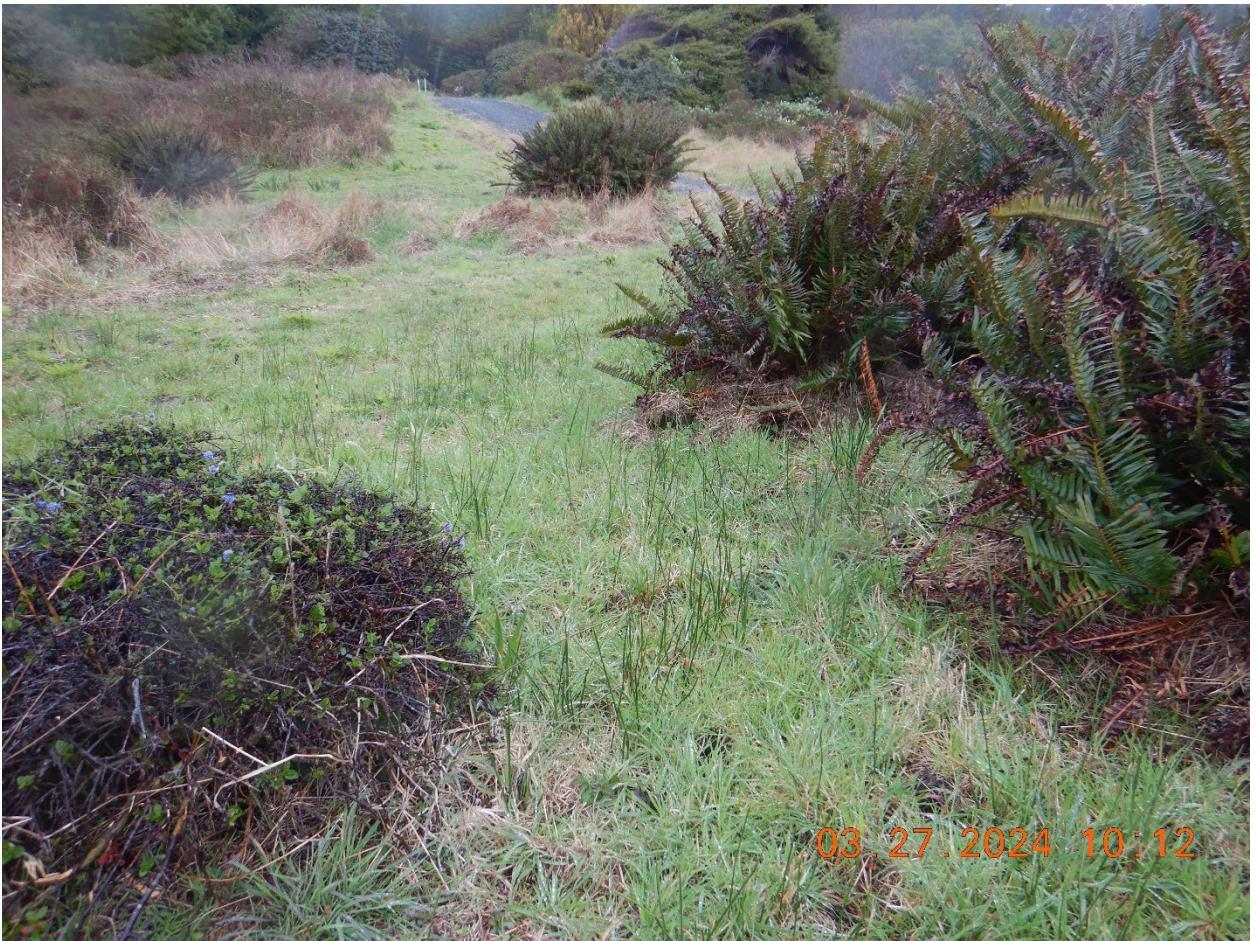
Photo 4: Facing east, wetland vegetation (*Juncus* sp.) is seen growing through an area that has been mowed. The gravel driveway is seen in the background.

North of the gravel driveway, within an area that has mowed vegetation and within the surrounding taller shrubs and grasses, we observed saturated soils, wetland vegetation species (see Photo 4), and pools of surface water. We also observed a picnic table and areas with wetland plants that had been recently and repeatedly mowed suppressing wetland plant growth. We walked east on the gravel driveway over a culvert measuring 20 feet long (Photo 5). The culvert appeared undersized. Properly sized and installed culverts are at reduced risk of plugging and potential crossing failure, and fine sediment discharge. As plans for this culvert were not reviewed by Regional Water Board staff, it is unknown what flow the structure currently has capacity for. Upstream of the culvert we observed altered site hydrology due to the installation of the gravel driveway. The edges of the driveway have begun to erode due to water being concentrated to a narrower channel, as opposed to spreading and sinking into a vegetated area as pre-gravel driveway would have allowed. Incision of the edge of the gravel driveway is seen in Photo 6 below.

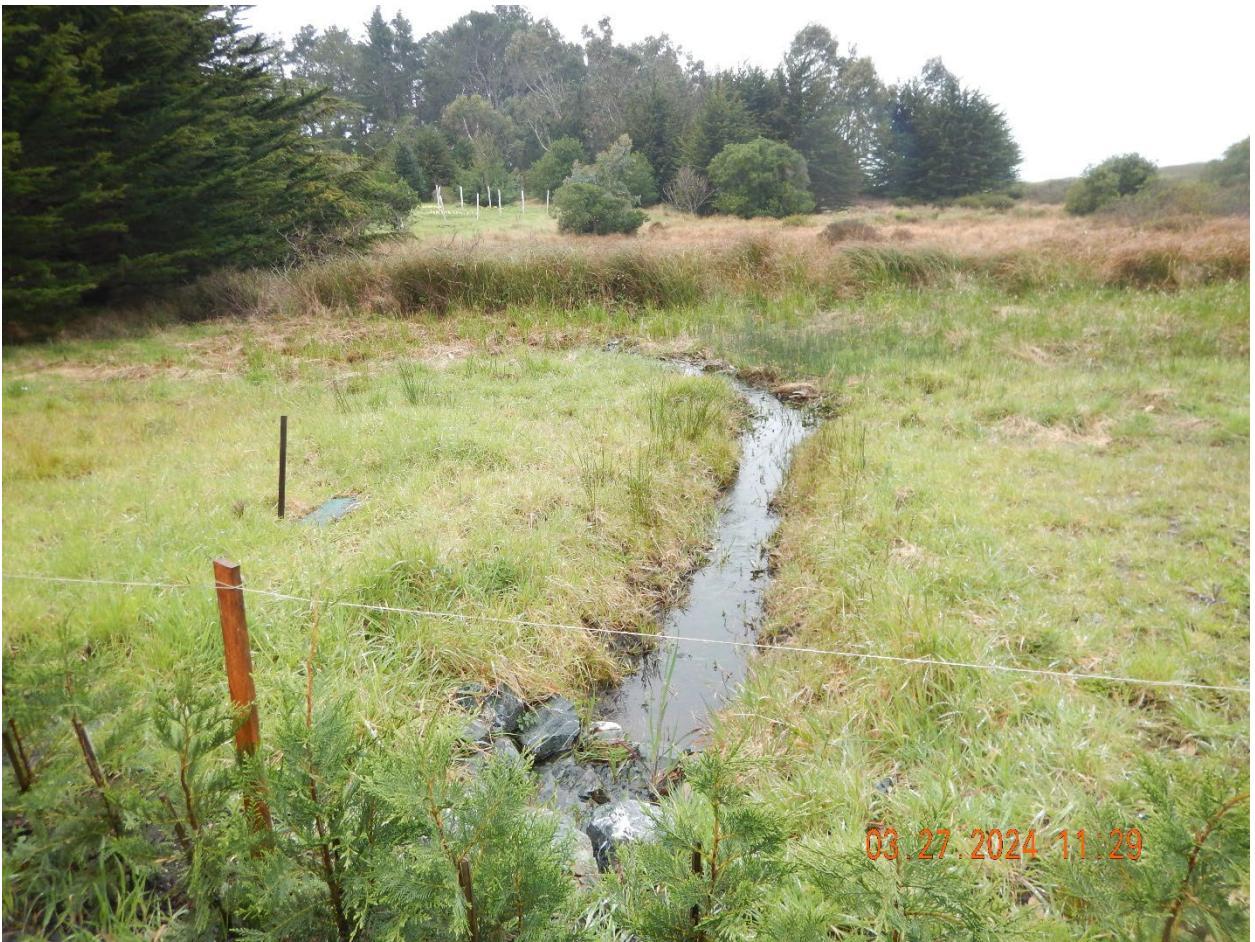
Photo 8: West of the corrugated HDPE culvert.

Next to the gravel driveway, on the eastern side of the property, water flows through the culvert and rocked outlet to a vegetated area. Rushes, shrubs, and trees are growing in this section of the property. From the observed vegetation and hydrology indicators, this area likely contains wetlands, however, a wetland delineation would need to be conducted in order to determine the location and extent of wetlands on the property. Water that is flowing through the culvert has begun to incise and create a channel for surface water flow at a lower elevation than the rest of the vegetated ground. This altered hydrology is a result of the unpermitted driveway and culvert installation.

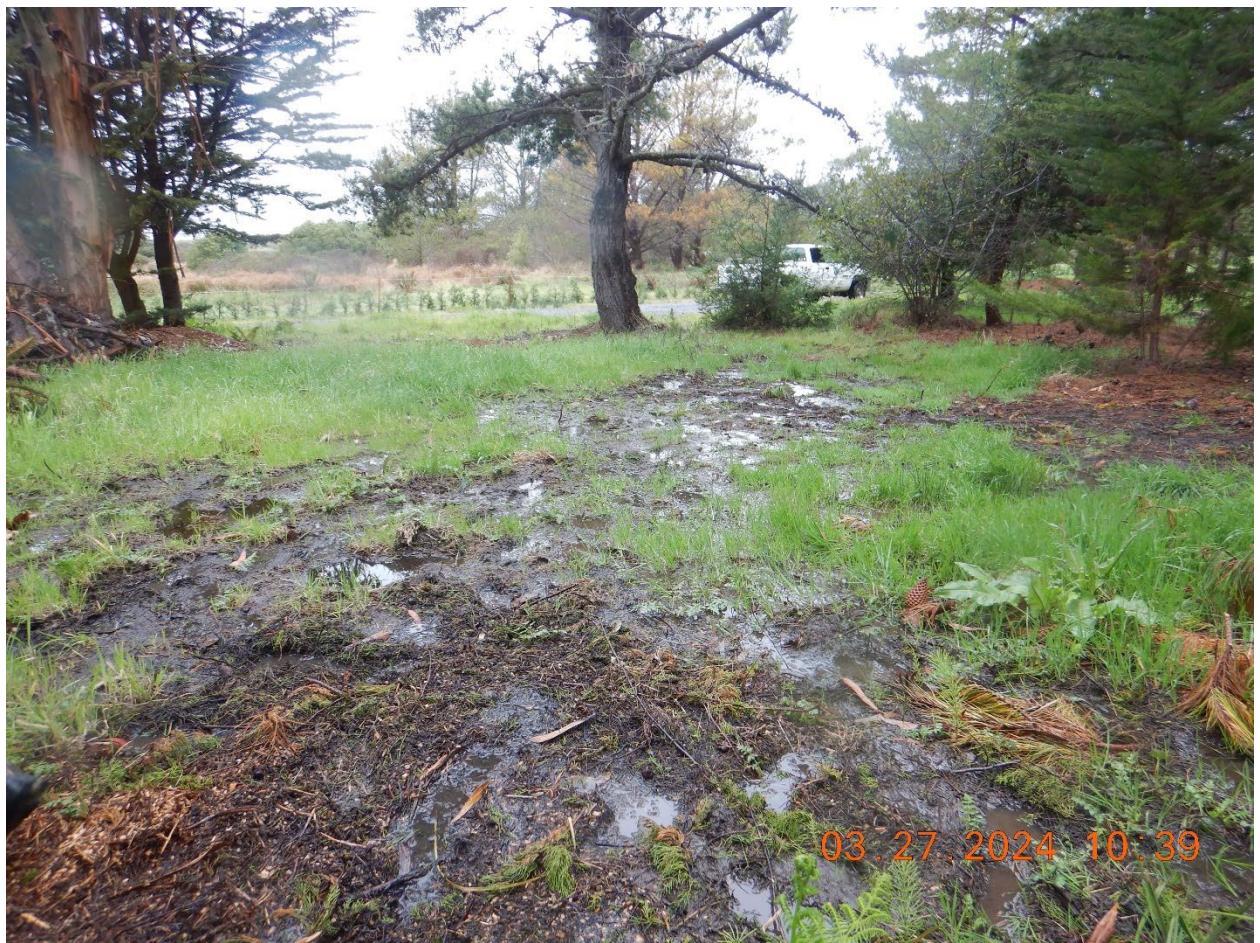
As we walk further east of the gravel driveway, we observe a water pump, trenching and water tank placed in an area with saturated soils and ponding of surface water, potentially a wetland. Placement of infrastructure within wetlands requires a permit from the Regional Water Board.

Photo 9: On the east side of the driveway facing west. Saturated soils and wetland vegetation are seen in the foreground east of the driveway where the truck is seen parked in the background.

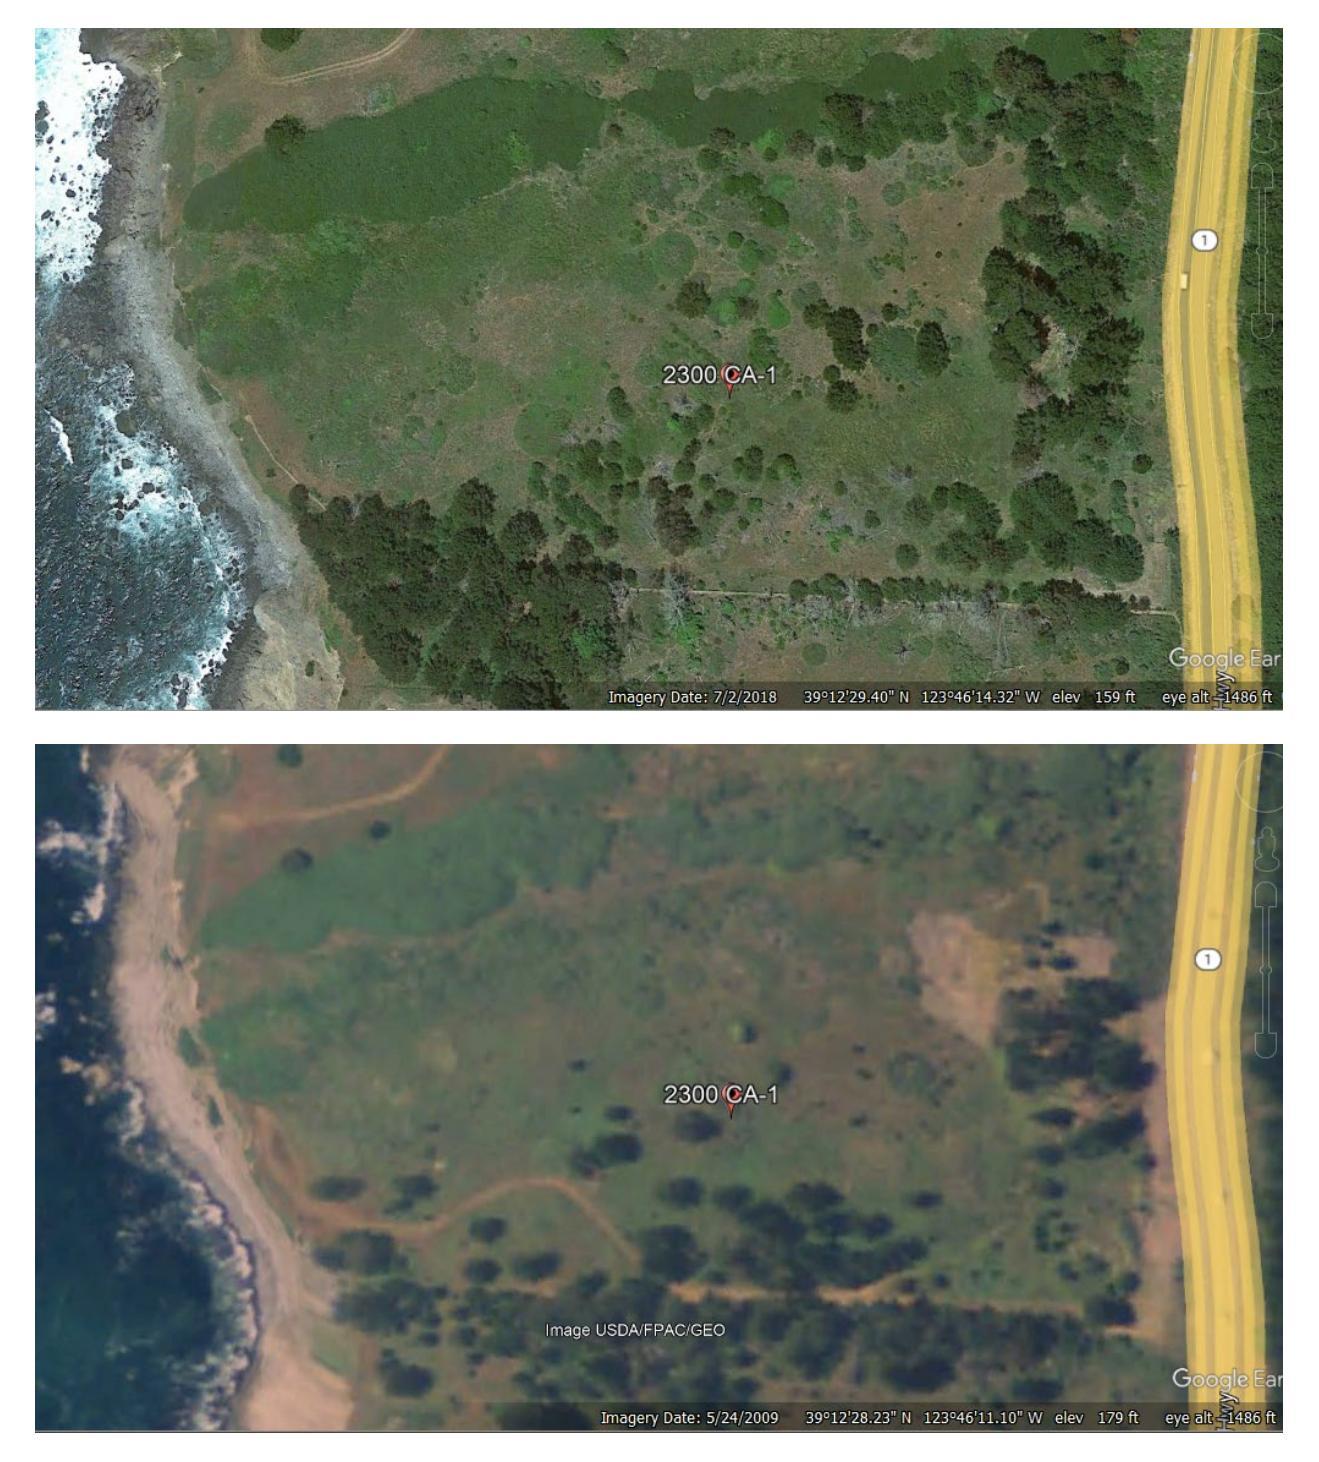
Image 12-15: Aerial images of the site in order from top to bottom: 2023, 2021, 2018, 2009.

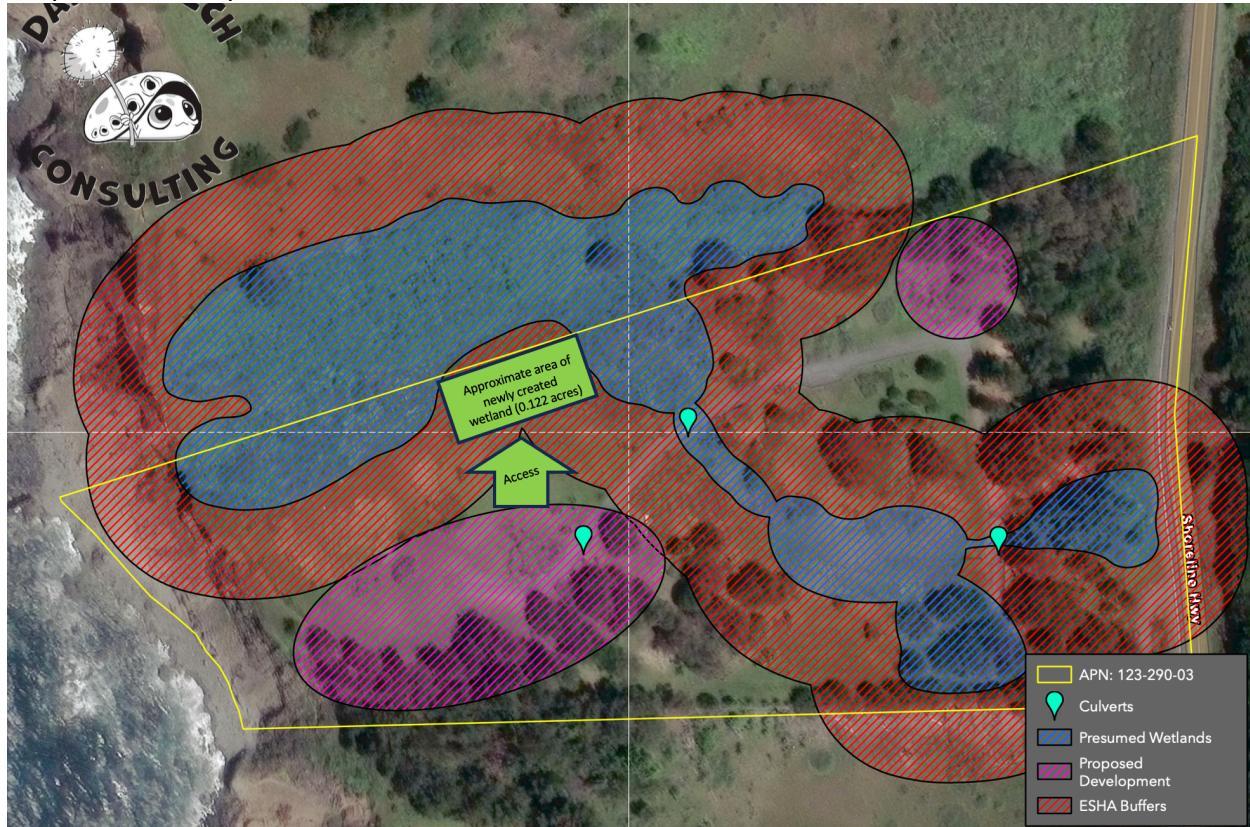
Where will the wetlands be created? As shown in Figure RMMP-1, the newly created wetland will be adjacent to a naturally occurring wetland to establish ecological continuity between existing and new wetlands. As per instructions from the Regional Water Control Board, this new wetland will be an extension of the existing wetlands, and will be outside of the buffer from the proposed development area. The new wetland sits at the same elevation as the adjacent wetland for water to ooze from the existing to the new wetland. It sits lower than an adjacent grass field and, therefore, is ideal for allowing additional water to ooze to the naturally occurring depression in the land to create hydric soils during seasonal rainfall. The size of the wetland will be 0.122 acres as per instructions from the Regional Water Control Board from October 29, 2024.
Figure RMMP-1: Bright Green Circle Represents the Approximate Location of the Newly Created Wetland in Relationship to the Presumed Seasonal Wetland ESHA & Existing and Proposed Development

What actions will be taken to grade the land and allow water to inundate to create hydric soils? The existing contour of the land will be carefully and minimally graded by using a small excavator/tractor to scrape the topsoil and thus achieve the same elevation of the adjacent existing wetland for water to ooze over to the new wetland. The scraped topsoil be evenly spread at a higher-level on the property location, outside the ESHA buffer. Grading will be conducted on no more than 0.122 acres to facilitate the naturally appearing depression in the land that collects rainwater and promotes the natural growth of native wetland vegetation. Grading will not result in standing water or a pond. The area will be accessed from the site of the proposed development (i.e., from the south; see Figure RMMP-1), and will thus have no impact on any of the existing wetlands. The work will be conducted by a professional contractor, highly knowledgeable in grading.

Identify where the water is coming from. The primary sources of water for the new wetland will be seasonal rainwater, including from the existing adjacent wetland and a higher-elevation grass field. This water will help maintain the minimum 14 consecutive days of saturation required to support hydric soils and wetland vegetation and ensure that the wetland receives adequate water year-round. Time table of when the creation is desired to occur, construction methods, timing, and sequence: The creation of the new wetland will occur toward the end of the 2025 dry season in October of 2025. The total duration of grading and planting will be approximately 1 week. The area will be staked to measure 0.122 acres, then graded with a small excavator/tractor to the same elevation as the existing adjacent wetland. Planting of native species will take place immediately thereafter to prevent the growth of invasive species and for plants to receive adequate water supply from rain storms during the following wet season.

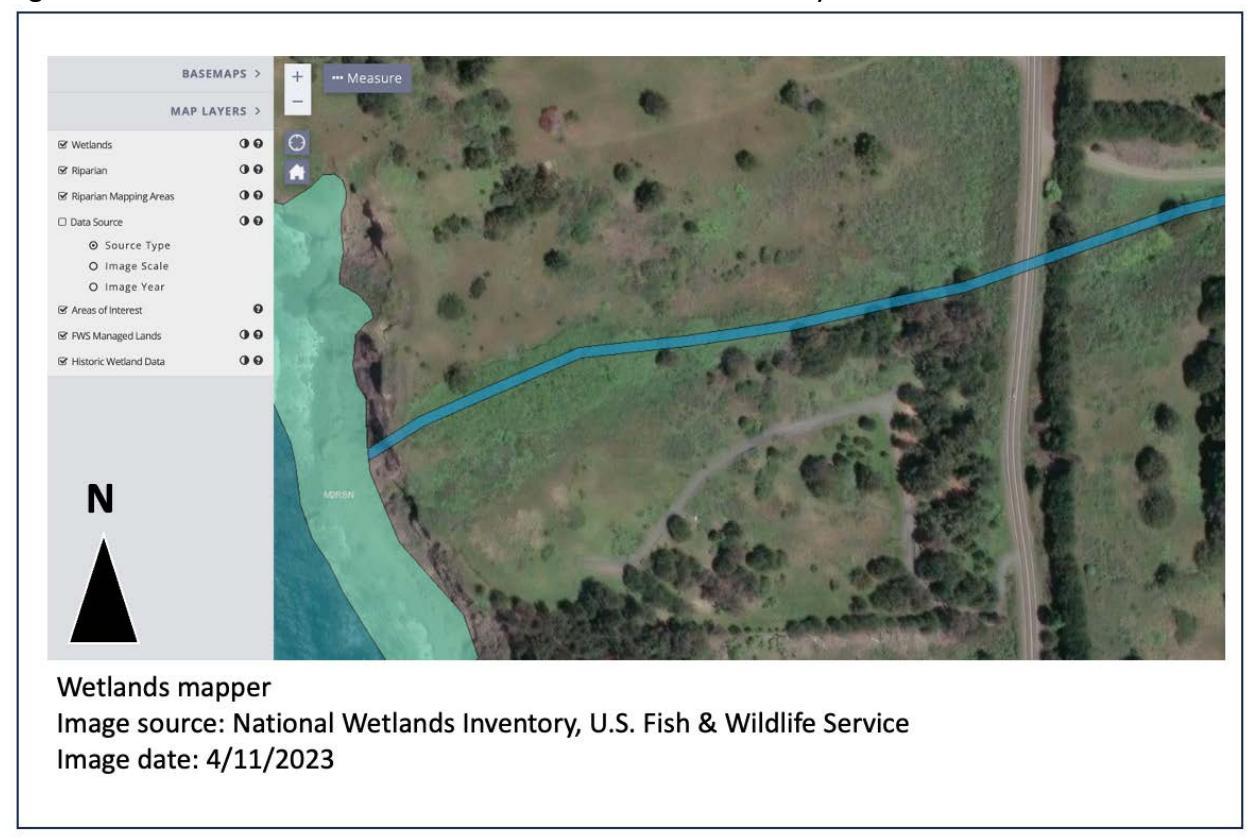
### Figure 7: Wetland Identified in the National Wetlands Inventory

During field work, a seasonal wetland was observed with water flowing through culverts under the Shoreline Highway and onto the subject parcel, as identified in extant wetland delineations of the subject parcel. An forensic wetland delineation was conducted and is described in Section 5.

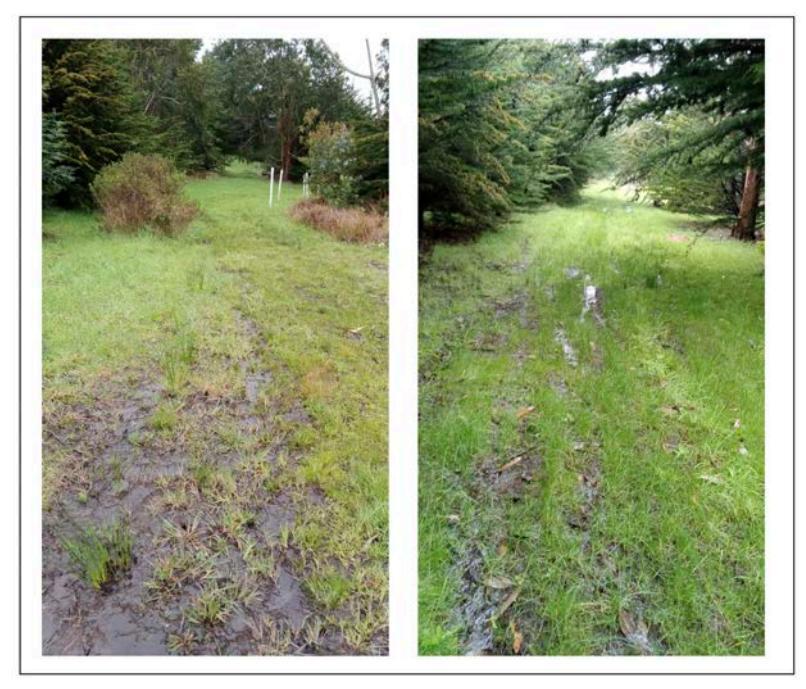
Figure 12: Alternate Access Driveway (titled Grass Path in Figure 1) Within Presumed Wetland ESHA
