# FEBRUARY 13, 2025 CDP\_2024-0004

## **PROJECT BACKGROUND & INFORMATION**

**PROJECT DESCRIPTION:** The proposed development includes (1) the construction of a two thousand (2,000) square foot single-family residence, (2) the creation of a circular berm/knoll and landscaped area surrounding the residence, (3) the creation of a berm between the residence and an existing parking area, (4) a water catchment area, (5) the construction of a seven hundred forty-four (744) square foot "garage-studio" which would be permitted as an Accessory Dwelling Unit (ADU), (6) the construction of a five hundred forty-three (543) square foot storage shed, (7) improvements to an existing driveway, (8) repairing and raising an existing wooden fence, (9) deepening an existing well, (10) a new entry gate, and (11) a new fence near the entrance to the property. The project would also involve after-the-fact permitting of a driveway and mitigation of impacts to wetlands due to the development of the unpermitted driveway.

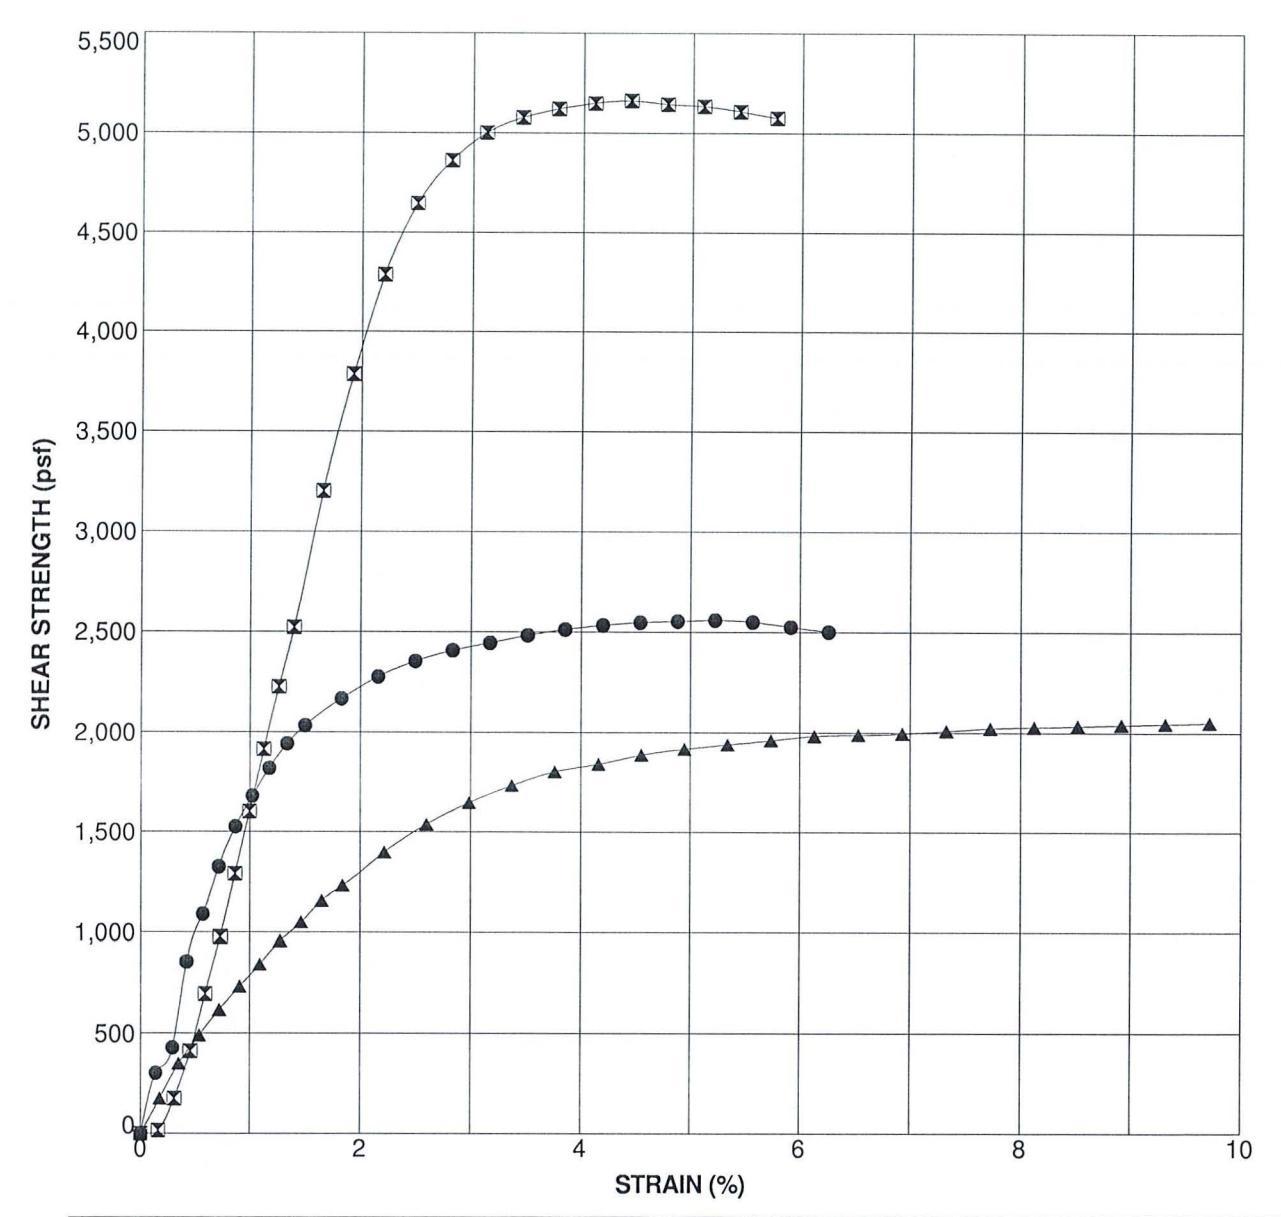
Sample Source	Classification	Confining Pressure (psf)	Ultimate Strength (psf)	Strain (%)	Dry Density (pcf)	Moisture Content (%)
B-1 at 6 ft	LIGHT ORANGE-BROWN SILTY SAND (SM)	1152	2559	5.2	107	15.1
🕱 B-2 at 13 ft	LIGHT ORANGE-BROWN SILTY SAND (SM)	2160	5161	4.4	100	11.8
▲ B-4 at 4.5 ft	DARK BROWN SILTY SAND (SM)	864	2051	9.7	103	18.5

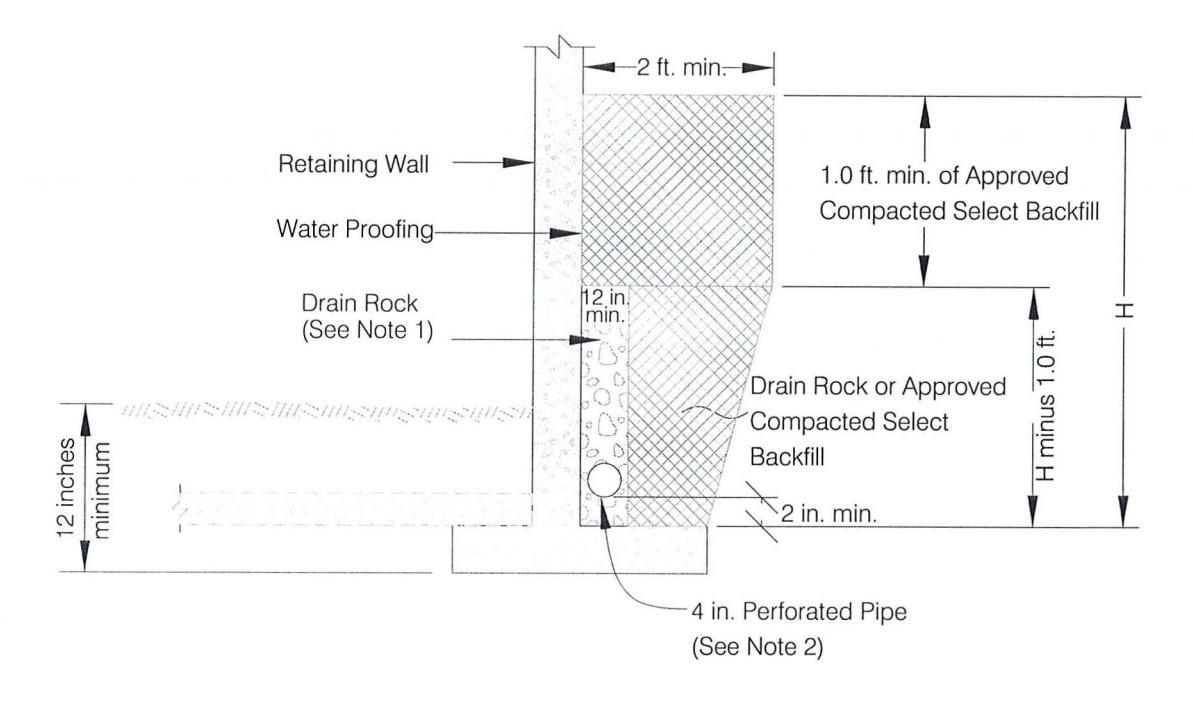
RETAINING WALL DRAINAGE DETAIL (Not to Scale)
