### Appendix B Biological Resources Letter Report

#### Beyer Community Resources Center Project Biological Resources Letter Report Community of San Ysidro in San Diego, San Diego County, California

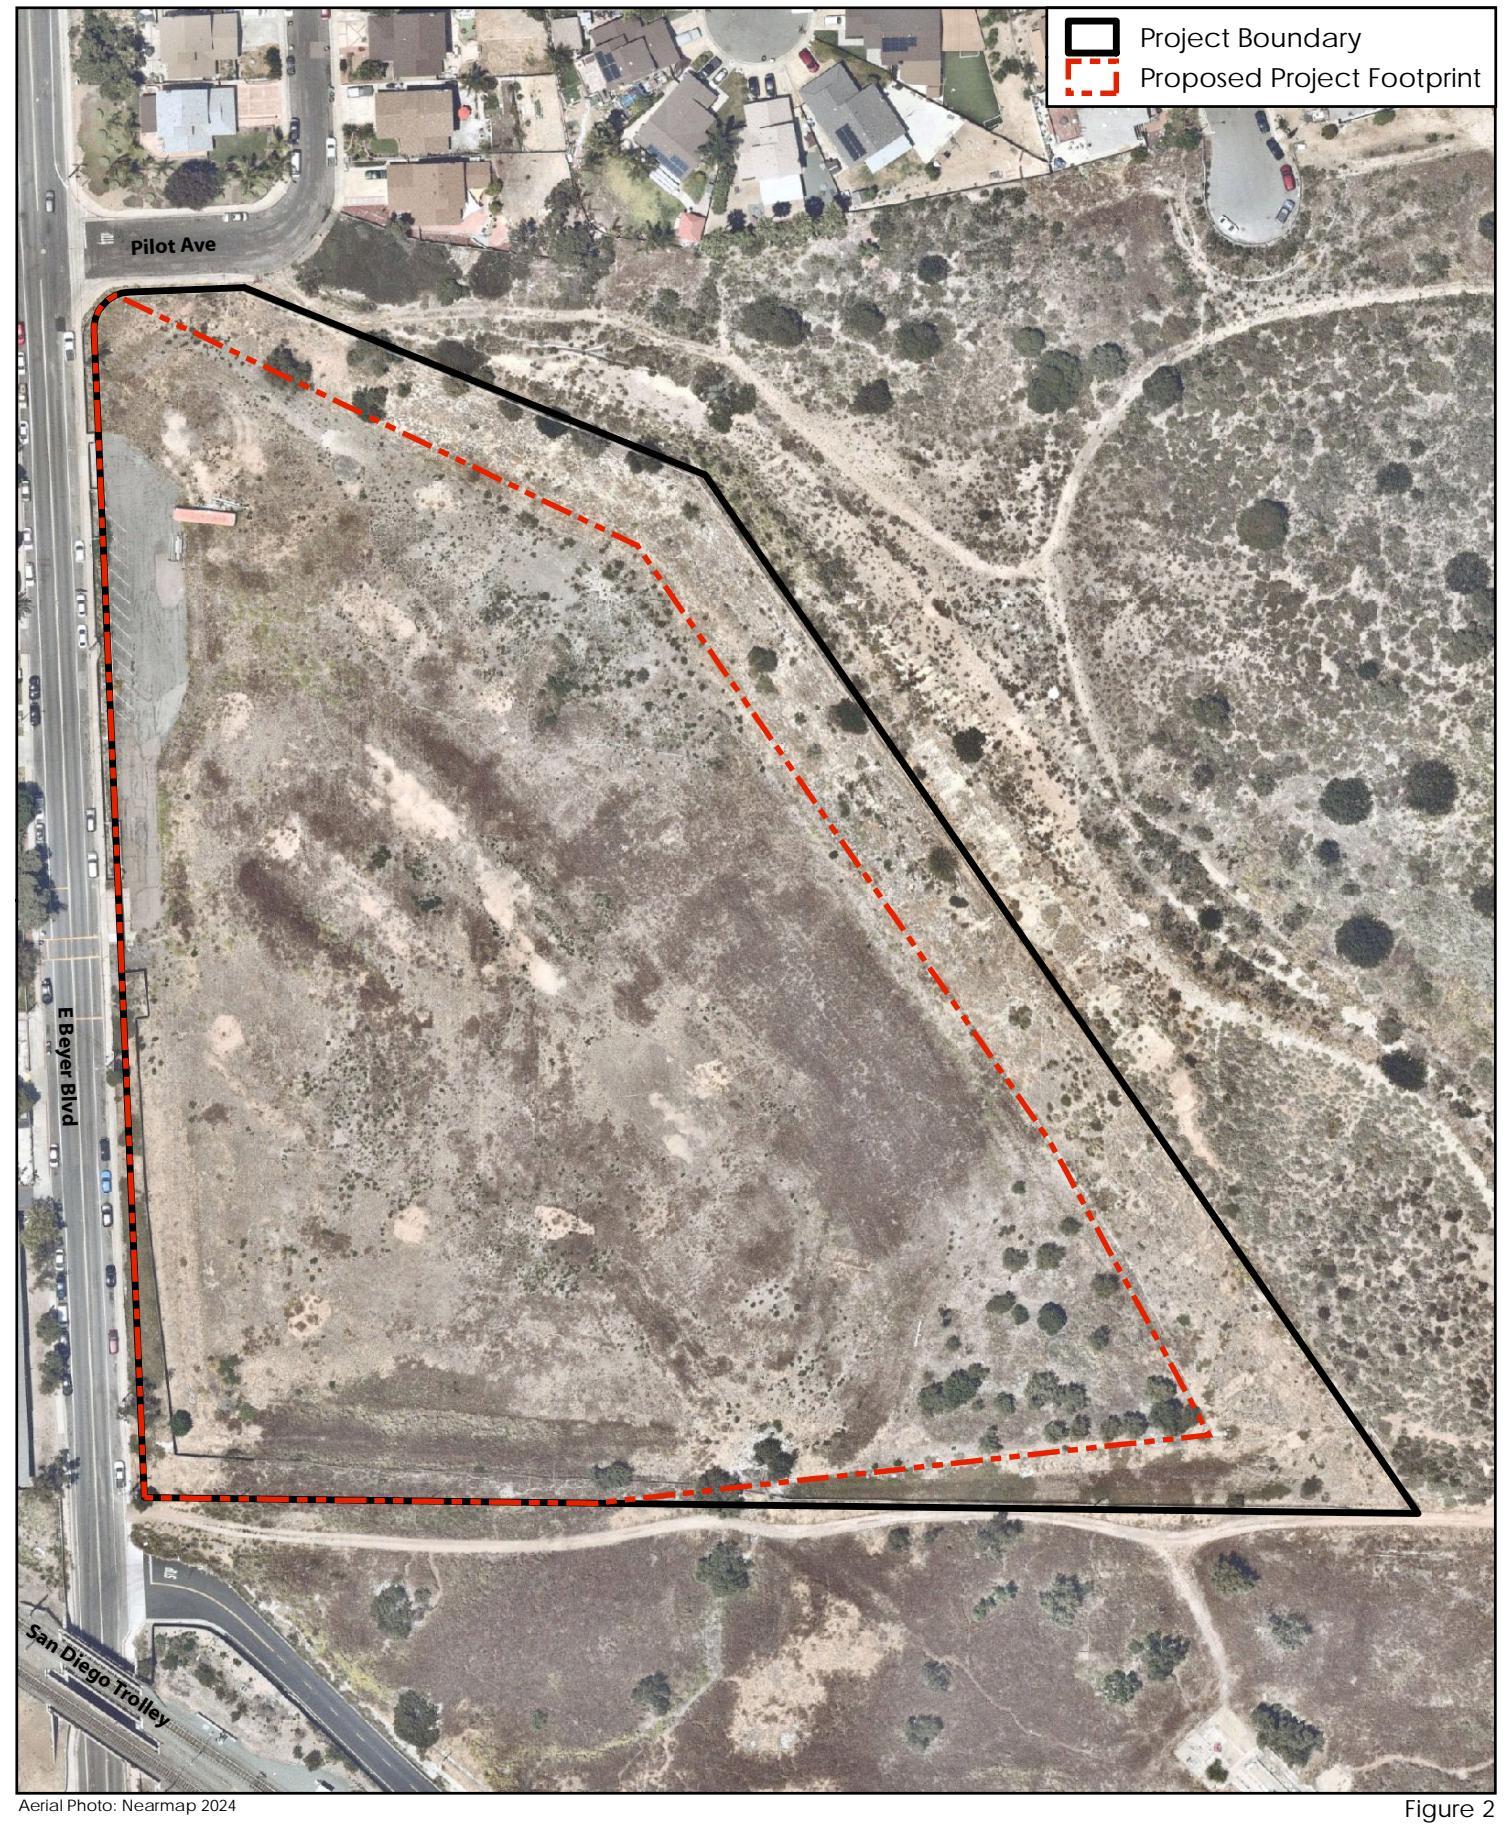
BLACKHAWK Environmental Proposed Project Footprint

The San Ysidro School District anticipates constructing a community resources center on the grounds of the former Beyer Elementary School, which was demolished in 2012, to better serve the needs of district students and their families in the coming years. Therefore, the San Ysidro School District has proposed the Beyer Community Resources Center Project (proposed Project). The proposed Project includes construction of a family resources and community events center with an outdoor event space, playground, ball courts and soccer field, landscaping improvements, and associated parking. All proposed work will be restricted to the proposed Project footprint (Attachment A, Figure 2).

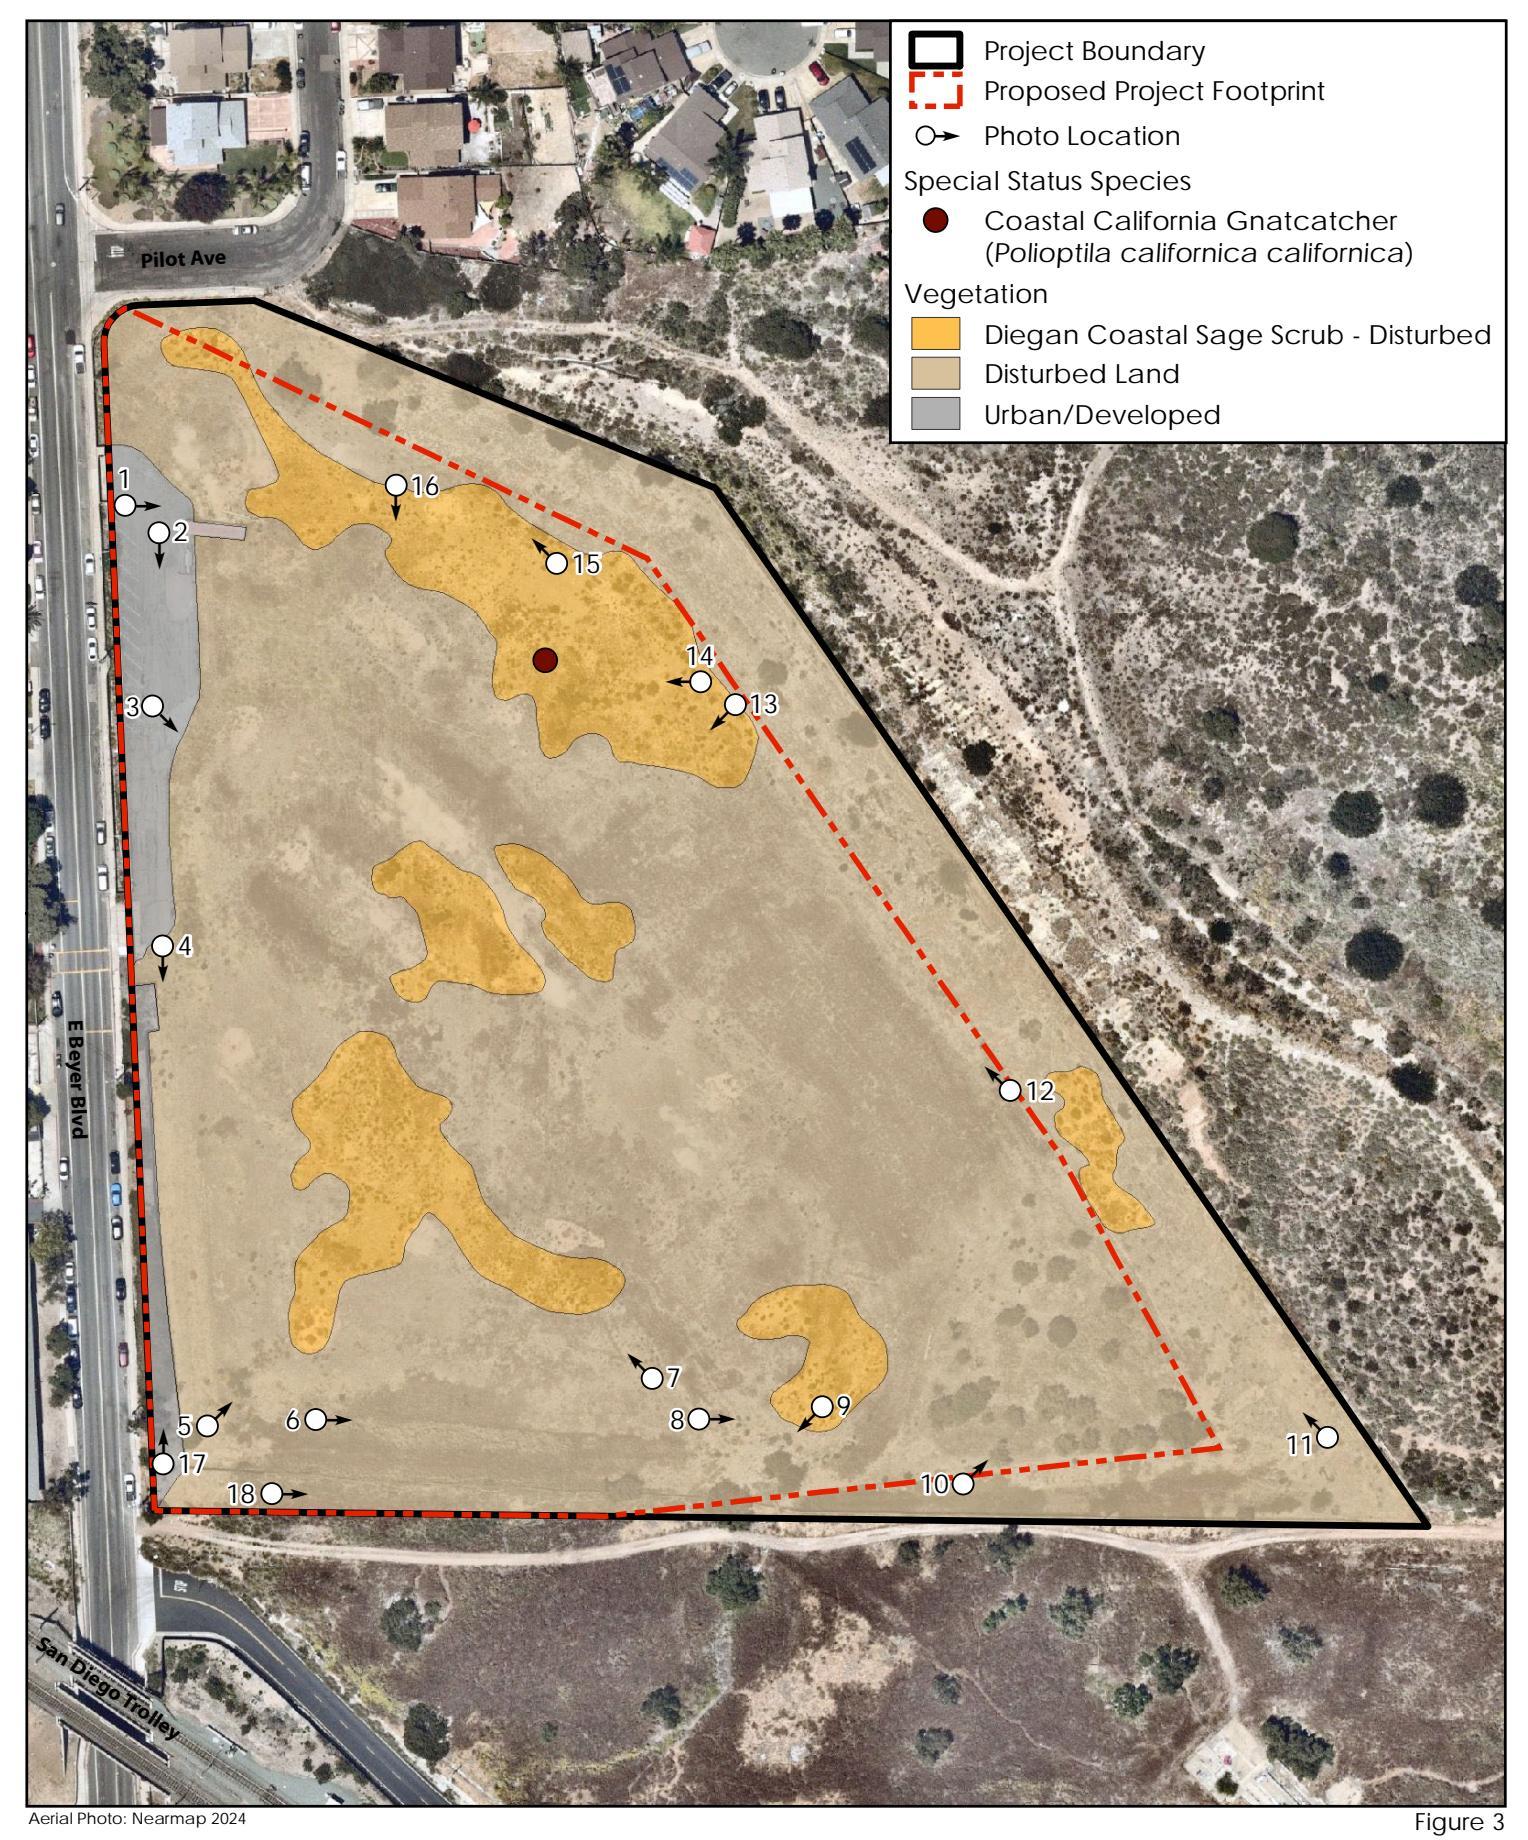
**Biological Resources and Habitat Assessment**

Three vegetation communities/land use types were observed within both the Project footprint and Project Boundary (Attachment A – Figure 3).

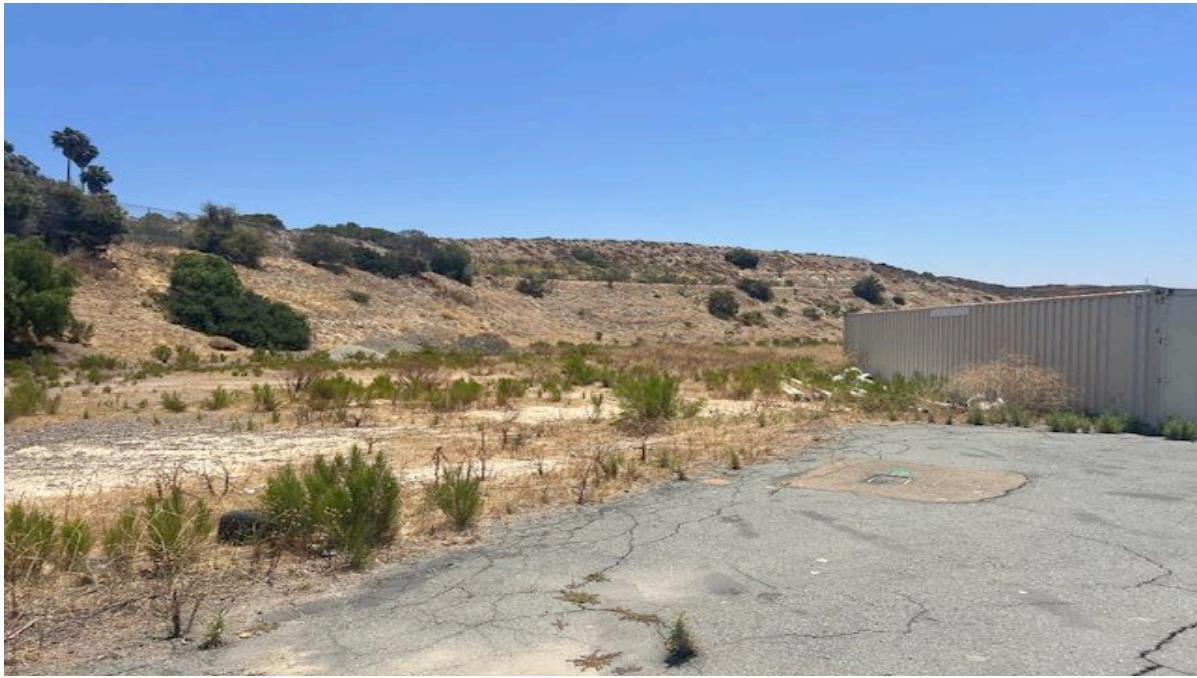
Photo Point 1: East-facing view from the northern entrance off Beyer Boulevard at a storage container and remnants of a parking lot for the former Beyer Elementary School.

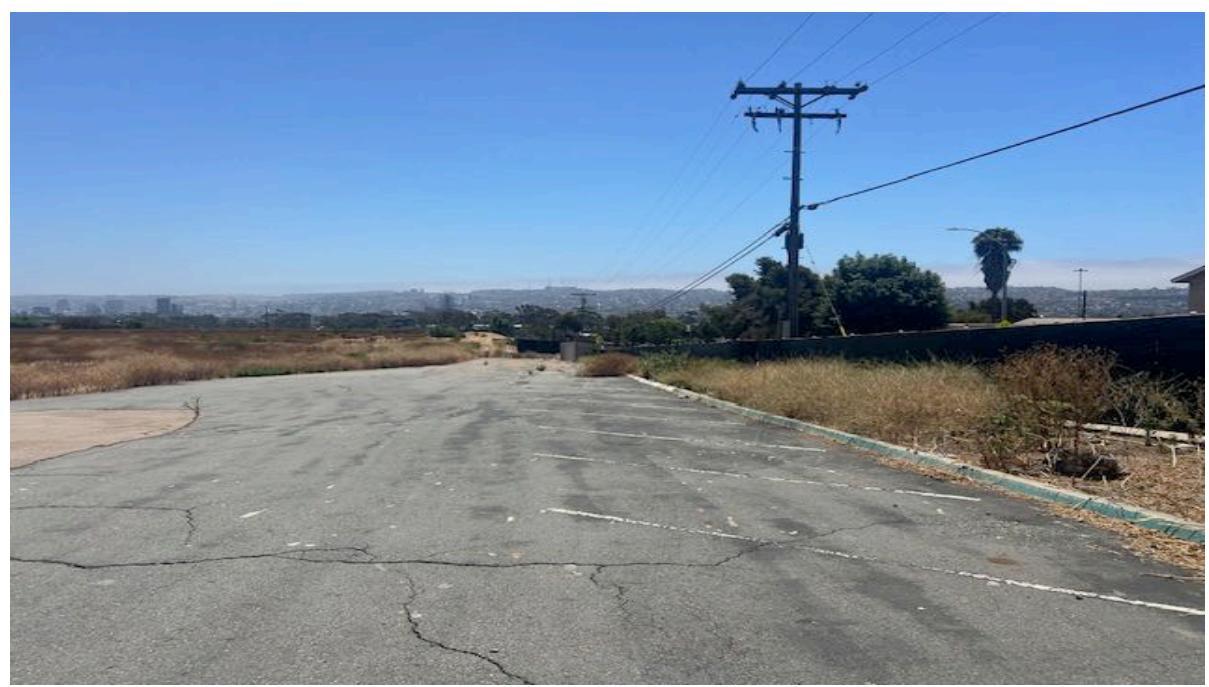
Photo Point 2: South-facing view along the western Project Boundary through the remnants of a parking lot for the former Beyer Elementary School.

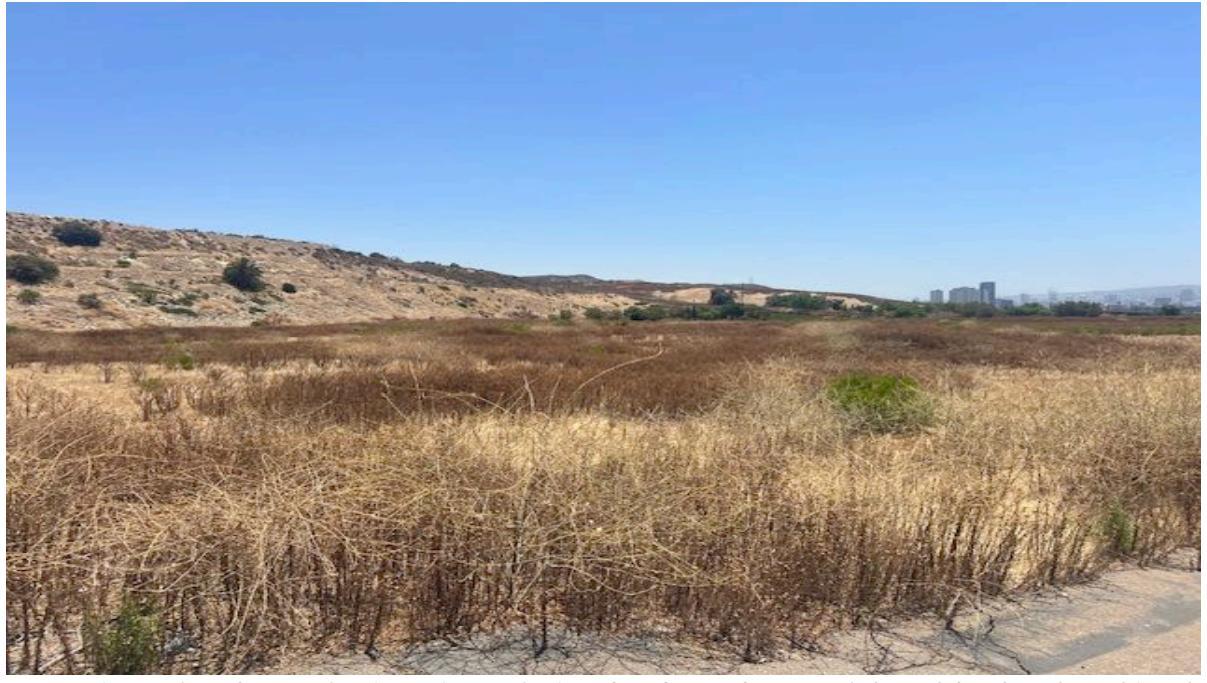
Photo Point 3: Southeast-facing view of Disturbed Land east of the old school parking lot.

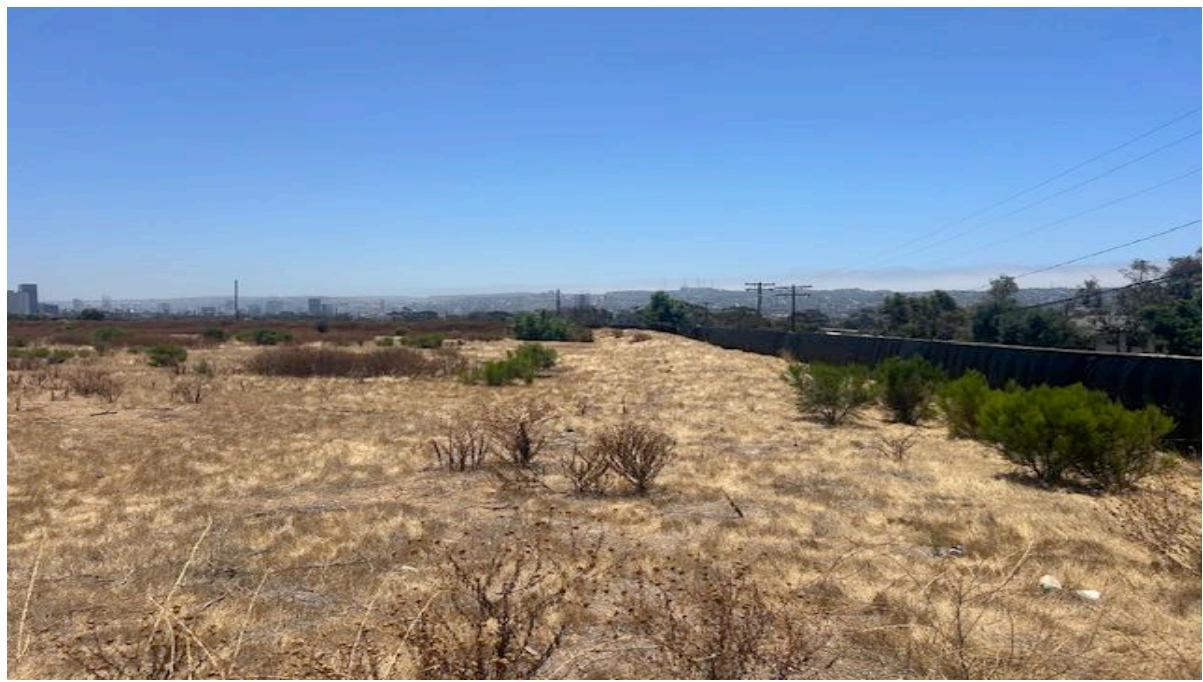
Photo Point 4: South-facing view of Disturbed Land along the western Project Boundary/proposed Project footprint.

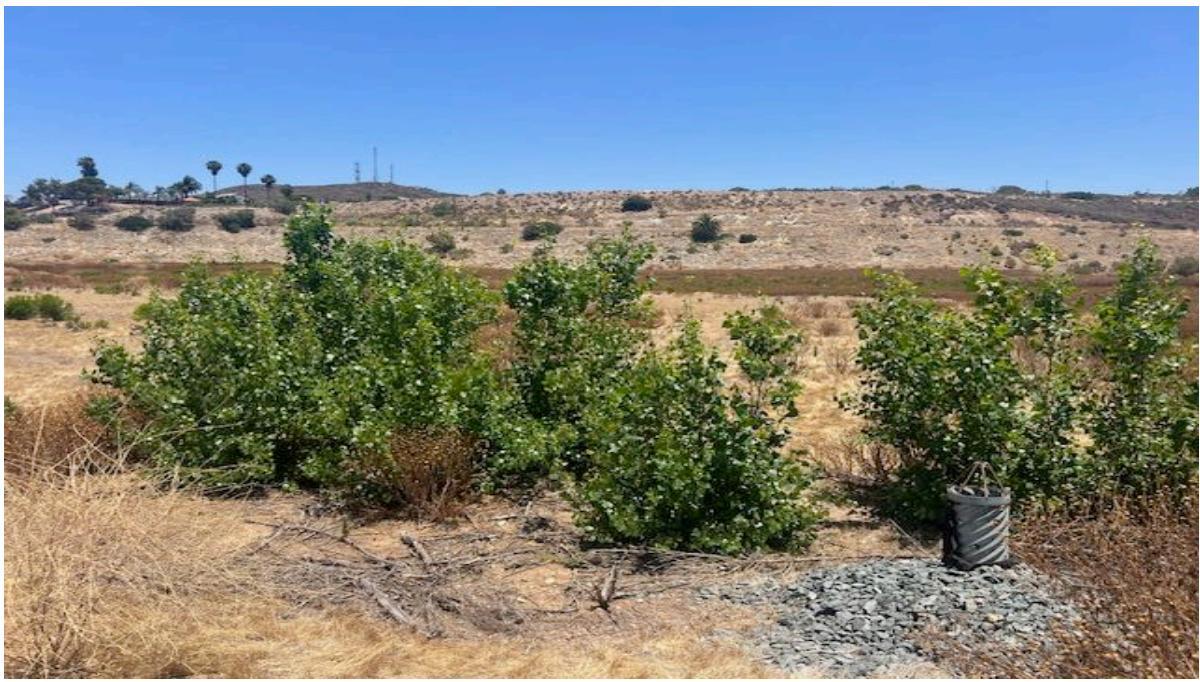
Photo Point 5: Northeast-facing overview of the proposed Project footprint from its southwest corner.

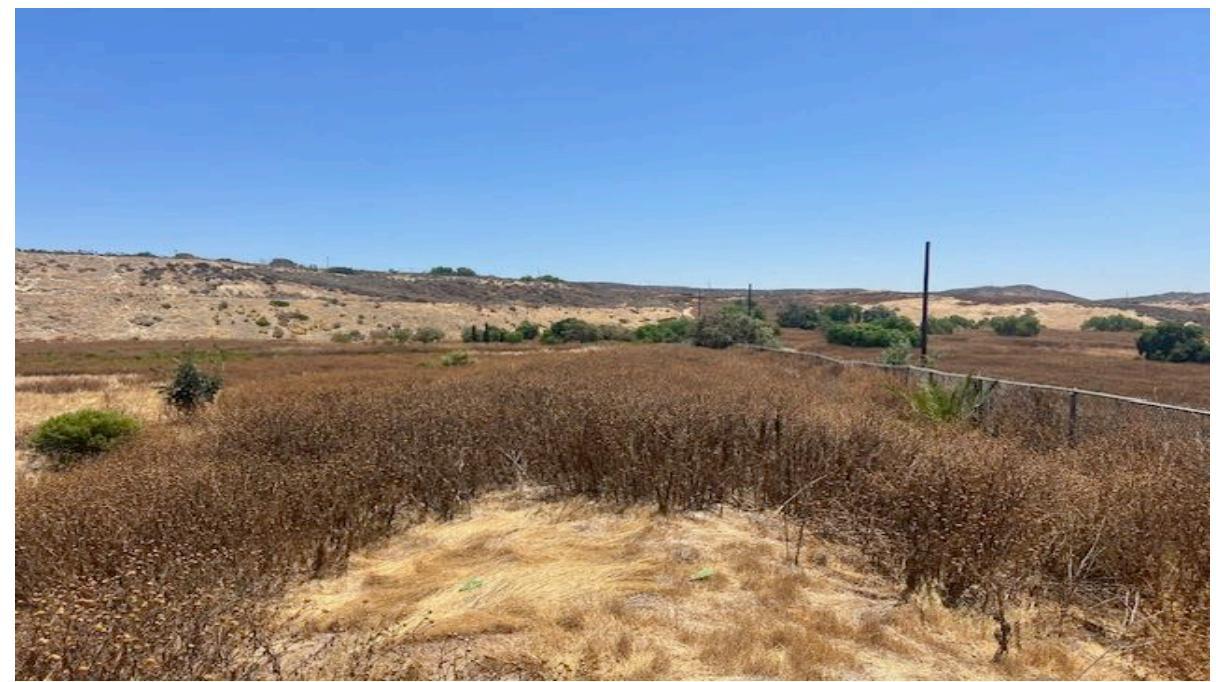
Photo Point 6: East-facing view of Disturbed Land along the southern Project Boundary.

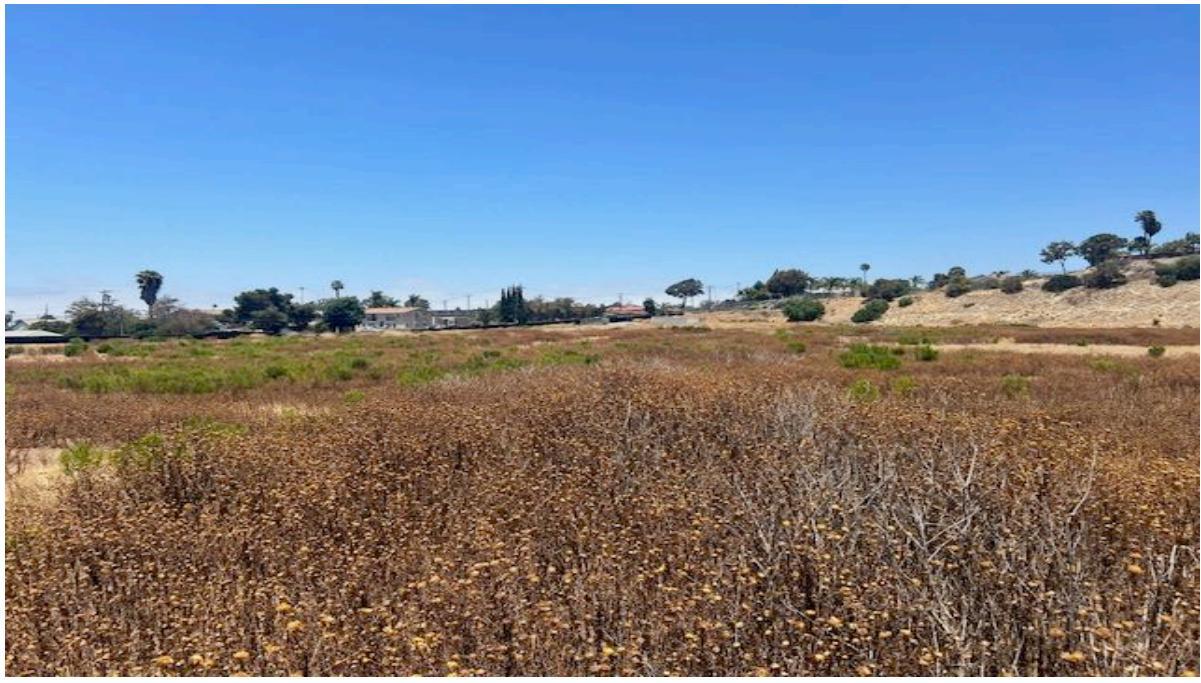
Photo Point 7: Northwest-facing view of Disturbed Land within the proposed Project footprint.

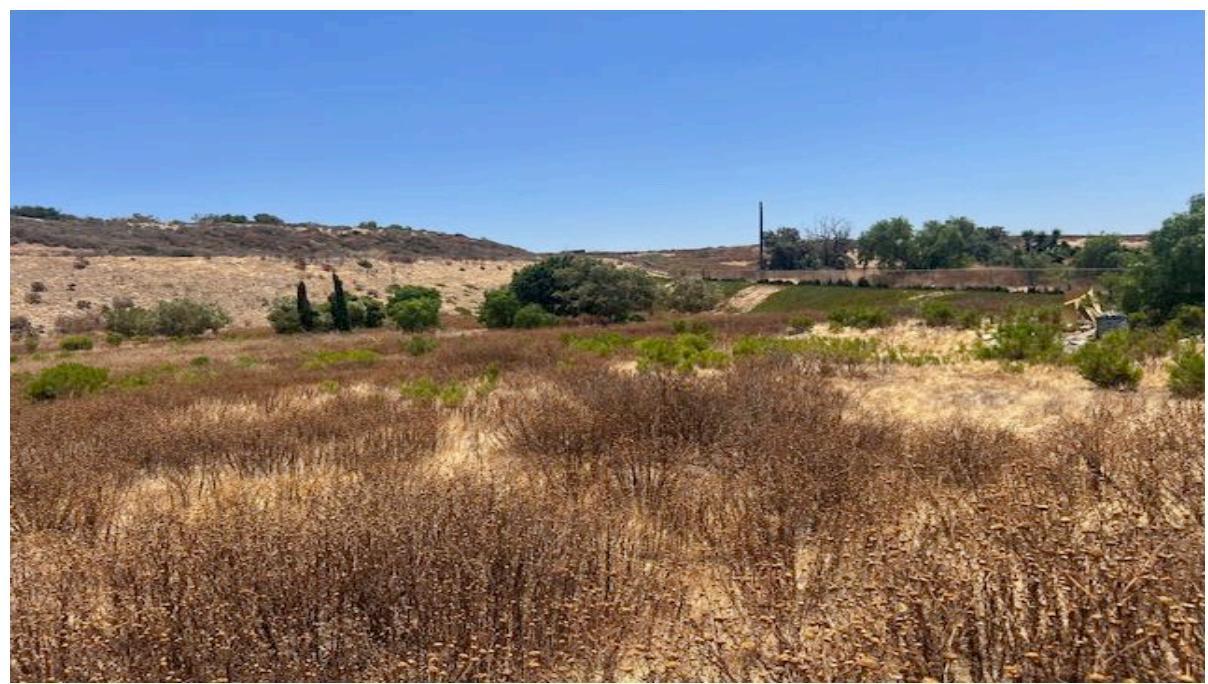
Photo Point 8: East-facing view of Disturbed Land along the southern Project Boundary.

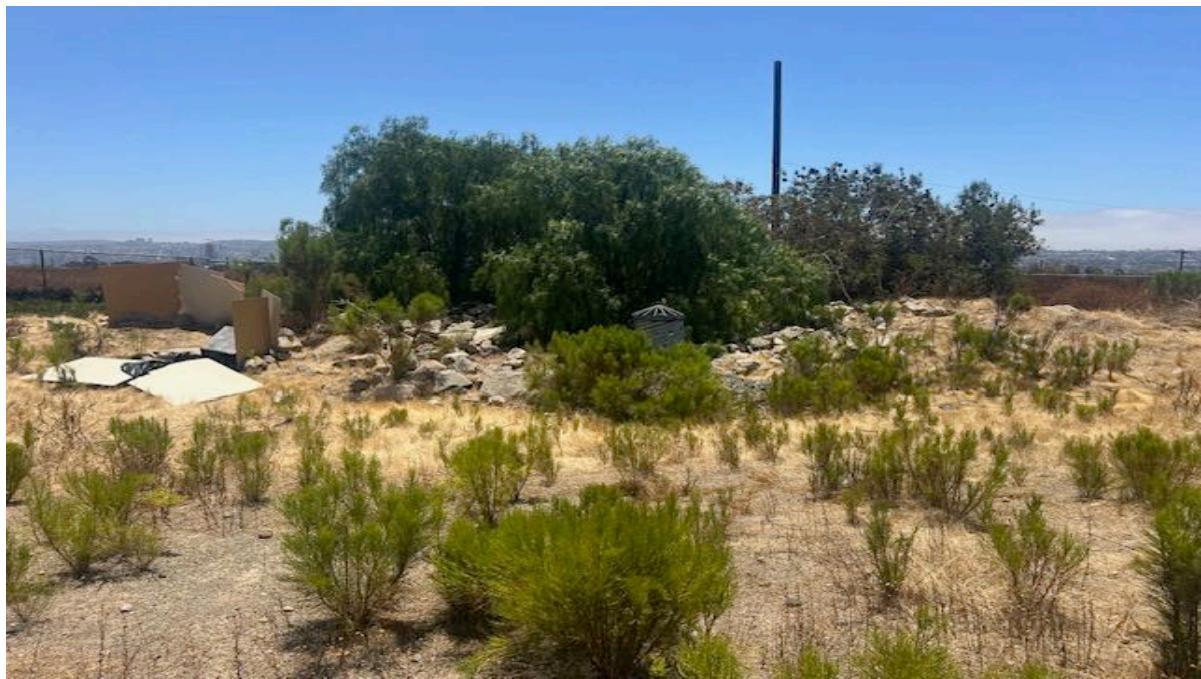
Photo Point 9: South-facing view of Disturbed Land containing a debris pile and transient living camp near the southern Project Boundary.

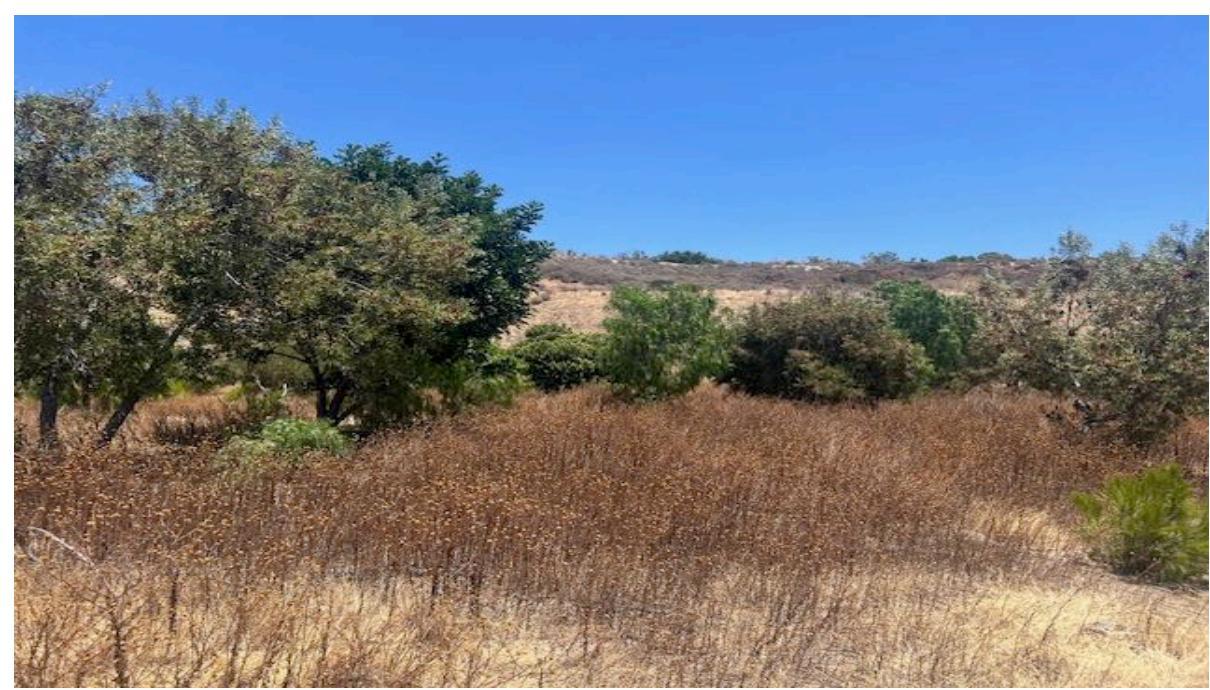
Photo Point 10: Northeast-facing view of the remnants of an orchard on the grounds of the former Beyer Elementary School property.

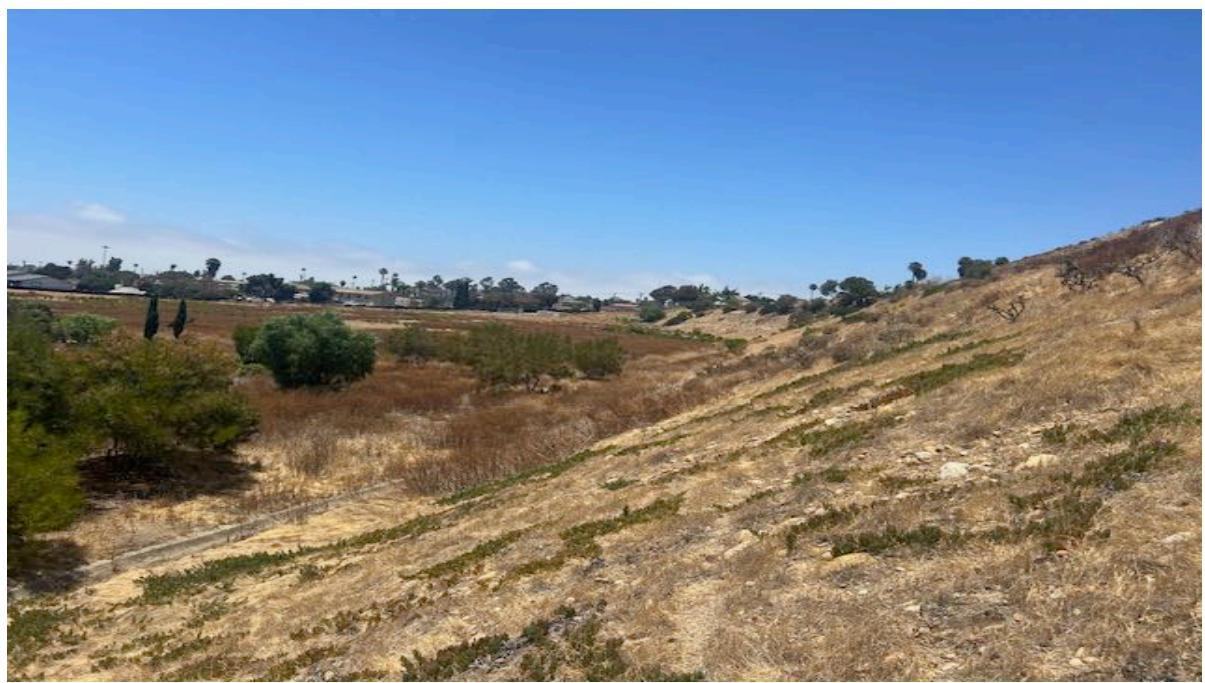
Photo Point 11: Northwest-facing view of the sloped eastern Project Boundary, a portion of which contains Diegan Coastal Sage Scrub – Disturbed habitat.

BIO-1 Permanent impacts to Diegan Coastal Sage Scrub – Disturbed habitat shall be offset through mitigation of habitat of equal or higher biological value at a one-to-one ratio. Mitigation shall occur by implementing one or a combination of the following: off-site or on-site preservation, enhancement, restoration, and/or creation of habitat; purchase of habitat mitigation credits from an approved mitigation area or bank, or other location deemed acceptable by the applicable regulatory agencies. If on-site preservation, enhancement, restoration, and/or creation of habitat is chosen, a restoration plan shall be prepared by qualified personnel with experience in Southern California ecosystems and native plant restoration techniques. At a minimum, the restoration plan shall include the following information: (a) the location of the mitigation site(s); (b) a schematic depicting the mitigation areas; (c) the plant species to be used, container sizes, and seeding rates; (d) a planting schedule; (e) a description of installation requirements, irrigation sources and methodology, erosion control, maintenance and monitoring requirements; (f) measures to properly control exotic vegetation on-site; (g) site-specific success criteria; (h) a detailed monitoring program; (i) contingency measures should the success criteria not be met; (j) a summary of the annual reporting requirements; and (k) identification of the responsible party(ies) for meeting the success criteria and providing for conservation of the mitigation site in perpetuity.

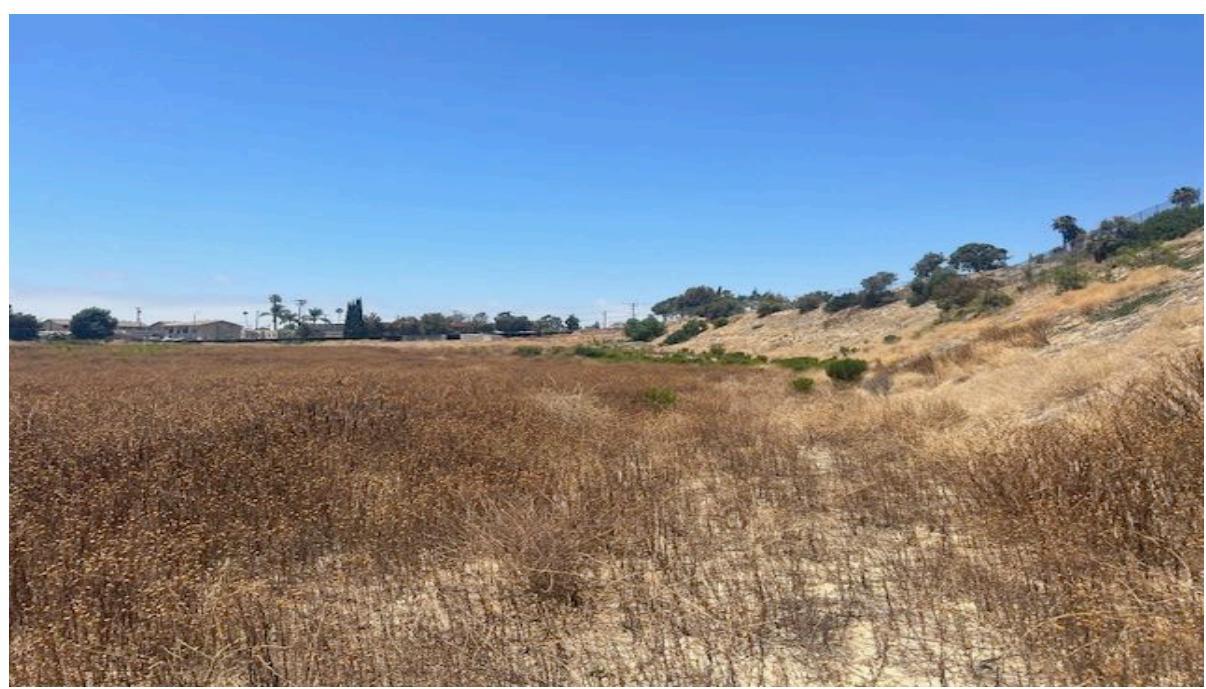
Photo Point 12: Northwest-facing view near the toe of the slope, which delineates the proposed Project footprint from the Project Boundary.

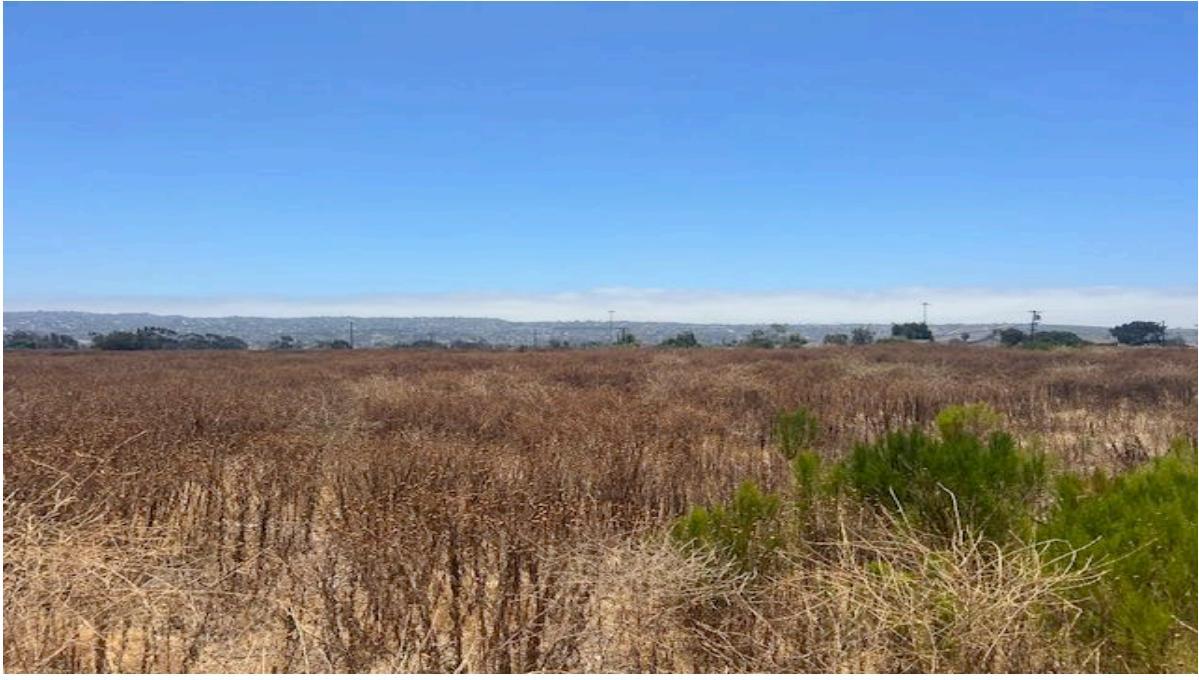
Photo Point 13: Southwest-facing view of Disturbed Land inside the proposed Project footprint.

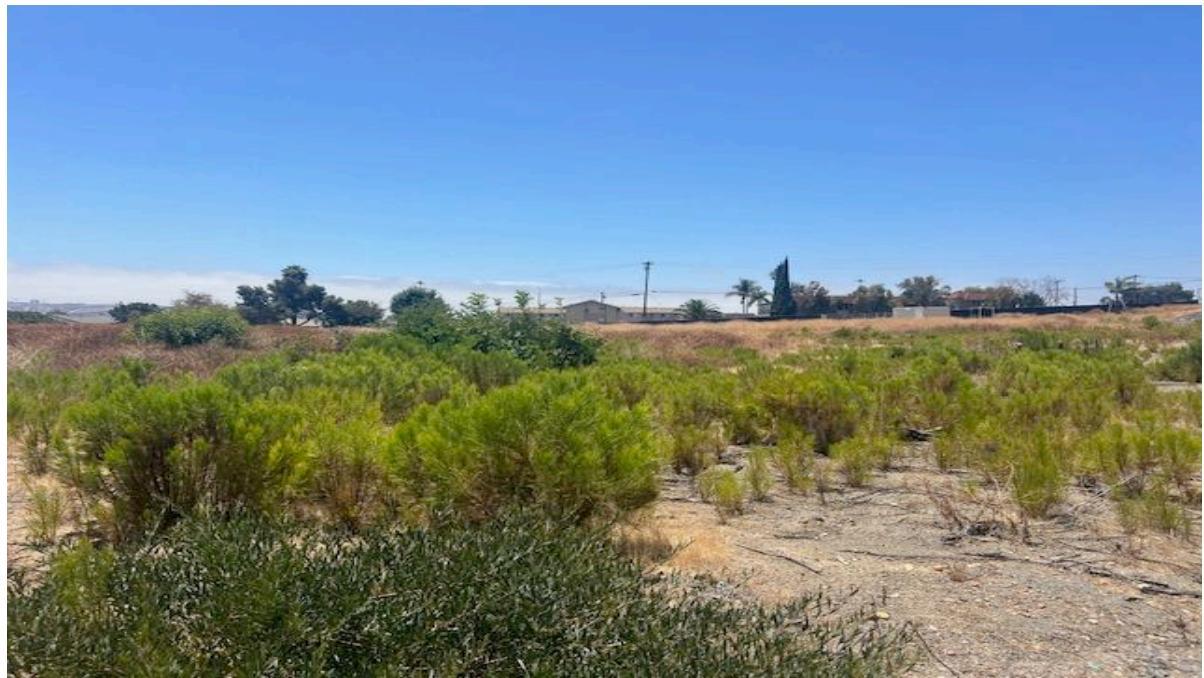
Photo Point 14: West-facing view of broom Baccharis dominated area within the proposed Project footprint.

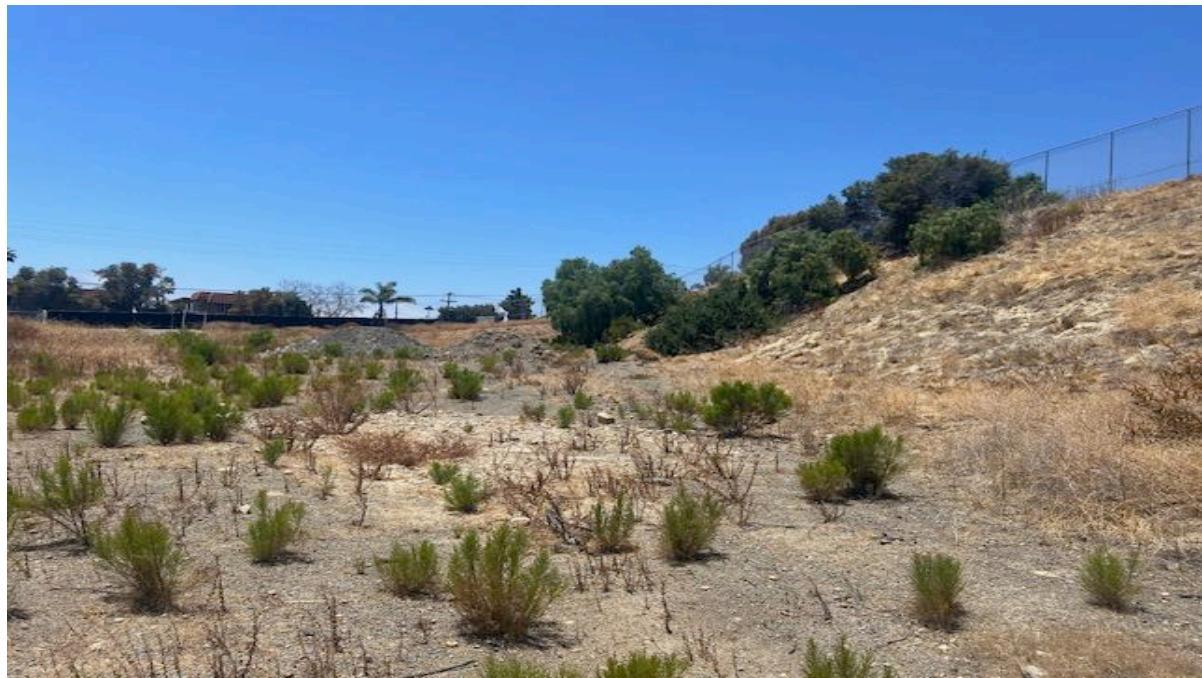
Photo Point 15: Northwest-facing view near the divide between the proposed Project footprint and the Project Boundary.

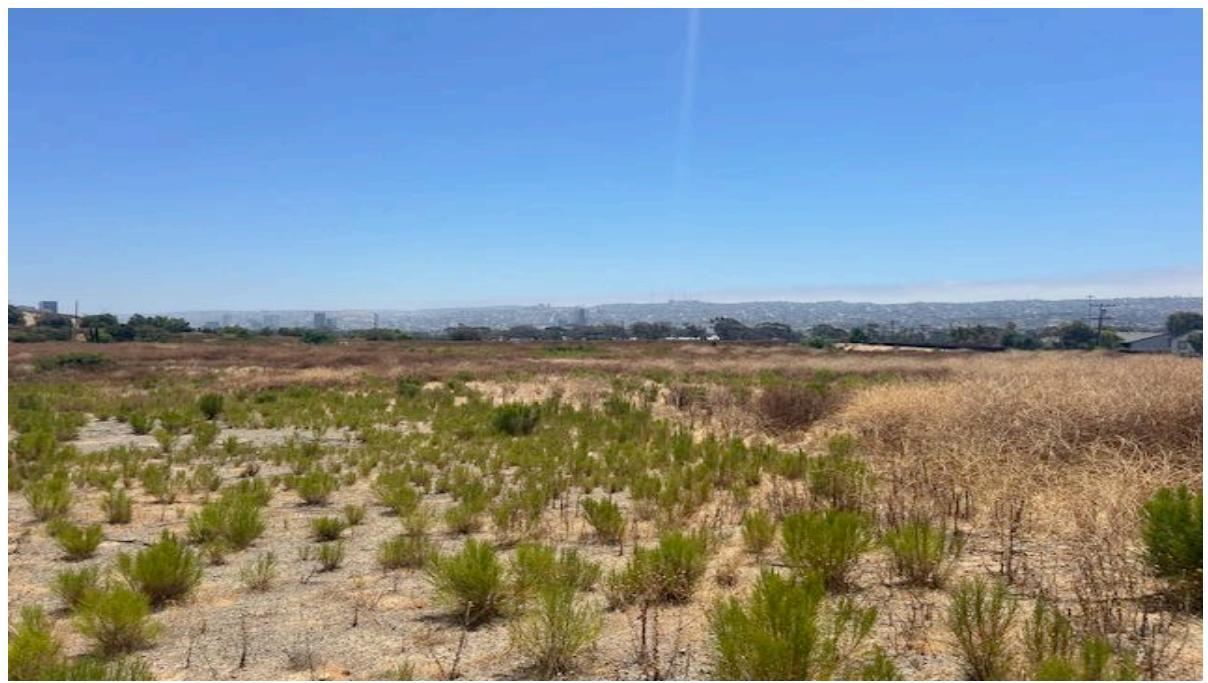
Photo Point 16: South-facing overview of the proposed Project footprint.

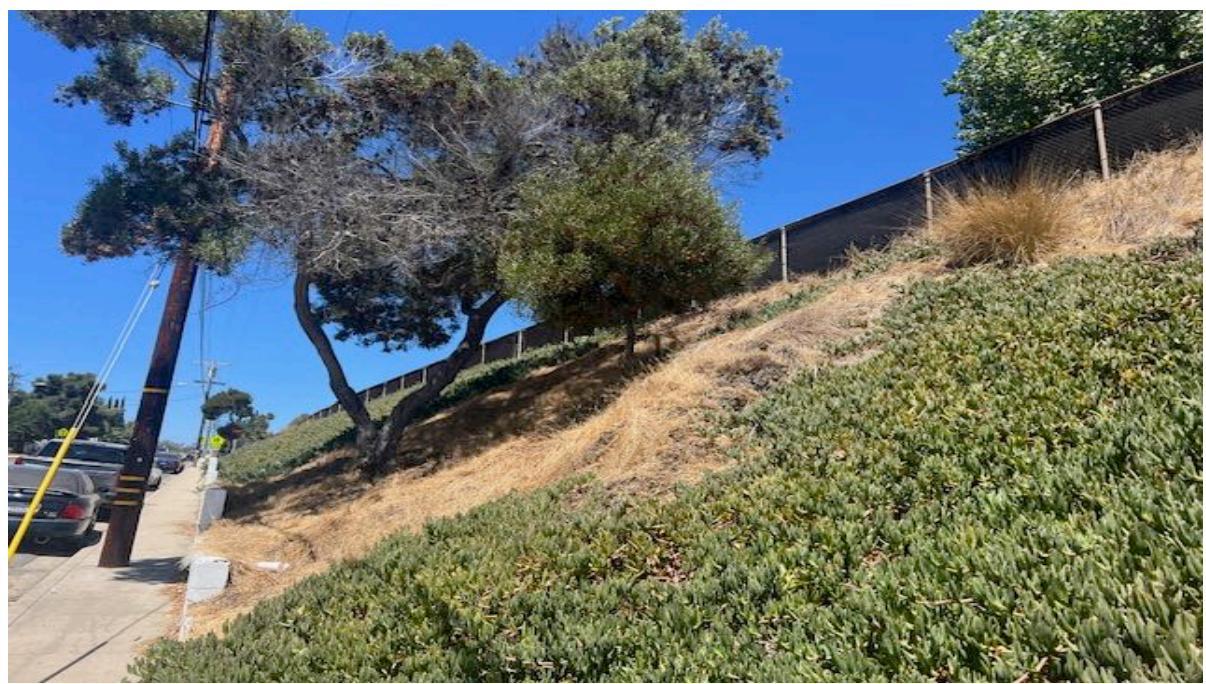
Photo Point 17: North-facing view of the unmaintained landscaped slope parallel to Otay Mesa Road.

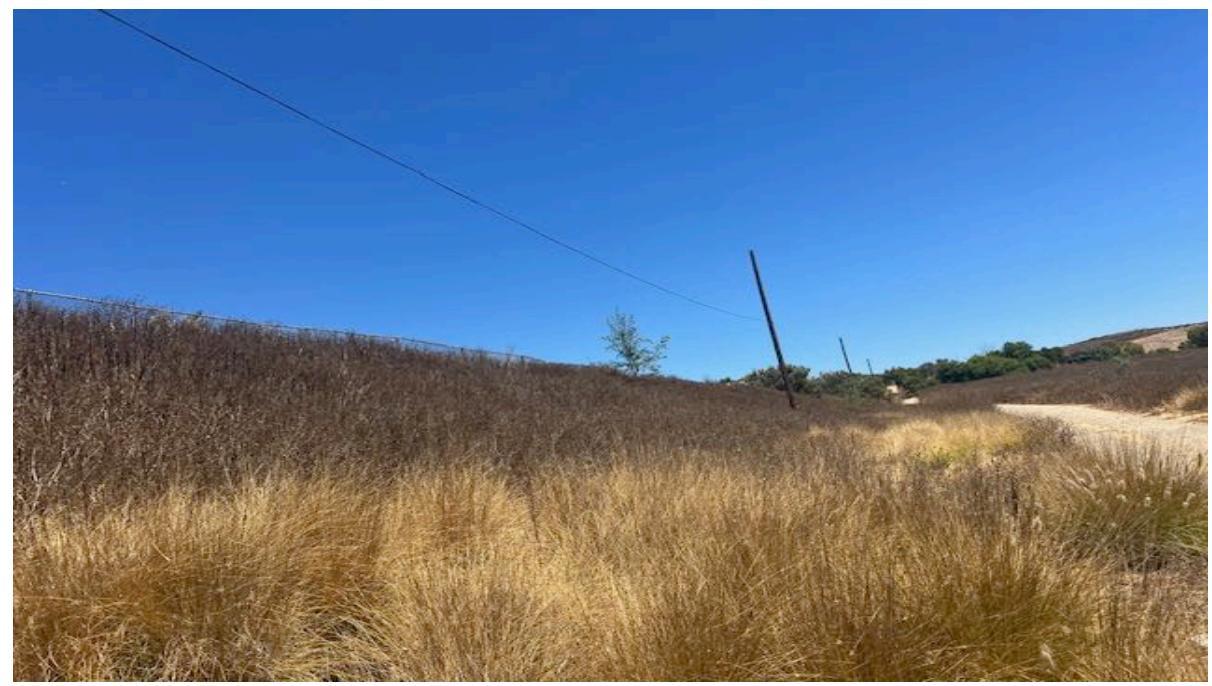
Photo Point 18: East-facing view of a south-facing slope along the southern Project Boundary.

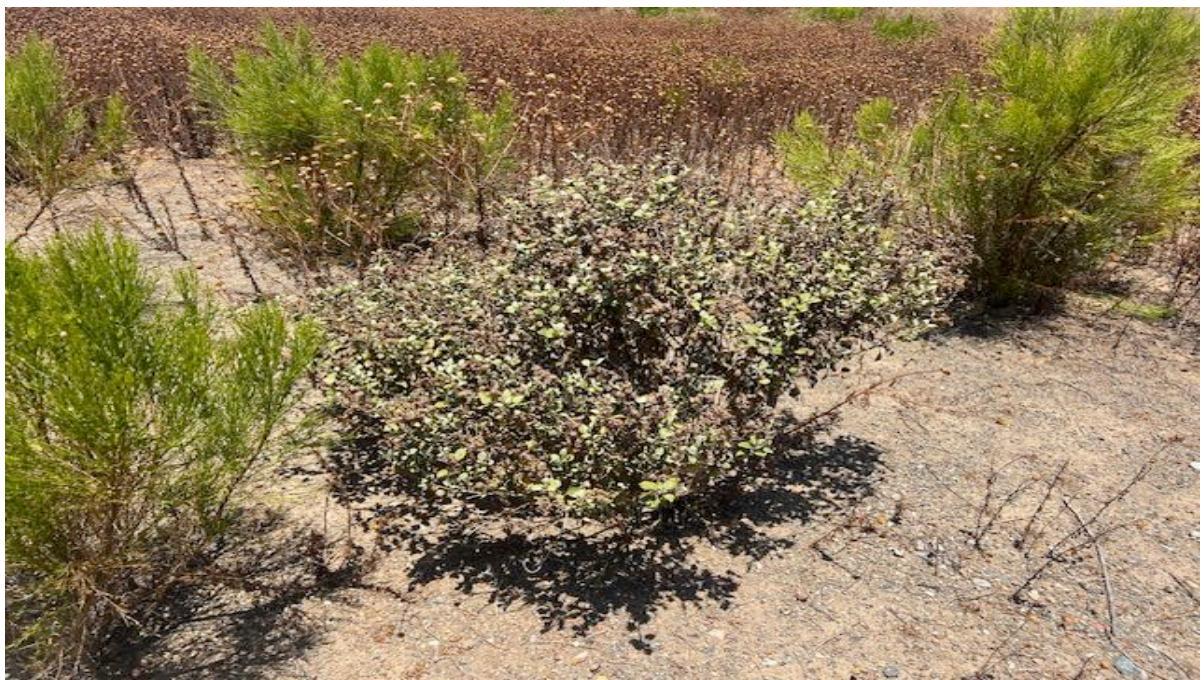
Although the literature review revealed 19 sensitive plant species occurring in the vicinity of the Project, only one species was observed during the field survey. San Diego bur-sage is a component of the Diegan Coastal Sage Scrub – Disturbed habitat that occurs within the proposed Project footprint. Therefore, direct impacts to this species are expected. Based on these findings, Mitigation Measure BIO-1, which requires preservation of Diegan Coastal Sage Scrub habitat, would avoid, reduce, and/or minimize direct impacts to San Diego bur-sage.

Photo 19: San Diego bur-sage growing within the proposed Project footprint.
