### Appendix B Biological Resources Letter Report

#### Beyer Community Resources Center Project Biological Resources Letter Report Community of San Ysidro in San Diego, San Diego County, California

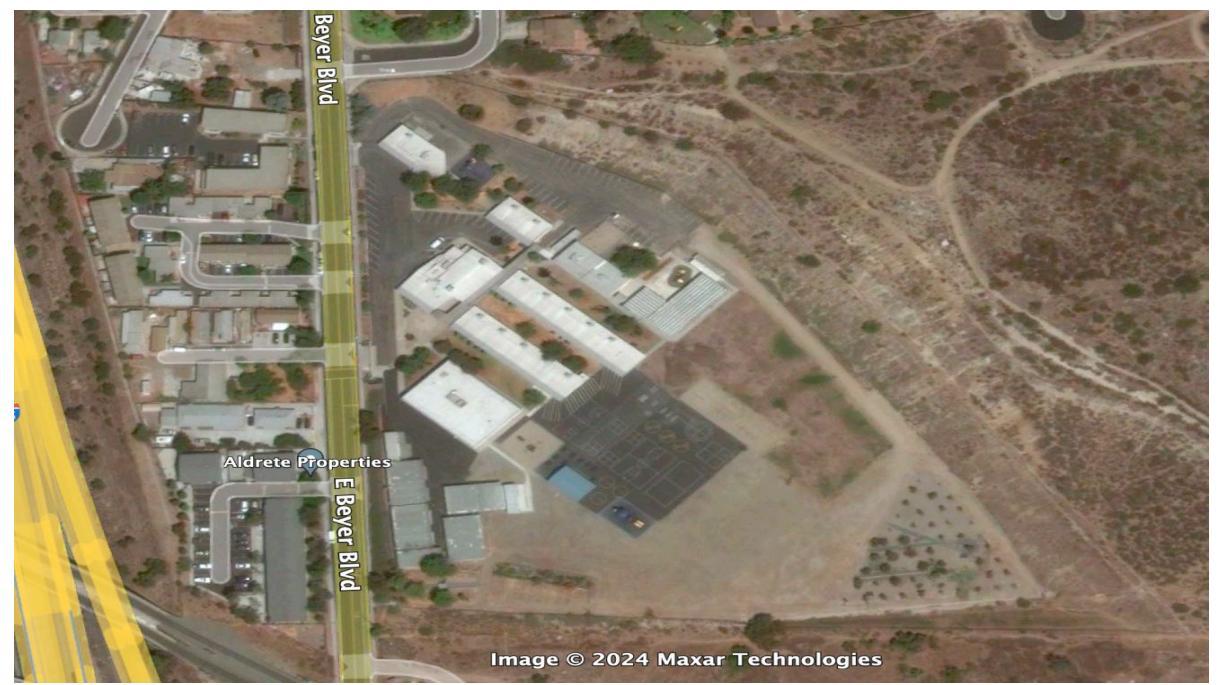
Photo 20: Google Earth aerial imagery from August 13, 2012, that depicts the former Beyer Elementary School still standing within the proposed Project footprint.

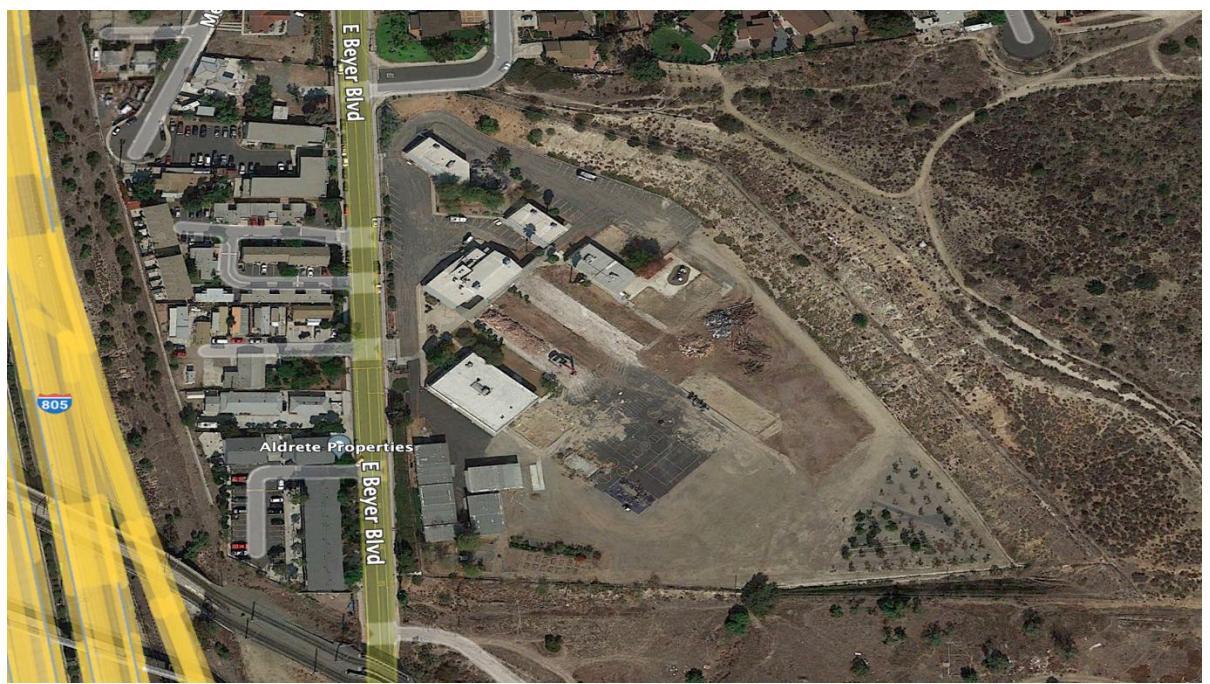
Photo 21: Google Earth aerial imagery from October 27, 2012, that depicts the demolition of the former Beyer Elementary School within the proposed Project footprint.

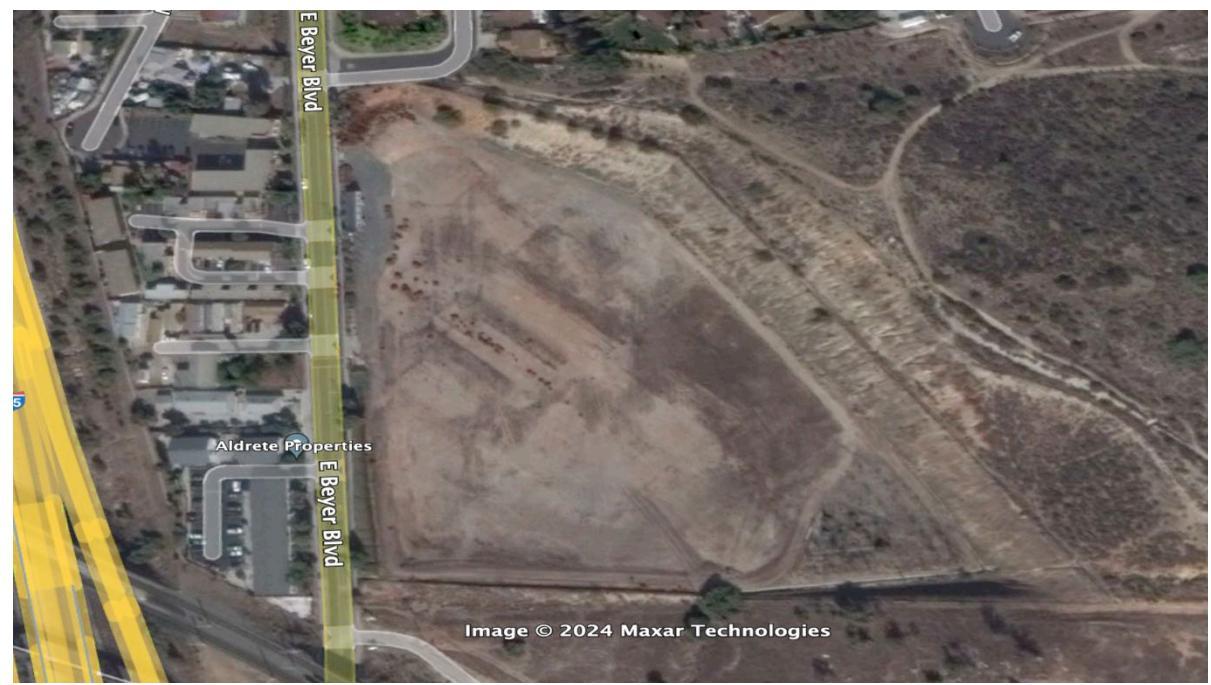
Photo 22: Google Earth aerial imagery from January 12, 2014, that depicts the proposed Project footprint free of any buildings and facilities associated with the former Beyer Elementary School.
