HEALTH PLAN OF SAN JOAQUIN BEWELL RETENTION ANALYSIS **MEMORANDUM**

RE: BE WELL DEVELOPMENT STORM DRAINAGE STUDY SAN JOAQUIN COUNTY HEALTH SERVICES BE WELL 55 W. HOSPITAL ROAD FRENCH CAMP, CA 92531

То:	Stephanie Swain, AIA
Cc:	Paul Schneider, Siegfried
From:	Charley Scott, PE
Date:	February 21, 2024
Subject:	Retention Basin Infiltration Testing San Joaquin County Morgue and Medical Examiner's Office Storm Study San Joaquin County, California

We have completed our geotechnical report for the proposed Health Plan of San Joaquin – Be Well project located at the northwest corner of W. Hospital Road and S. El Dorado Street, French Camp, California. The purpose of our study was to explore the subsurface soil and groundwater conditions at the site to provide <u>preliminary</u> geotechnical engineering recommendations related to foundation design and earthwork construction.

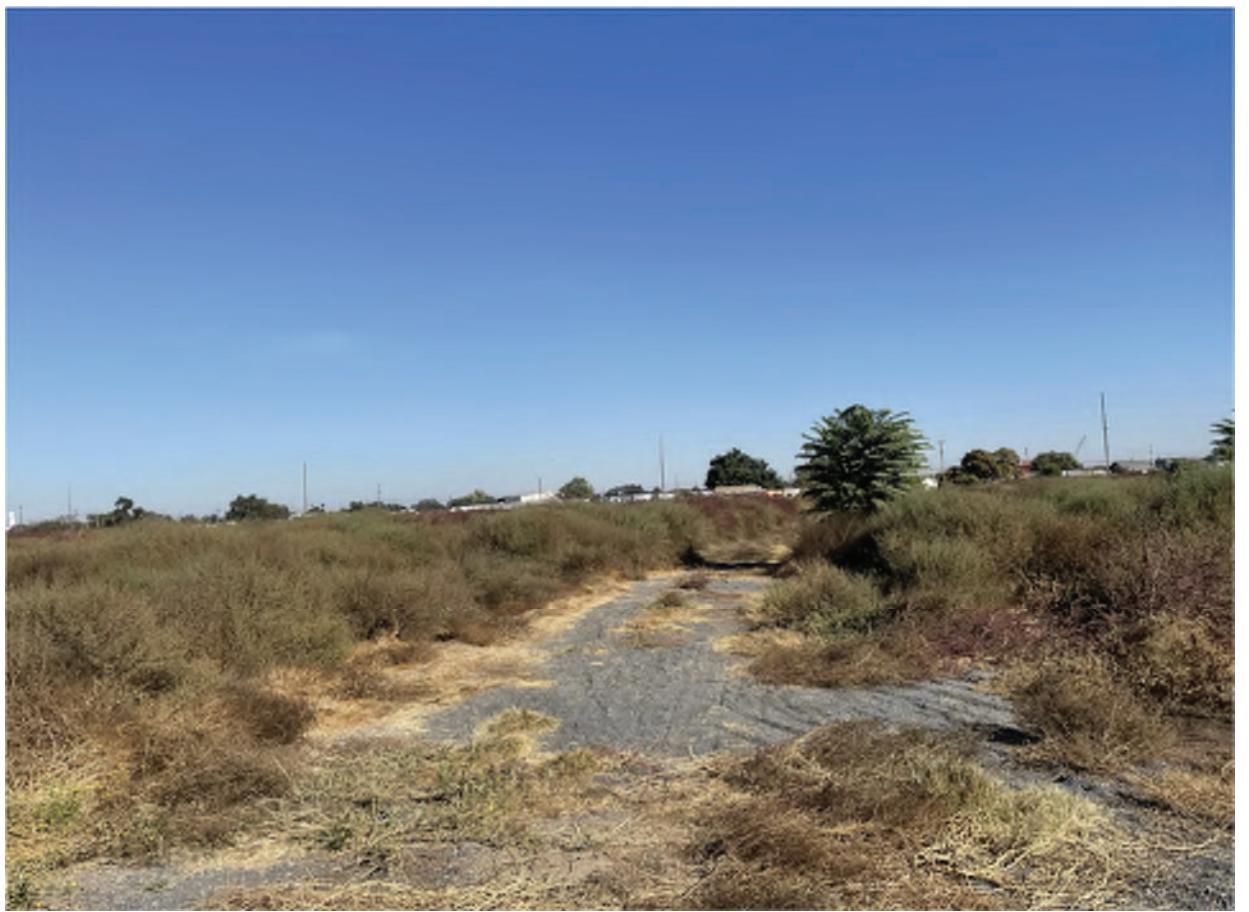
Figure 1: Typical growth of brush, vegetation, trees looking eastward on the site near the access road.

- Dense growth of brush approximately 4 to 5 feet tall blanketing the site and trees sporadic across the site as shown in Figure 1.
- Stockpiles of crushed rock, asphalt grindings and concrete rubble across the site (Approximate locations shown on Plate 2).
- A long stockpile of soil blanketed with dry grass east of the Interstate 5 embankment (Approximate location shown on Plate 2).
- Gravel surfaced access roads cut through the site.
- Existing single-story structure on the south portion of the site.
- Chain-link fencing around the perimeter of the site.
- Trash and miscellaneous non-deleterious materials around the surface of the site.
- Telephone and power poles around the site.

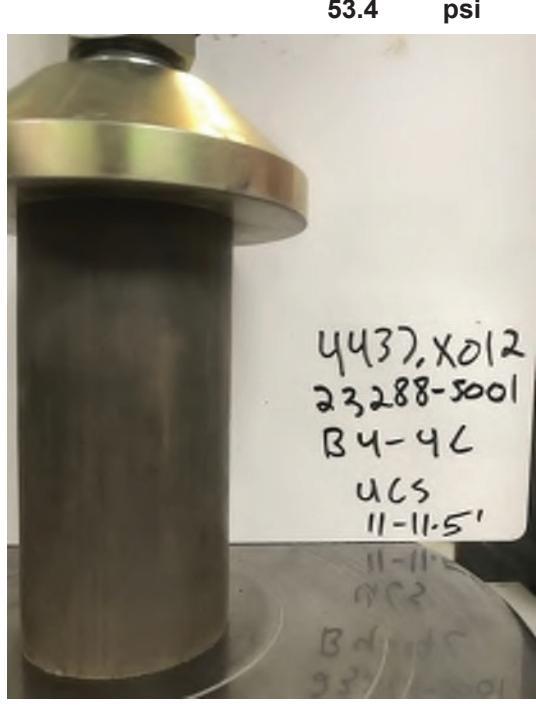
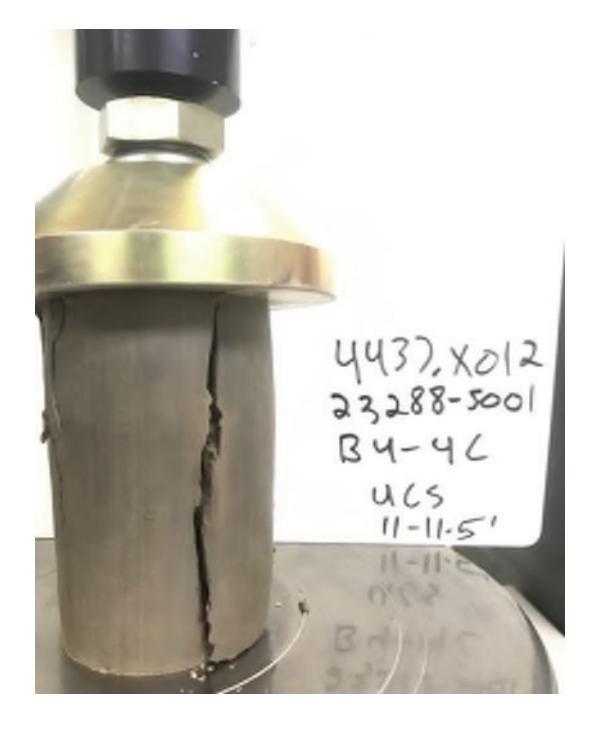
Unconfined Compression ASTM D 2166

Project Name: Siegfried - 23288-5001 Project Number: 4437.X012 Sample ID: B4-4C Type of Sample: CalMod Sample Description: SILT, grayish brown Depth: 11-11.5'

Compressive Strength:	3.84	tsf
	53.4	psi
