Notice of Completion & Environmental Document Transmittal

The following is an overview of each practice to be used in connection with the **Restoring the Deer Creek Headwaters at Childs Meadows Project** that will restore hydrologic, geomorphic and biological conditions within the Childs Meadows complex. In addition to the practices themselves, construction and maintenance requirements are described as well. Importantly, in addition to the maintenance and mowing requirements described in this Initial Study/Mitigated Negative Declaration and **Appendix L Post Project Maintenance and Monitoring Plan for the Restoring the Deer Creek Headwaters at Childs Meadows Project** found in the Initial Study/Mitigated Negative Declaration (IS/MND), additional requirements may be established for project work in the future by regulatory and funding entities. **Figure 2. Overview of Childs Meadows Project Area with Specific Features Identified** of the IS/MND provides an overview of treatment locations. A visual description of proposed meadow treatments is shown in generalized schematic drawings found in **Appendix J.** of the IS/MND. General construction and implementation techniques for these me

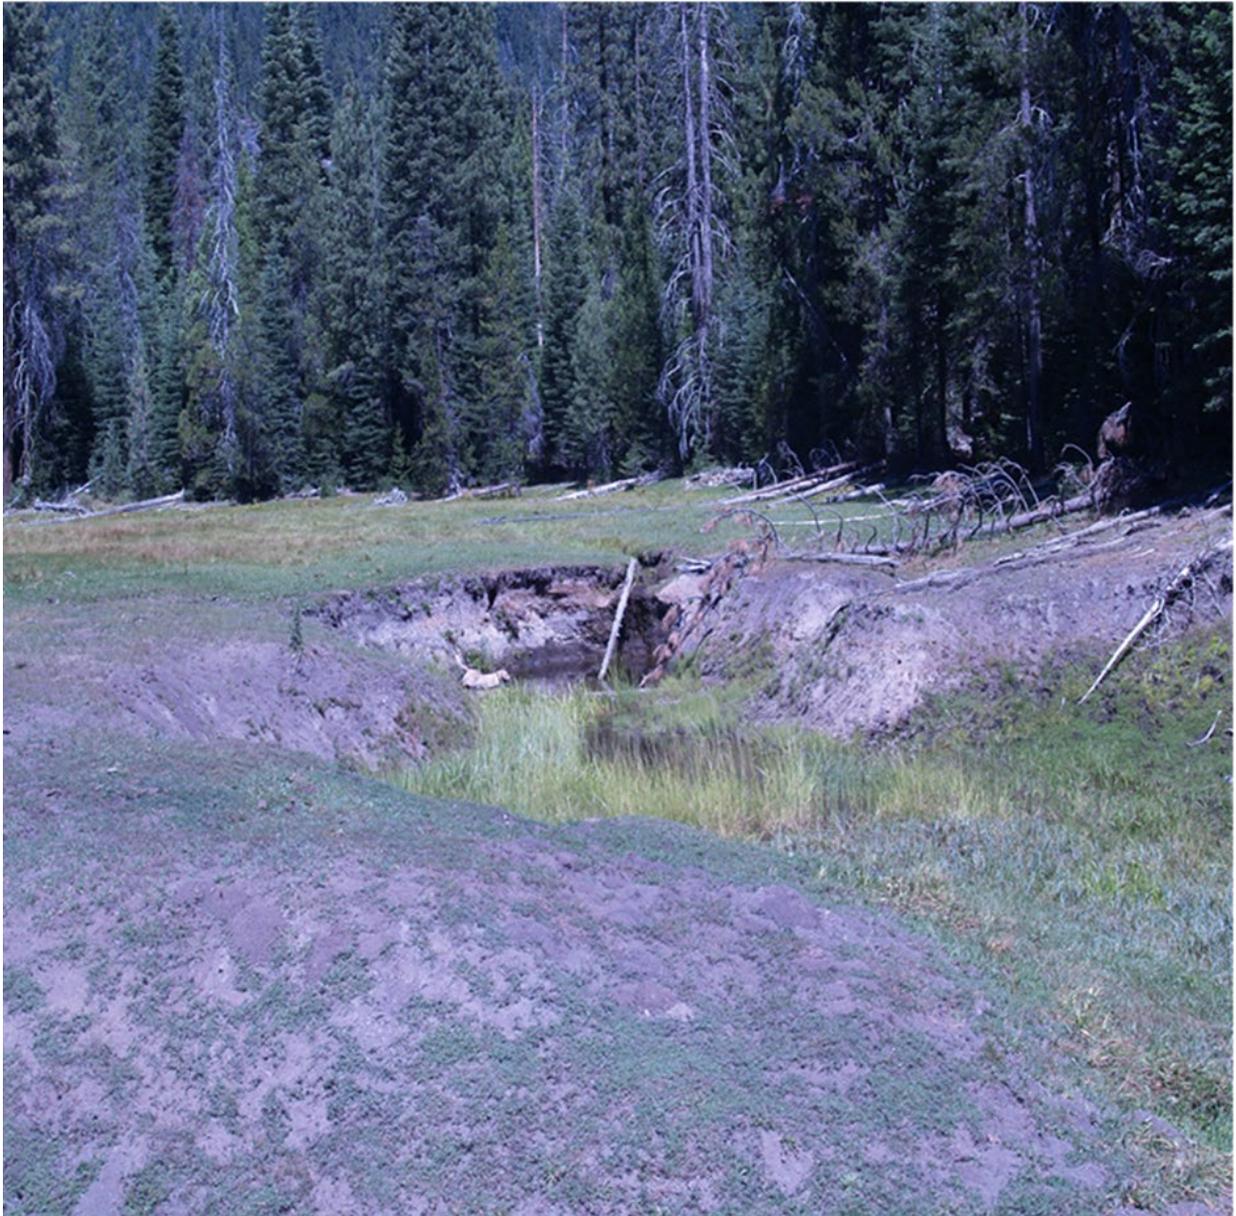
Photo 4: Overview of the 1.5-Meter-Deep Head Cut and Surrounding Impacted Area
Note the significant amount of scour along both banks of the channel and the surface above.

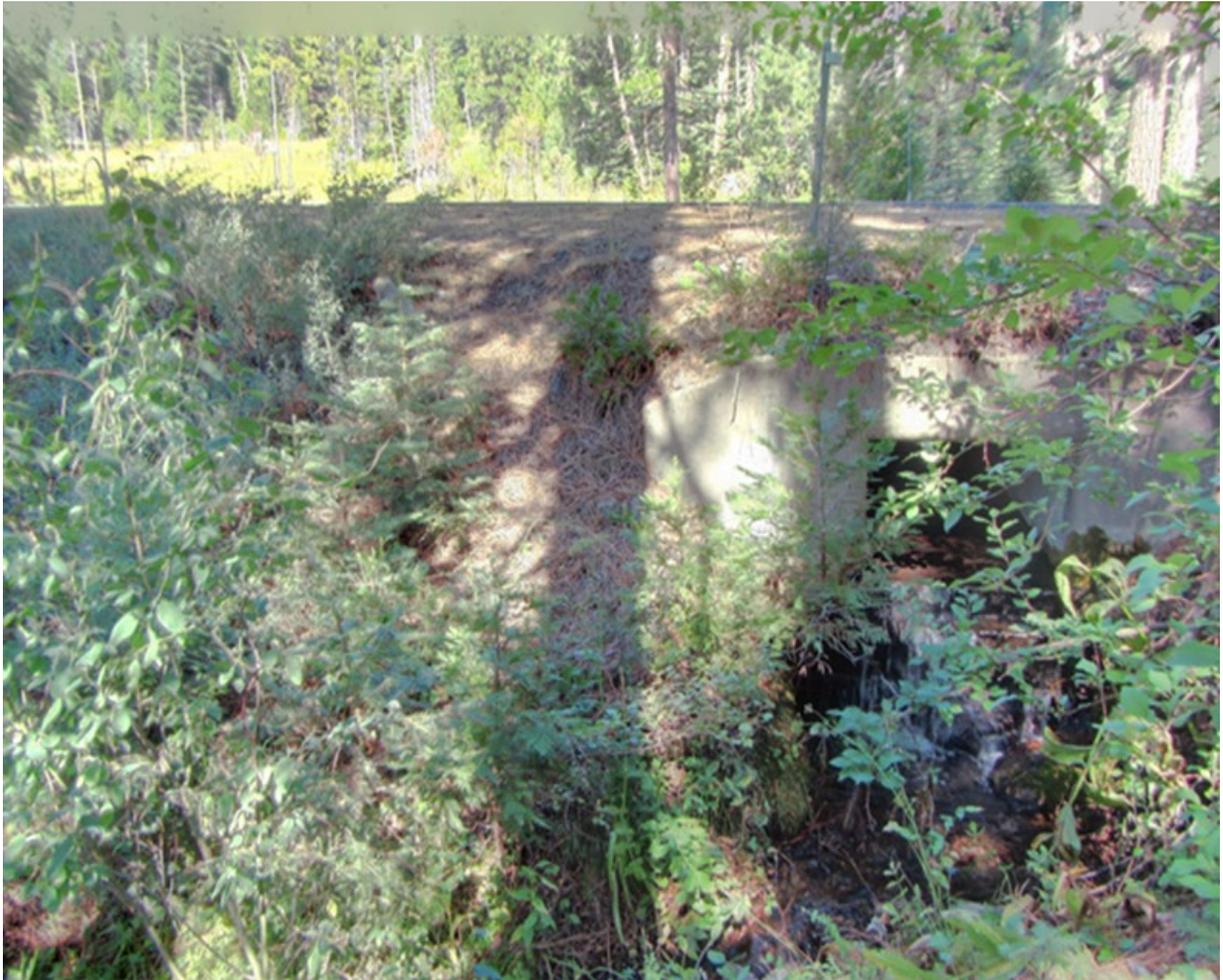
Photo 7: View Looking Upstream at Concrete Culvert Under Highway 36E

Current Site Conditions: A large gully receives concentrated flow from a culvert under Highway 36 (See Photo 7). The flow is generated from subsurface and surface flows from the fen, springs located to the north and from a small catchment northwest of Poppy's Fen captured by the Highway 36E road fill prism. The gully and other artificial channels below the highway are also likely capturing subsurface flow from the fen and springs below the highway. As evidenced by the presence of peat soils and remnant peat plants in currently dry areas, the natural condition of this entire area would have contained groundwater-saturated soils maintained and stabilized by dense wetland plants resistant to the formation of erosive, dewatering channels.

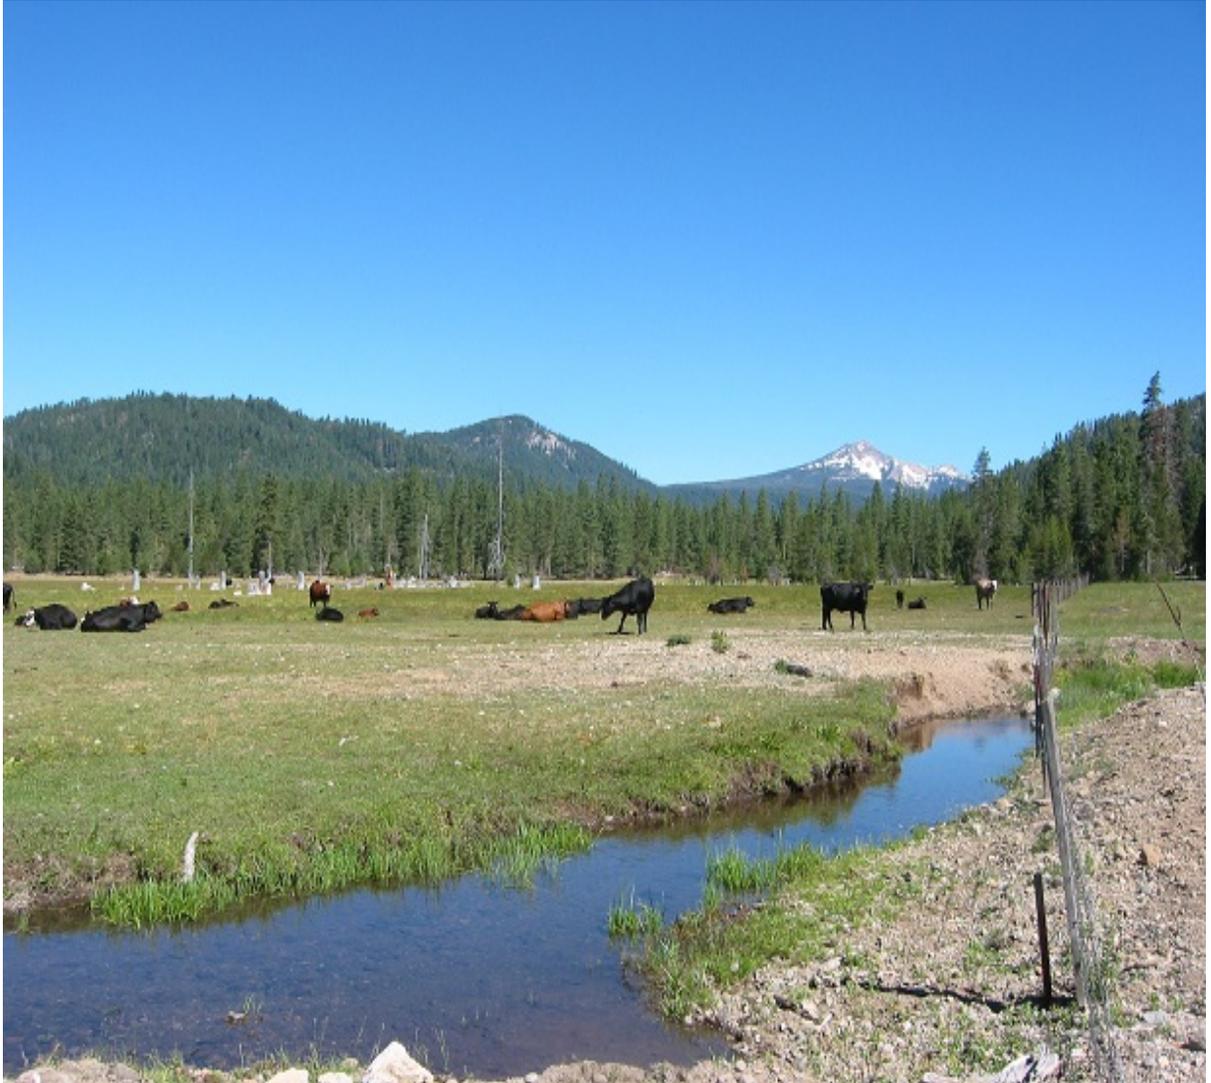
Photo 8: Ditched Flow in Area 8

Current Site Conditions: Stream diversions and the highway crossing have led to drying of the meadow on the alluvial fan in this area. The culvert under the highway is directing stream flow into the wet depressional meadow northeast of a split rail fence. Some of the surface flow through this wet depressional meadow is entering from the north via the large culvert and associated diversion near the parking pullout, though most of the surface flow seems to be coming from a tributary that crosses the highway farther south. Water leaves the depressional meadow bowl via an apparent ditch along the meadow edge that is leading to the water moving quickly through the system, entering Gurnsey Creek downstream of the split rail fence where it is actively headcutting.

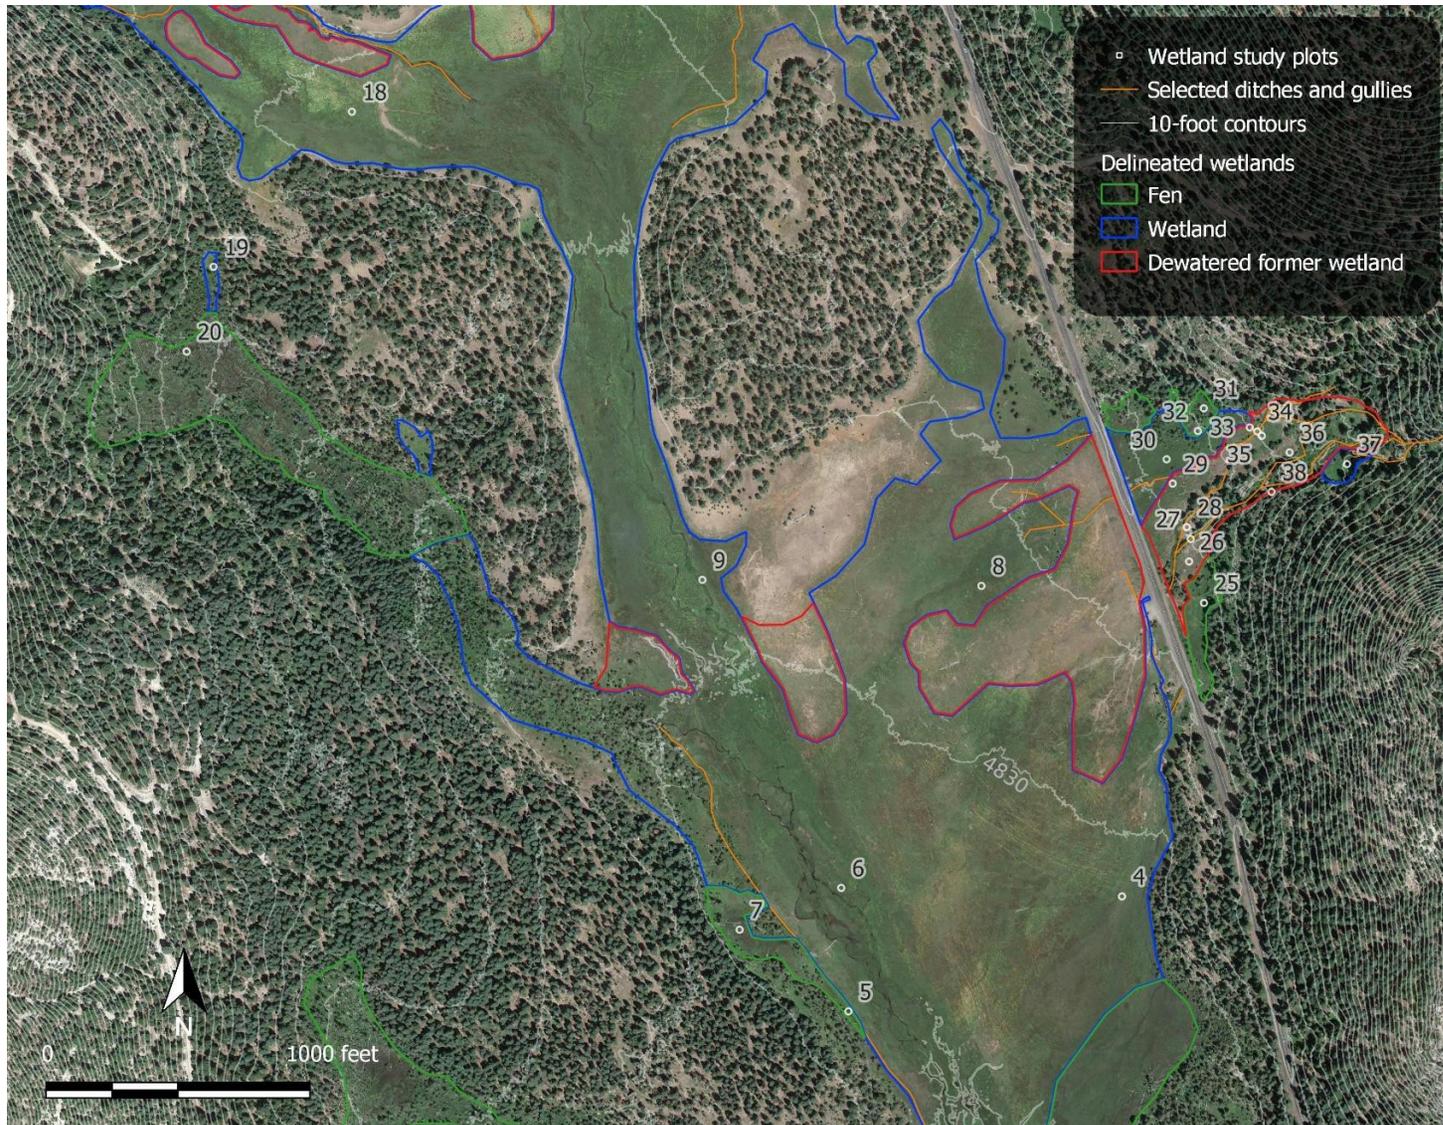
Figure 6. Zoom in on the third from top section of Childs Meadow. Plot 20 is a treed fen, plots 25-37 cover a range from intact fens to deeply gullied and dewatered wetlands. A long ditch runs from north of plot 7 south of plot 5, intercepting groundwater discharge the plot 20 and plot 7 fens and conveying it rapidly downstream.

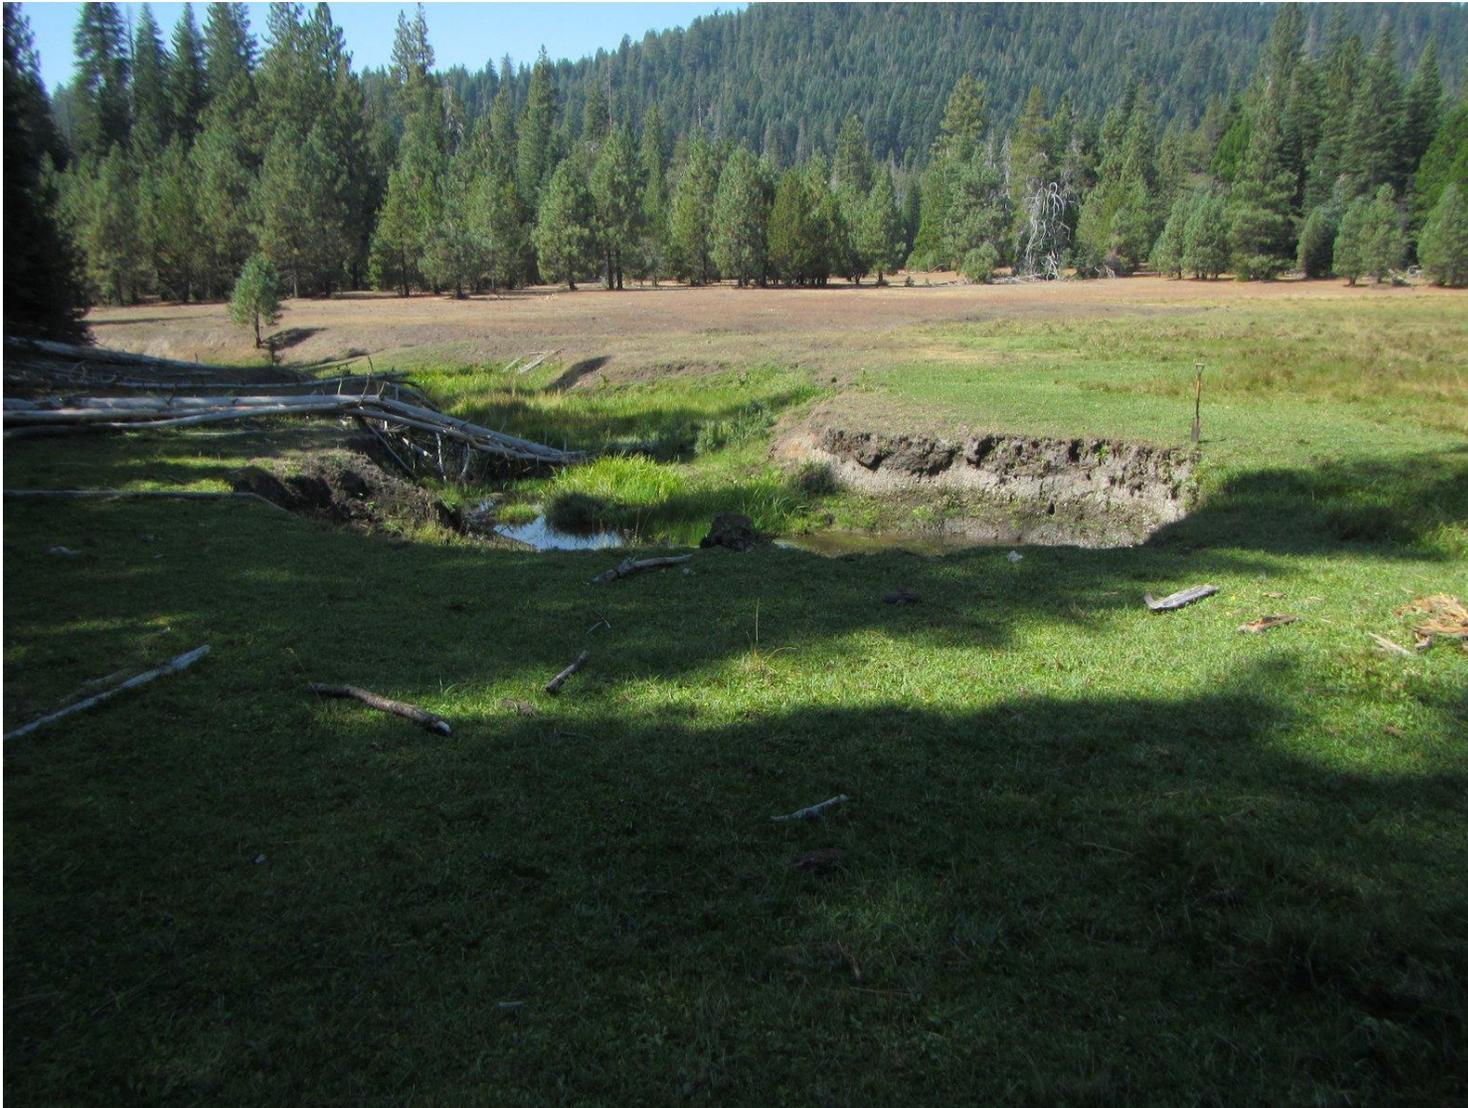
Figure 13. Plot 46 in the foreground, above and upstream of the large headcut. Plot 47 is in the middle background in the brown dewatered area. Note the close-cropped vegetation around the headcut from cattle grazing.

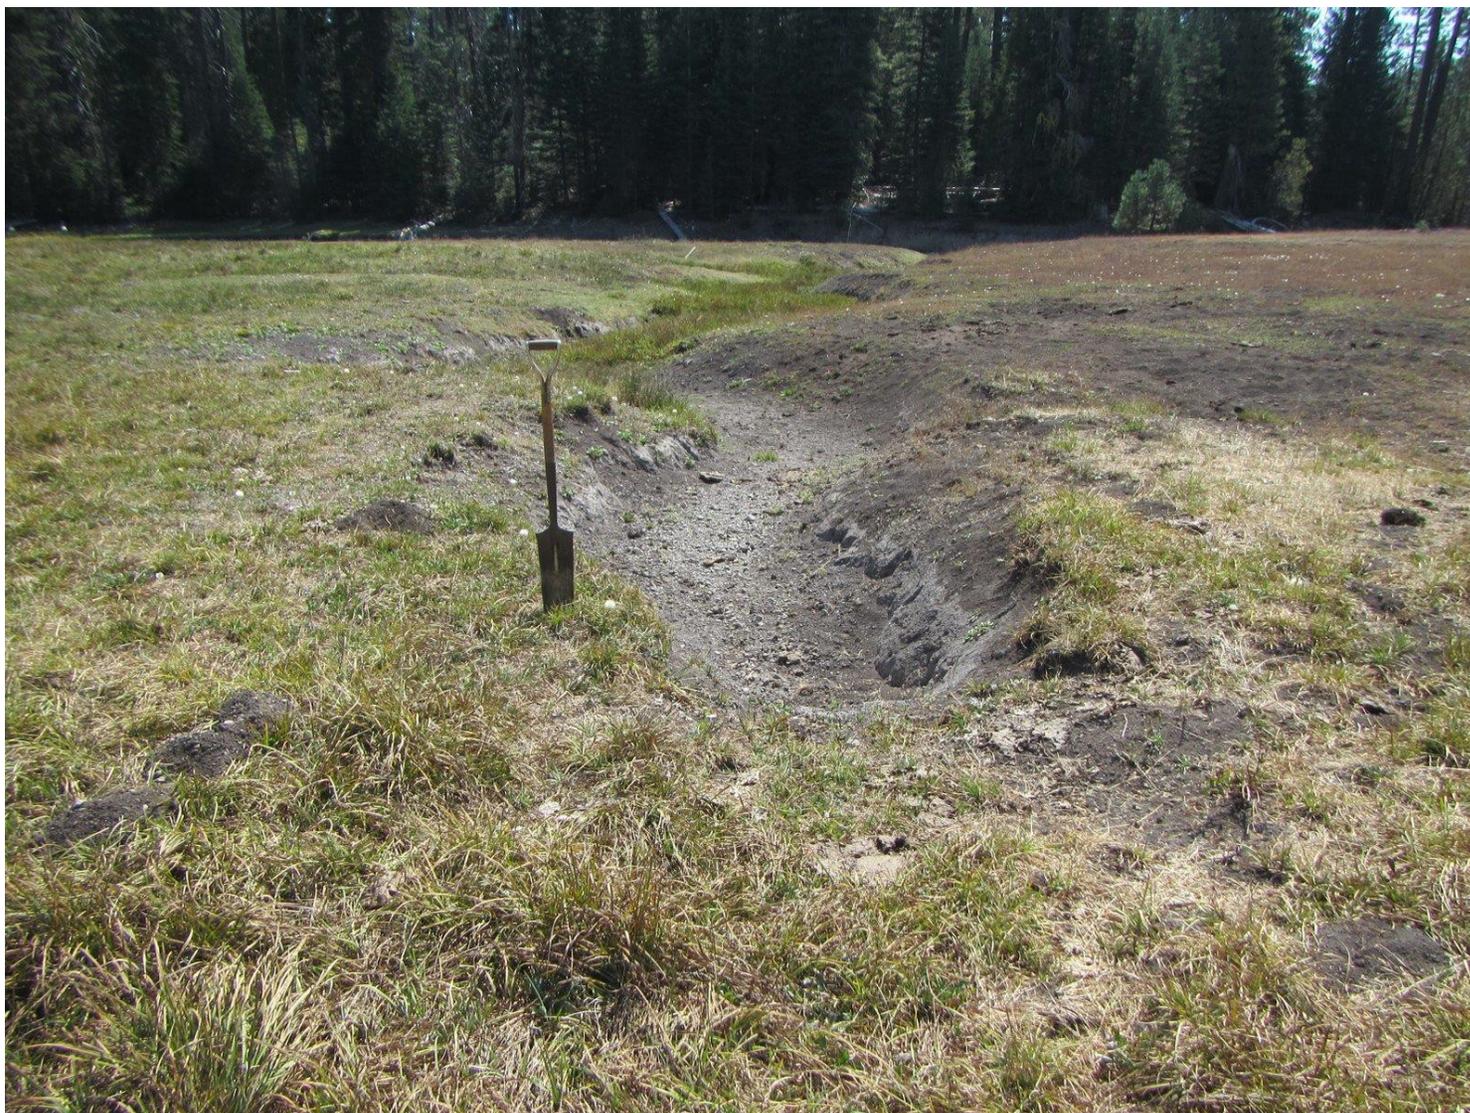
Figure 14. Plot 47 to the right of the headcut has wetland soil but lacks wetland hydrology and vegetation. Wetland extends to the left (upstream) of the headcut.

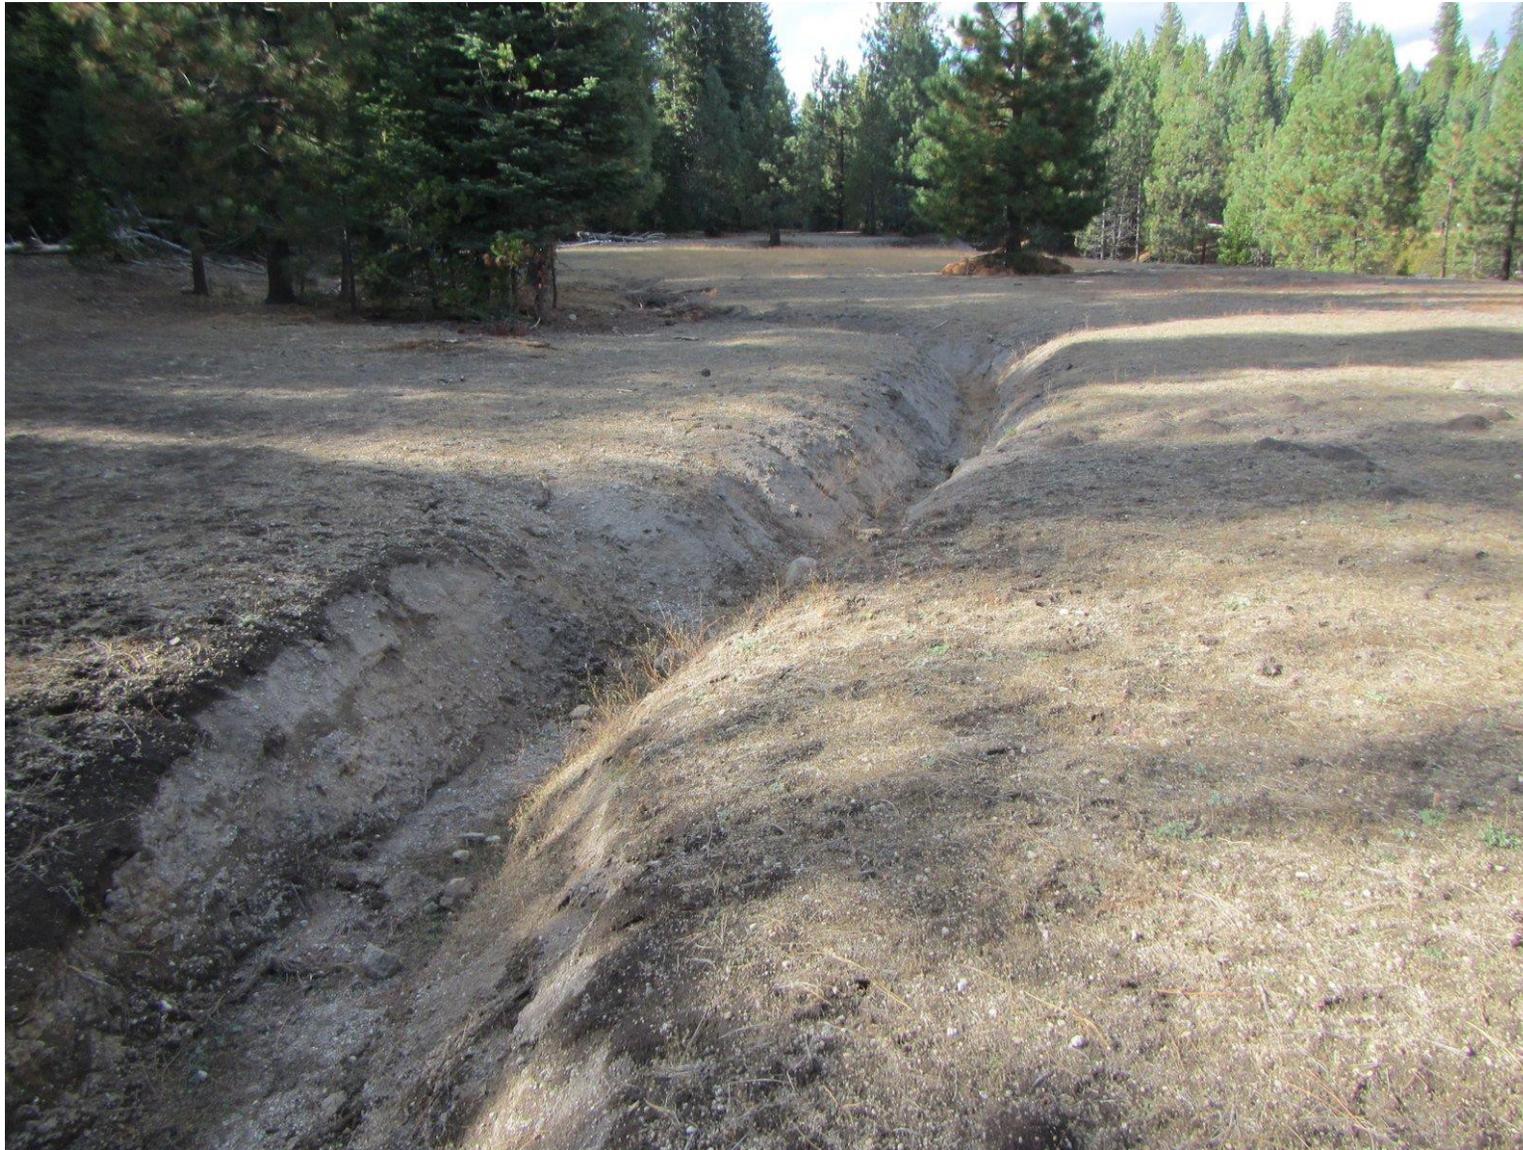
Figure 16. Remnant wetland soil visible as dark surface layer to the left, on vertical ditch bank. Plot 65 is to the right.

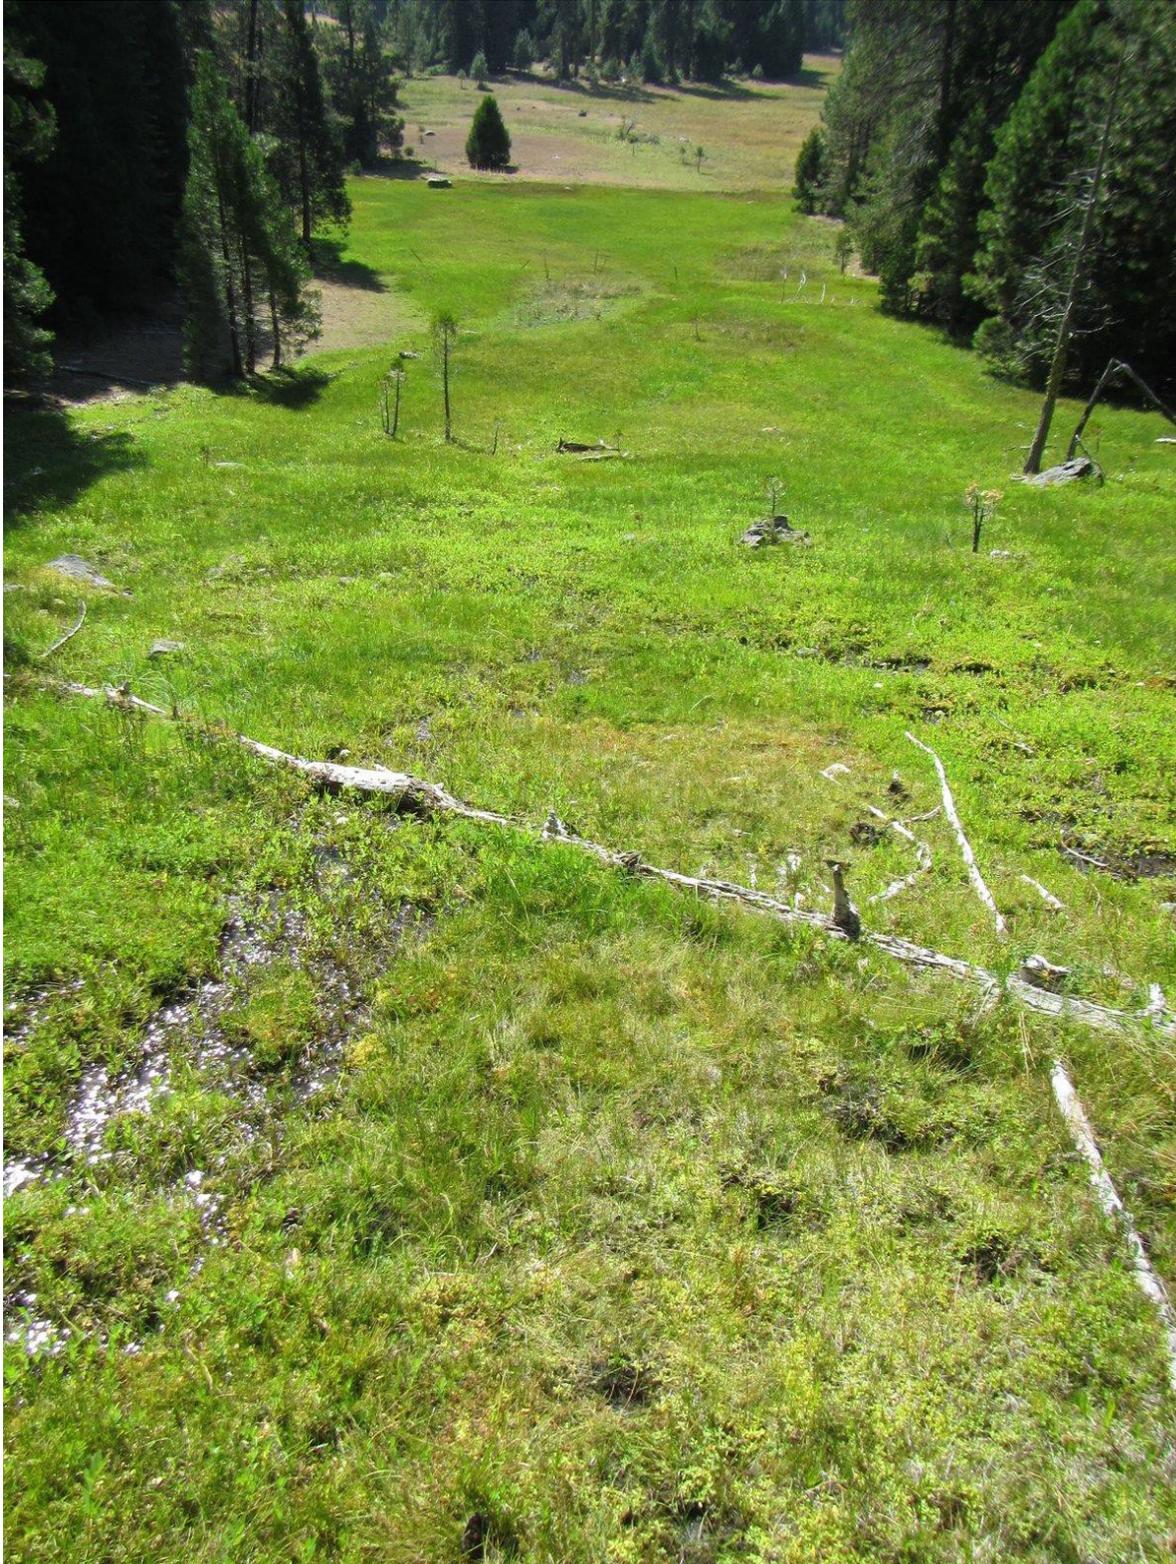
Figure 17. Plot 57, looking west down a 12.5% sloping fen to the valley floor of Childs Meadow below. Note mid-September flowing spring discharge and cattle hoof punches in foreground.
