From: [Tod Elliott](#)
To: [Laura Hall](#)
Subject: Belmont
Date: Tuesday, July 16, 2024 2:21:52 PM
Attachments: [IMG_2848.jpg](#)
[IMG_2849.jpg](#)
[IMG_2850.jpg](#)
[IMG_2851.jpg](#)
[IMG_2852.jpg](#)
[IMG_2853.jpg](#)
[IMG_2854.jpg](#)
[IMG_2855.jpg](#)
[IMG_2856.jpg](#)
[IMG_2857.jpg](#)
[IMG_2858.jpg](#)

Elliott 07-16-2024 site inspection

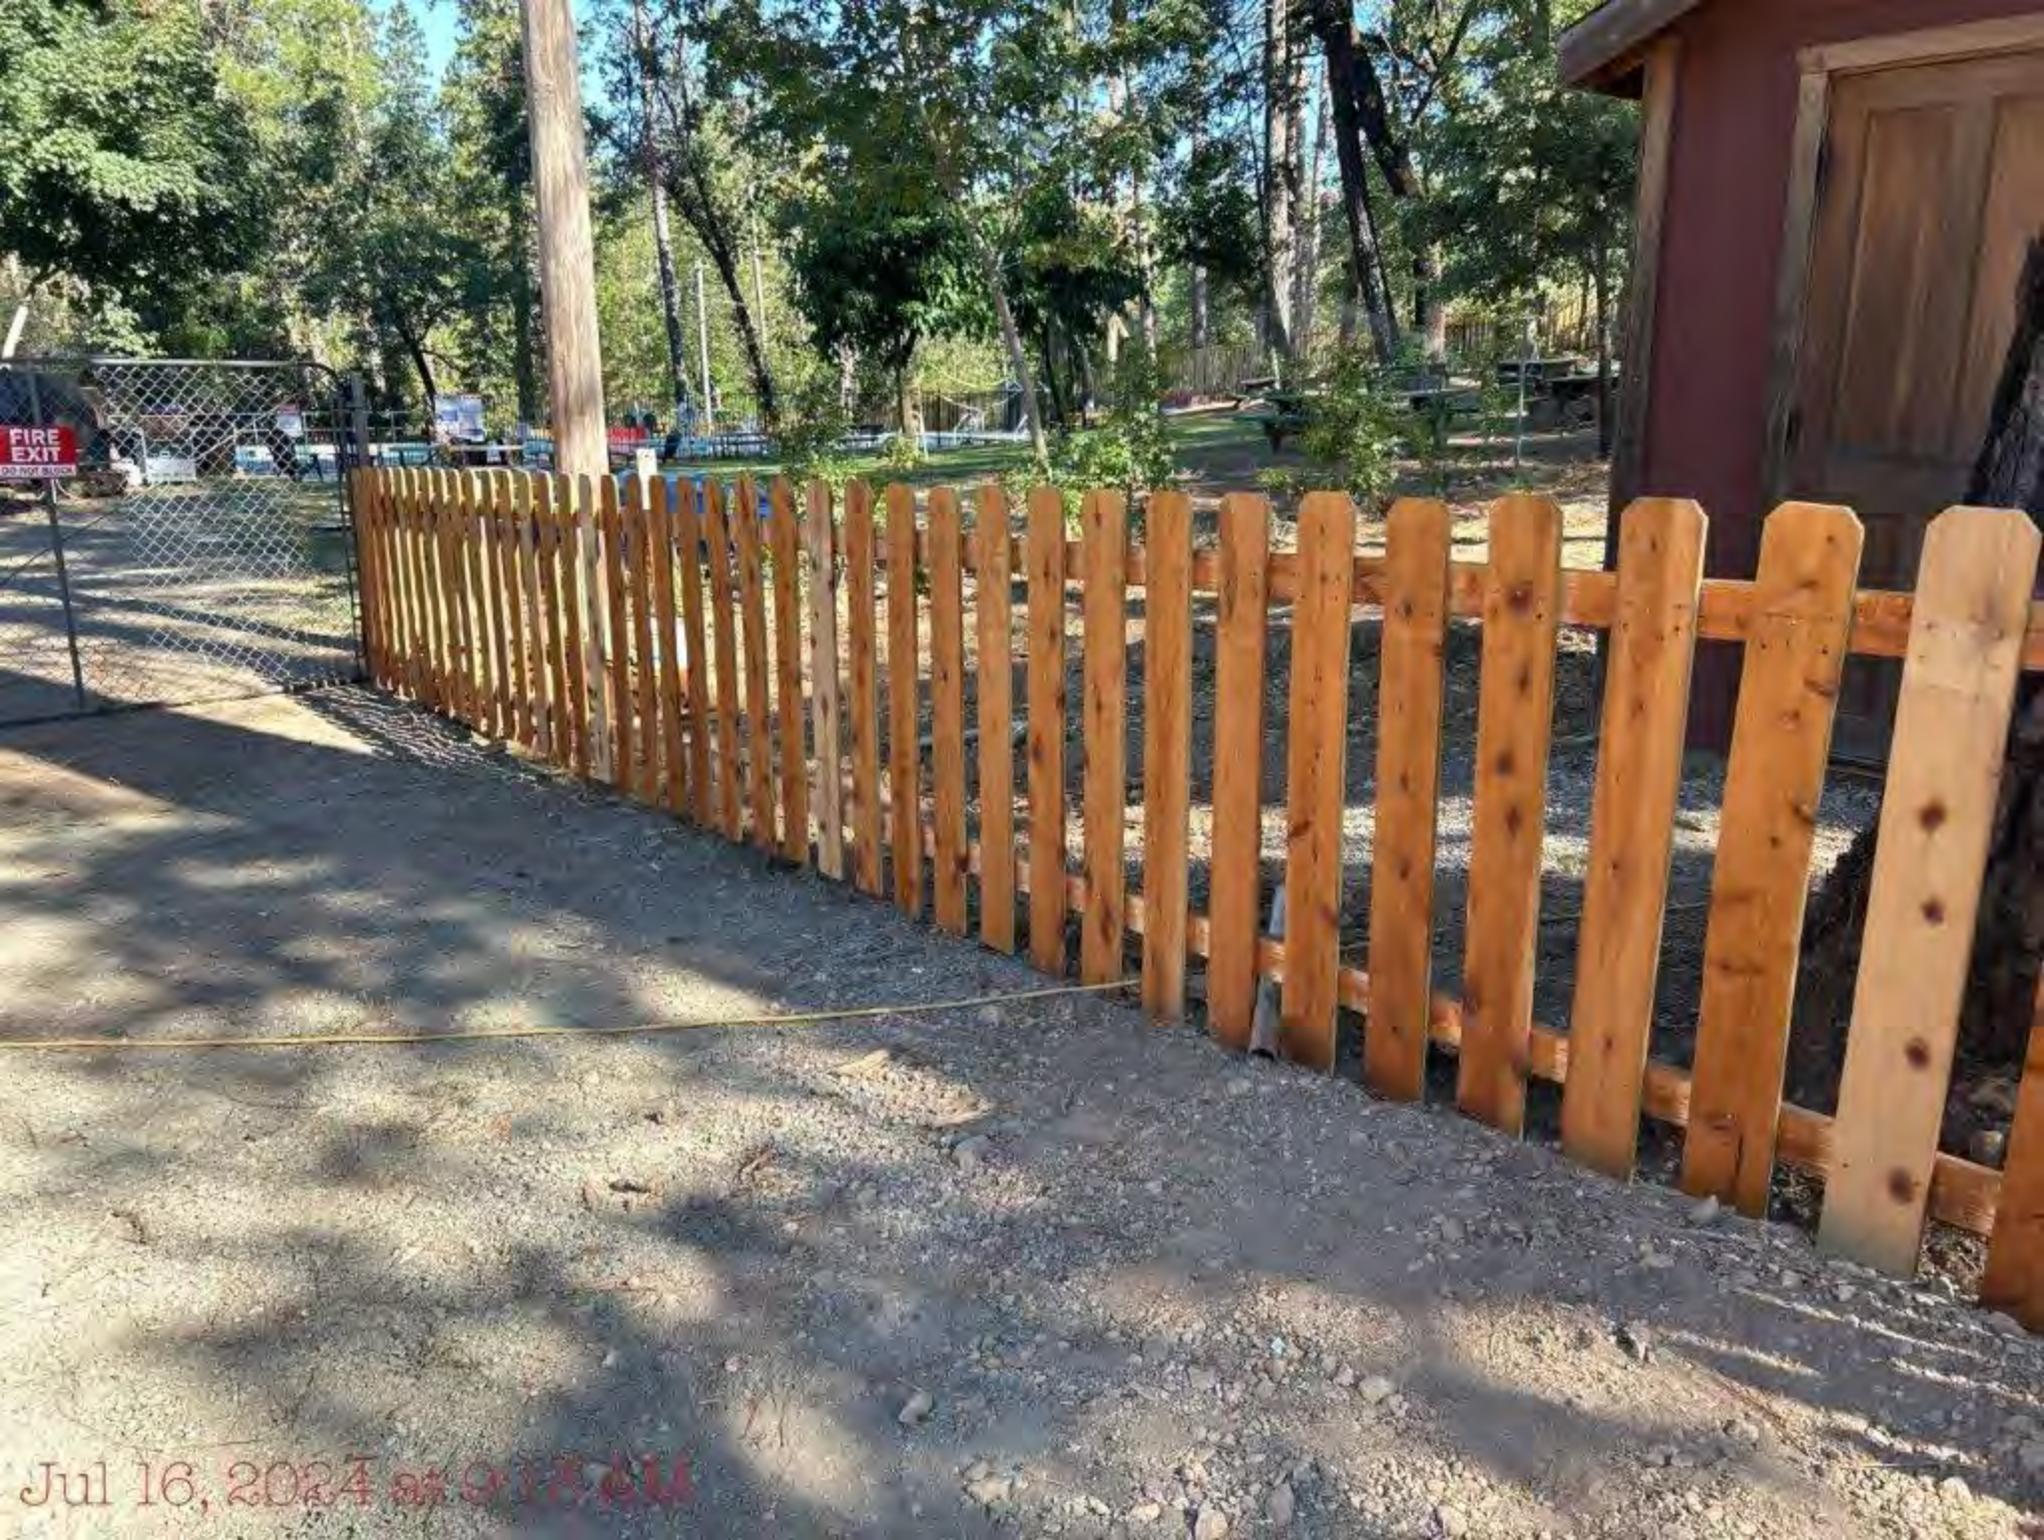
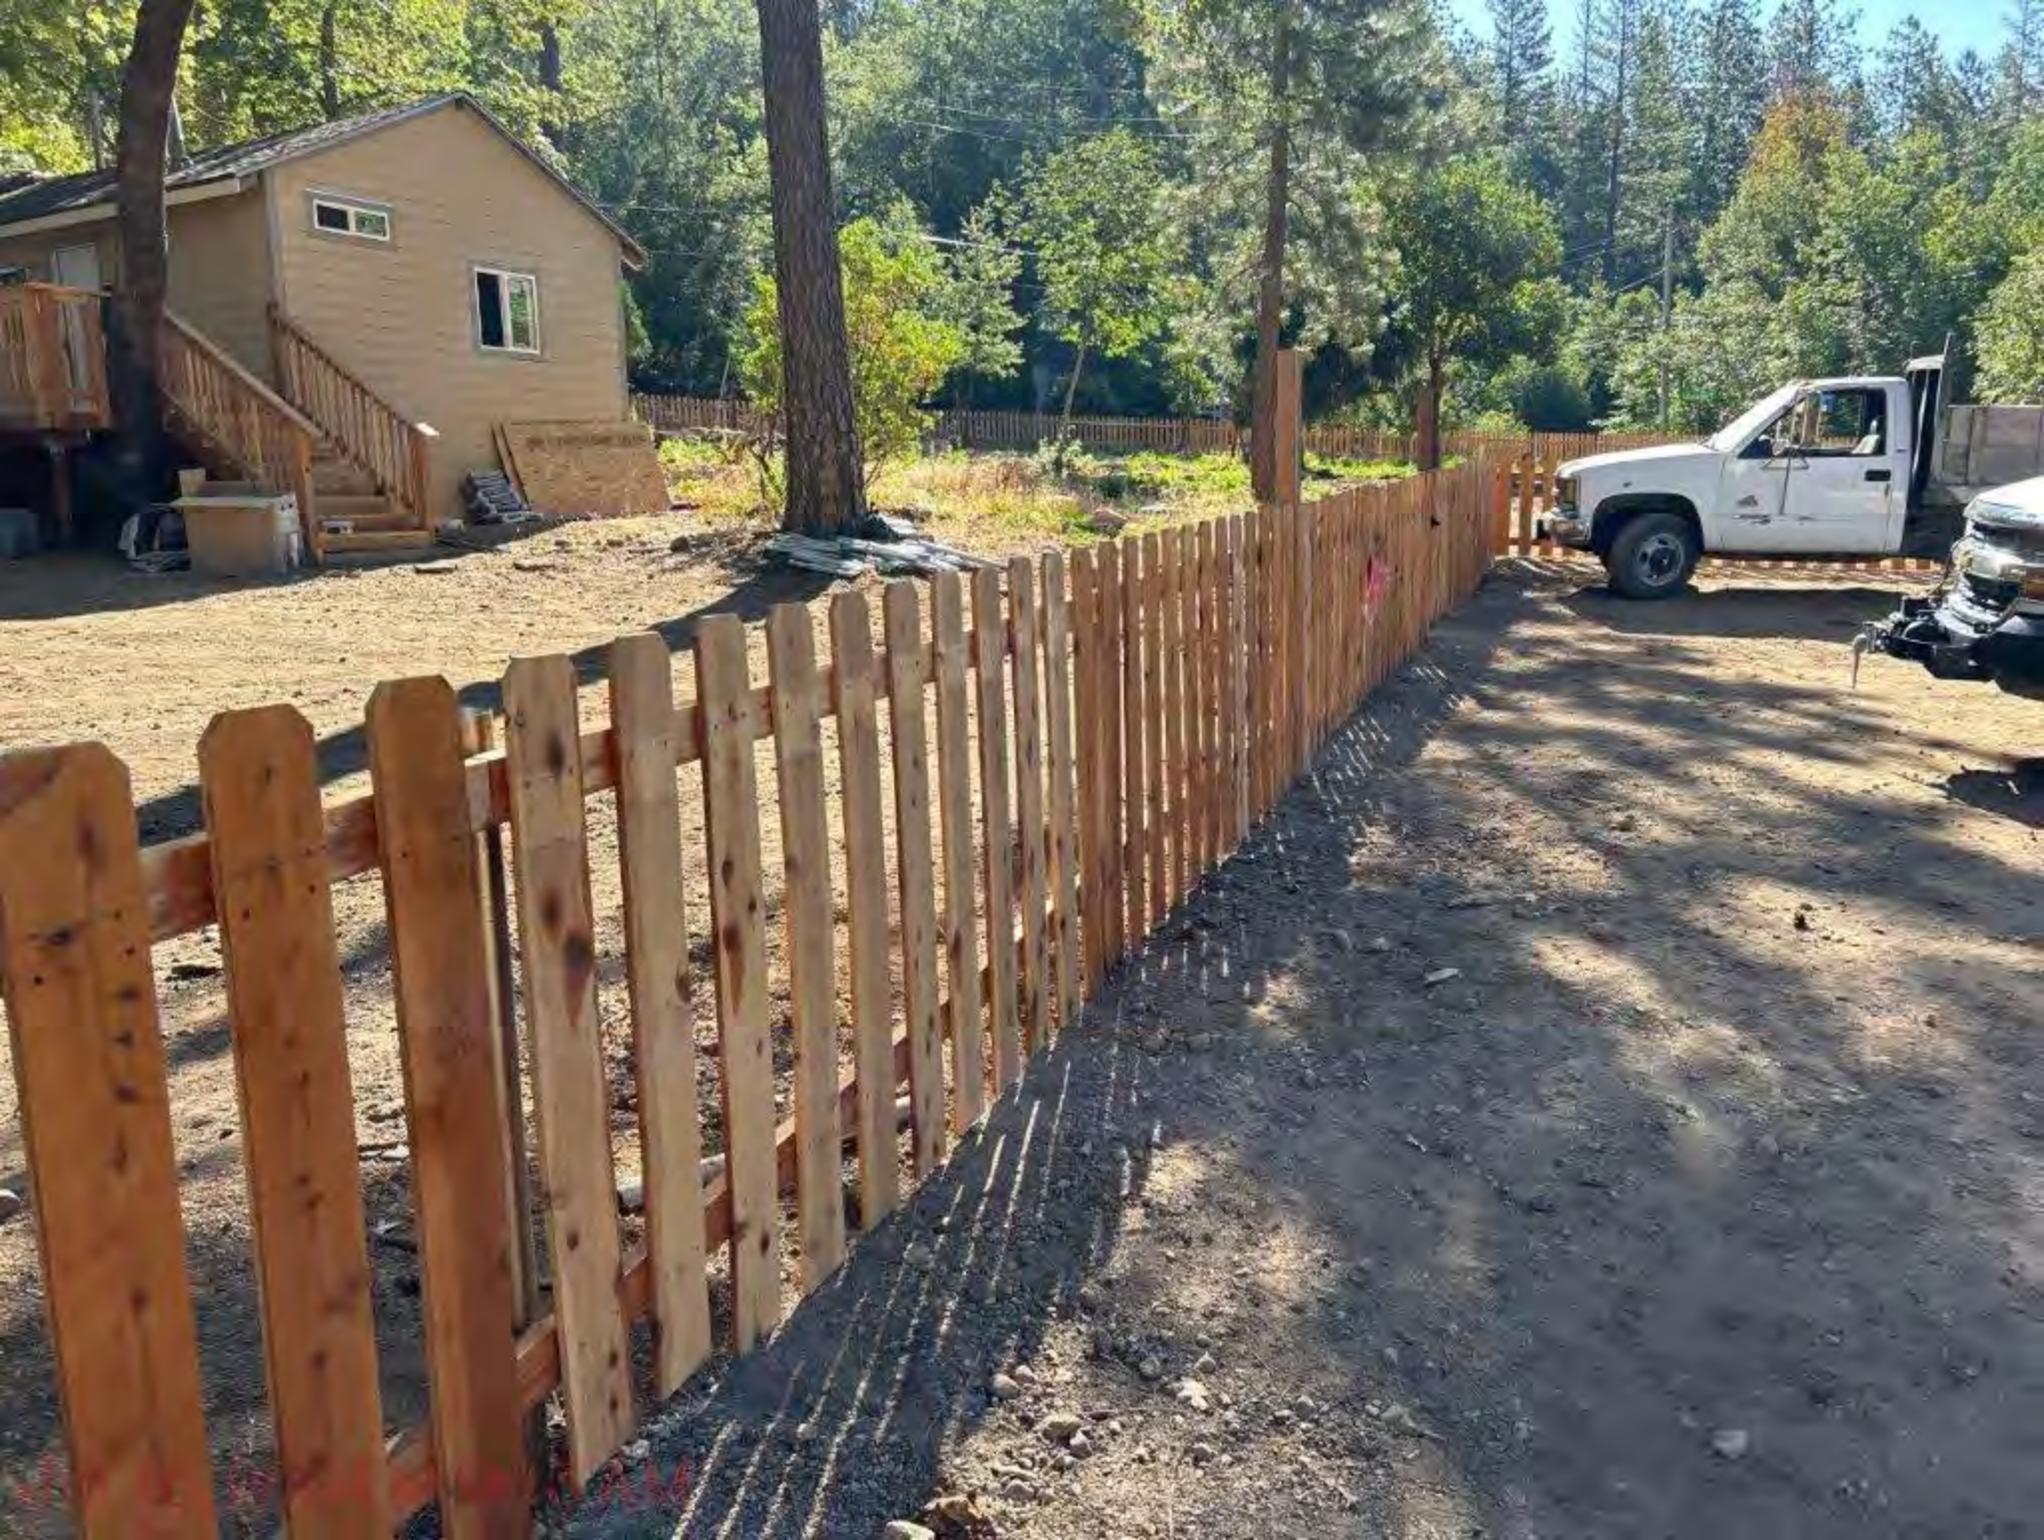
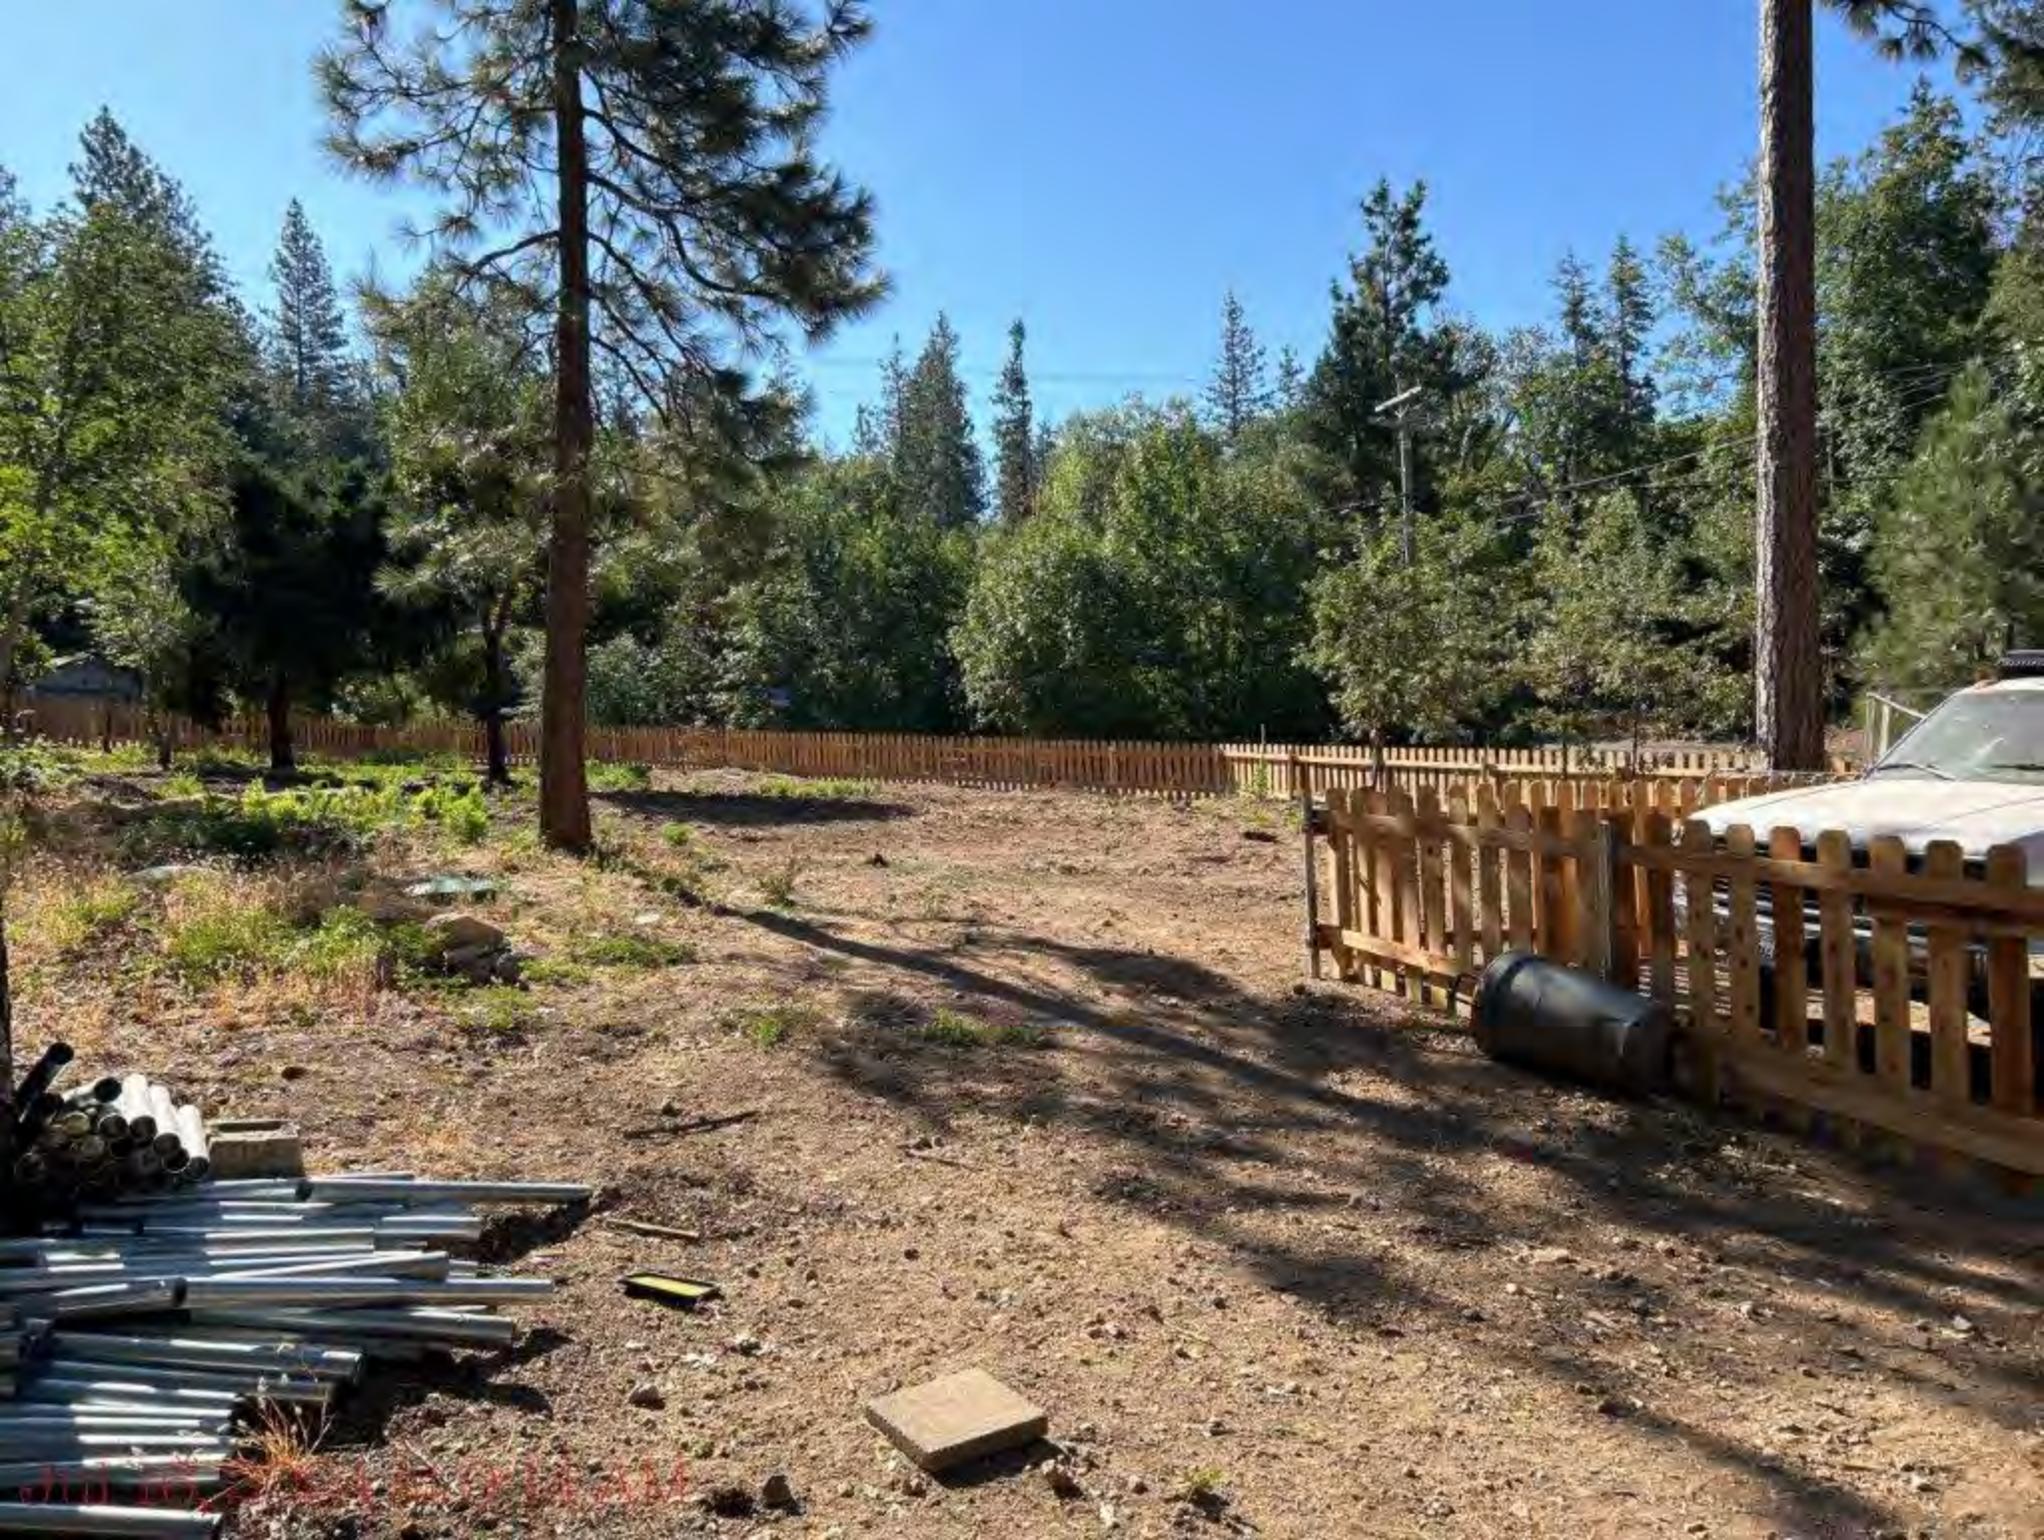
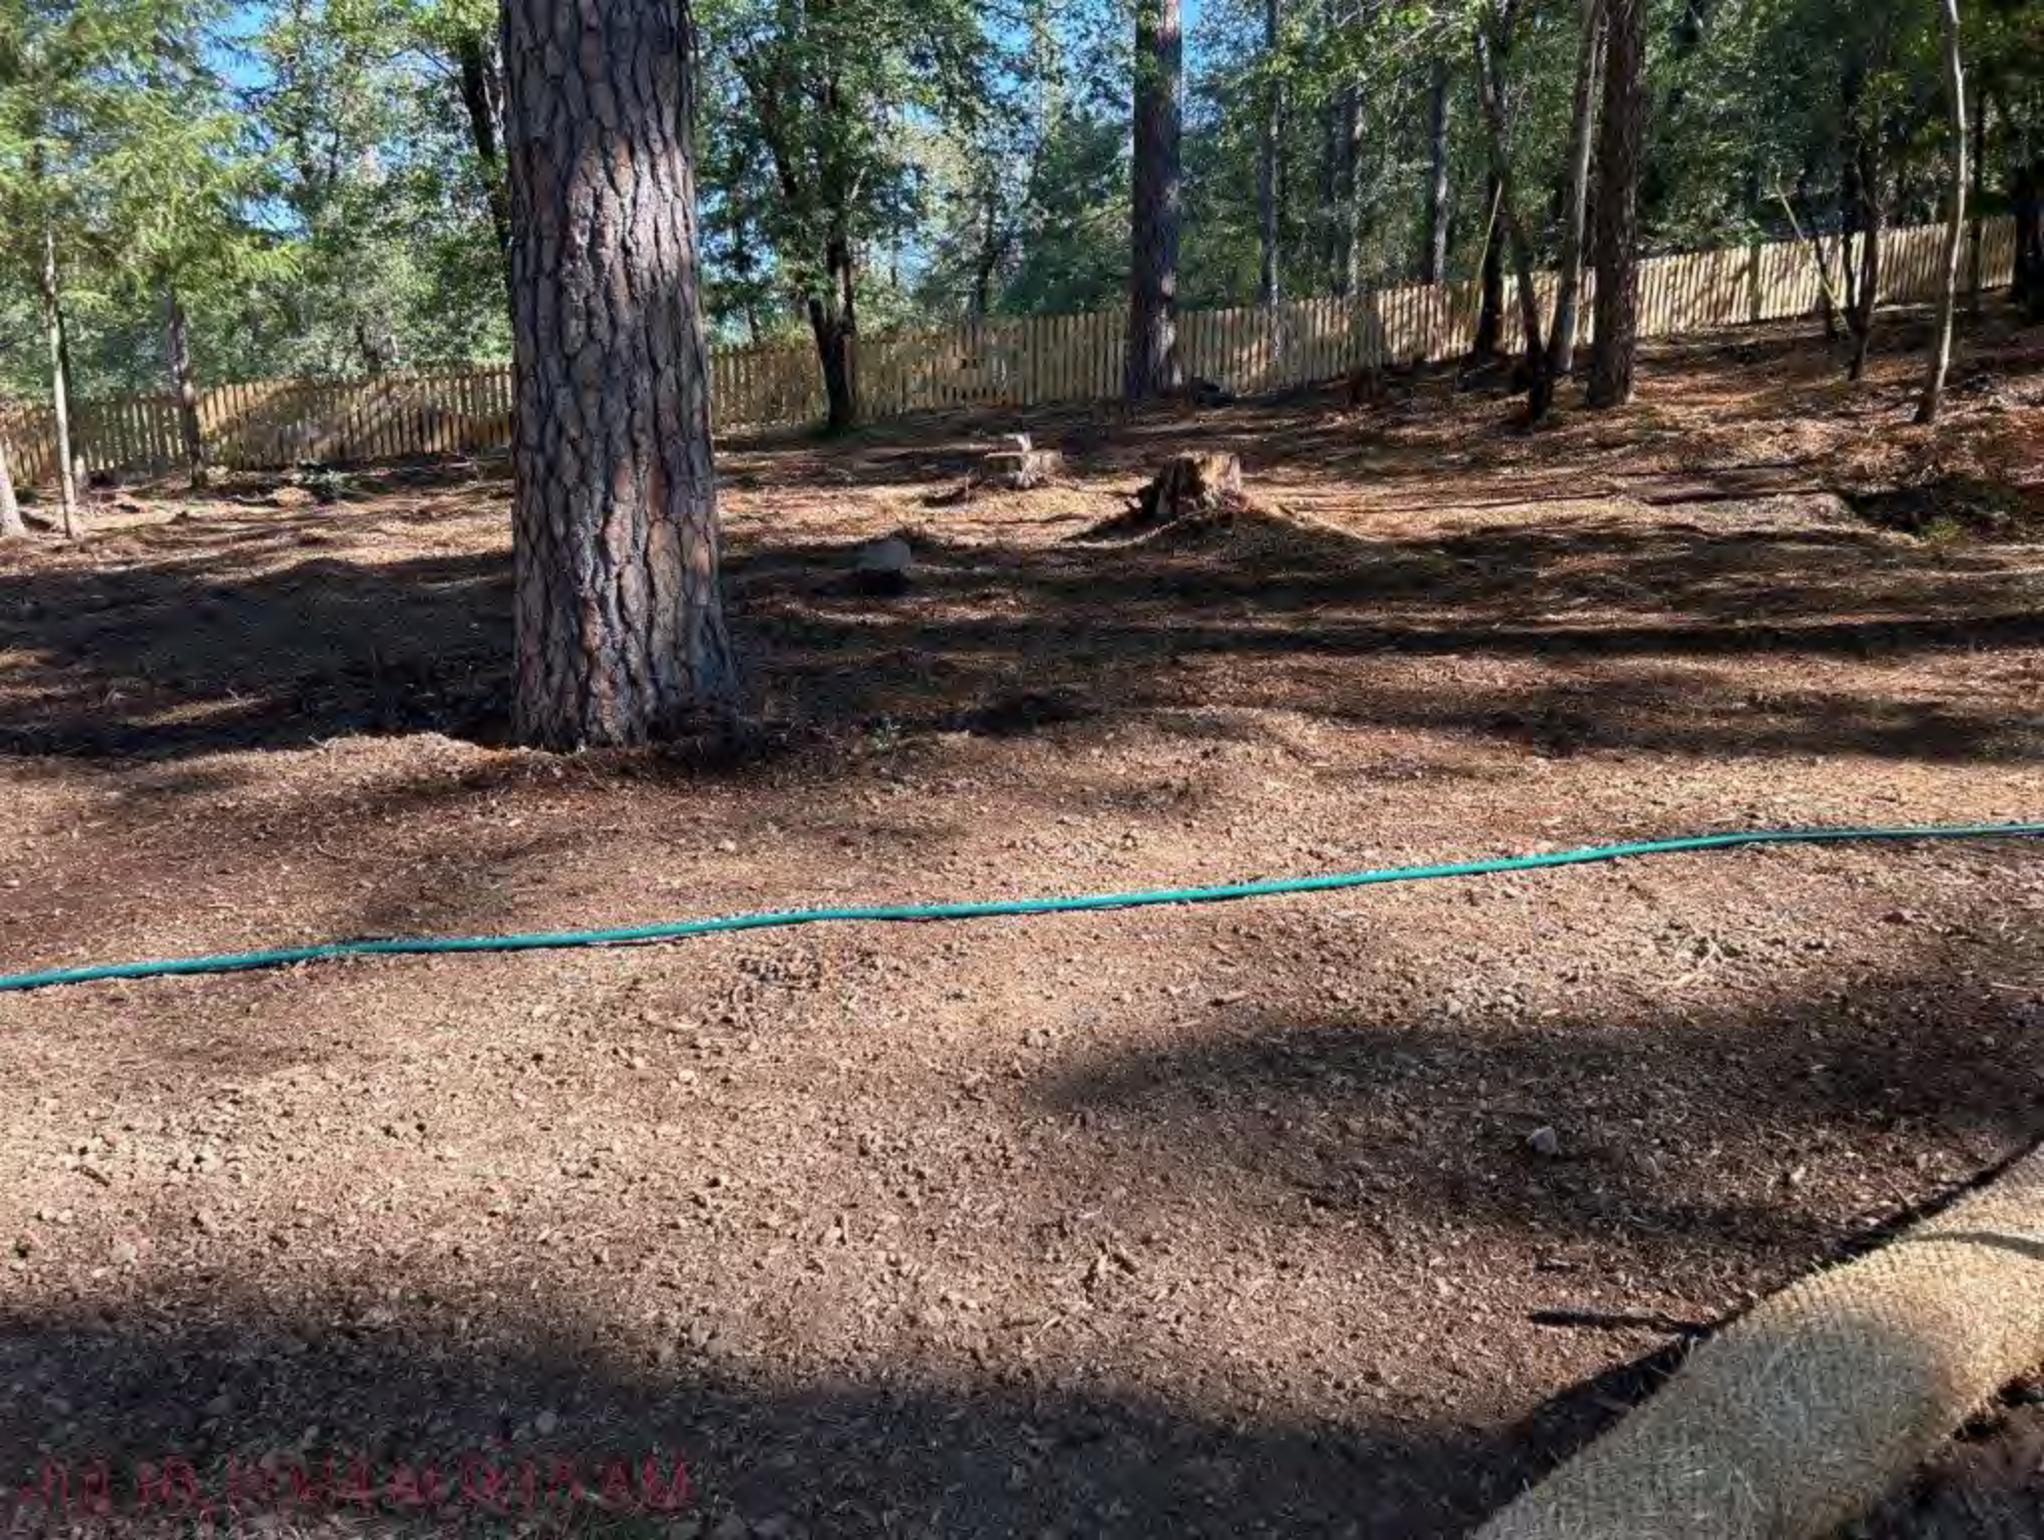
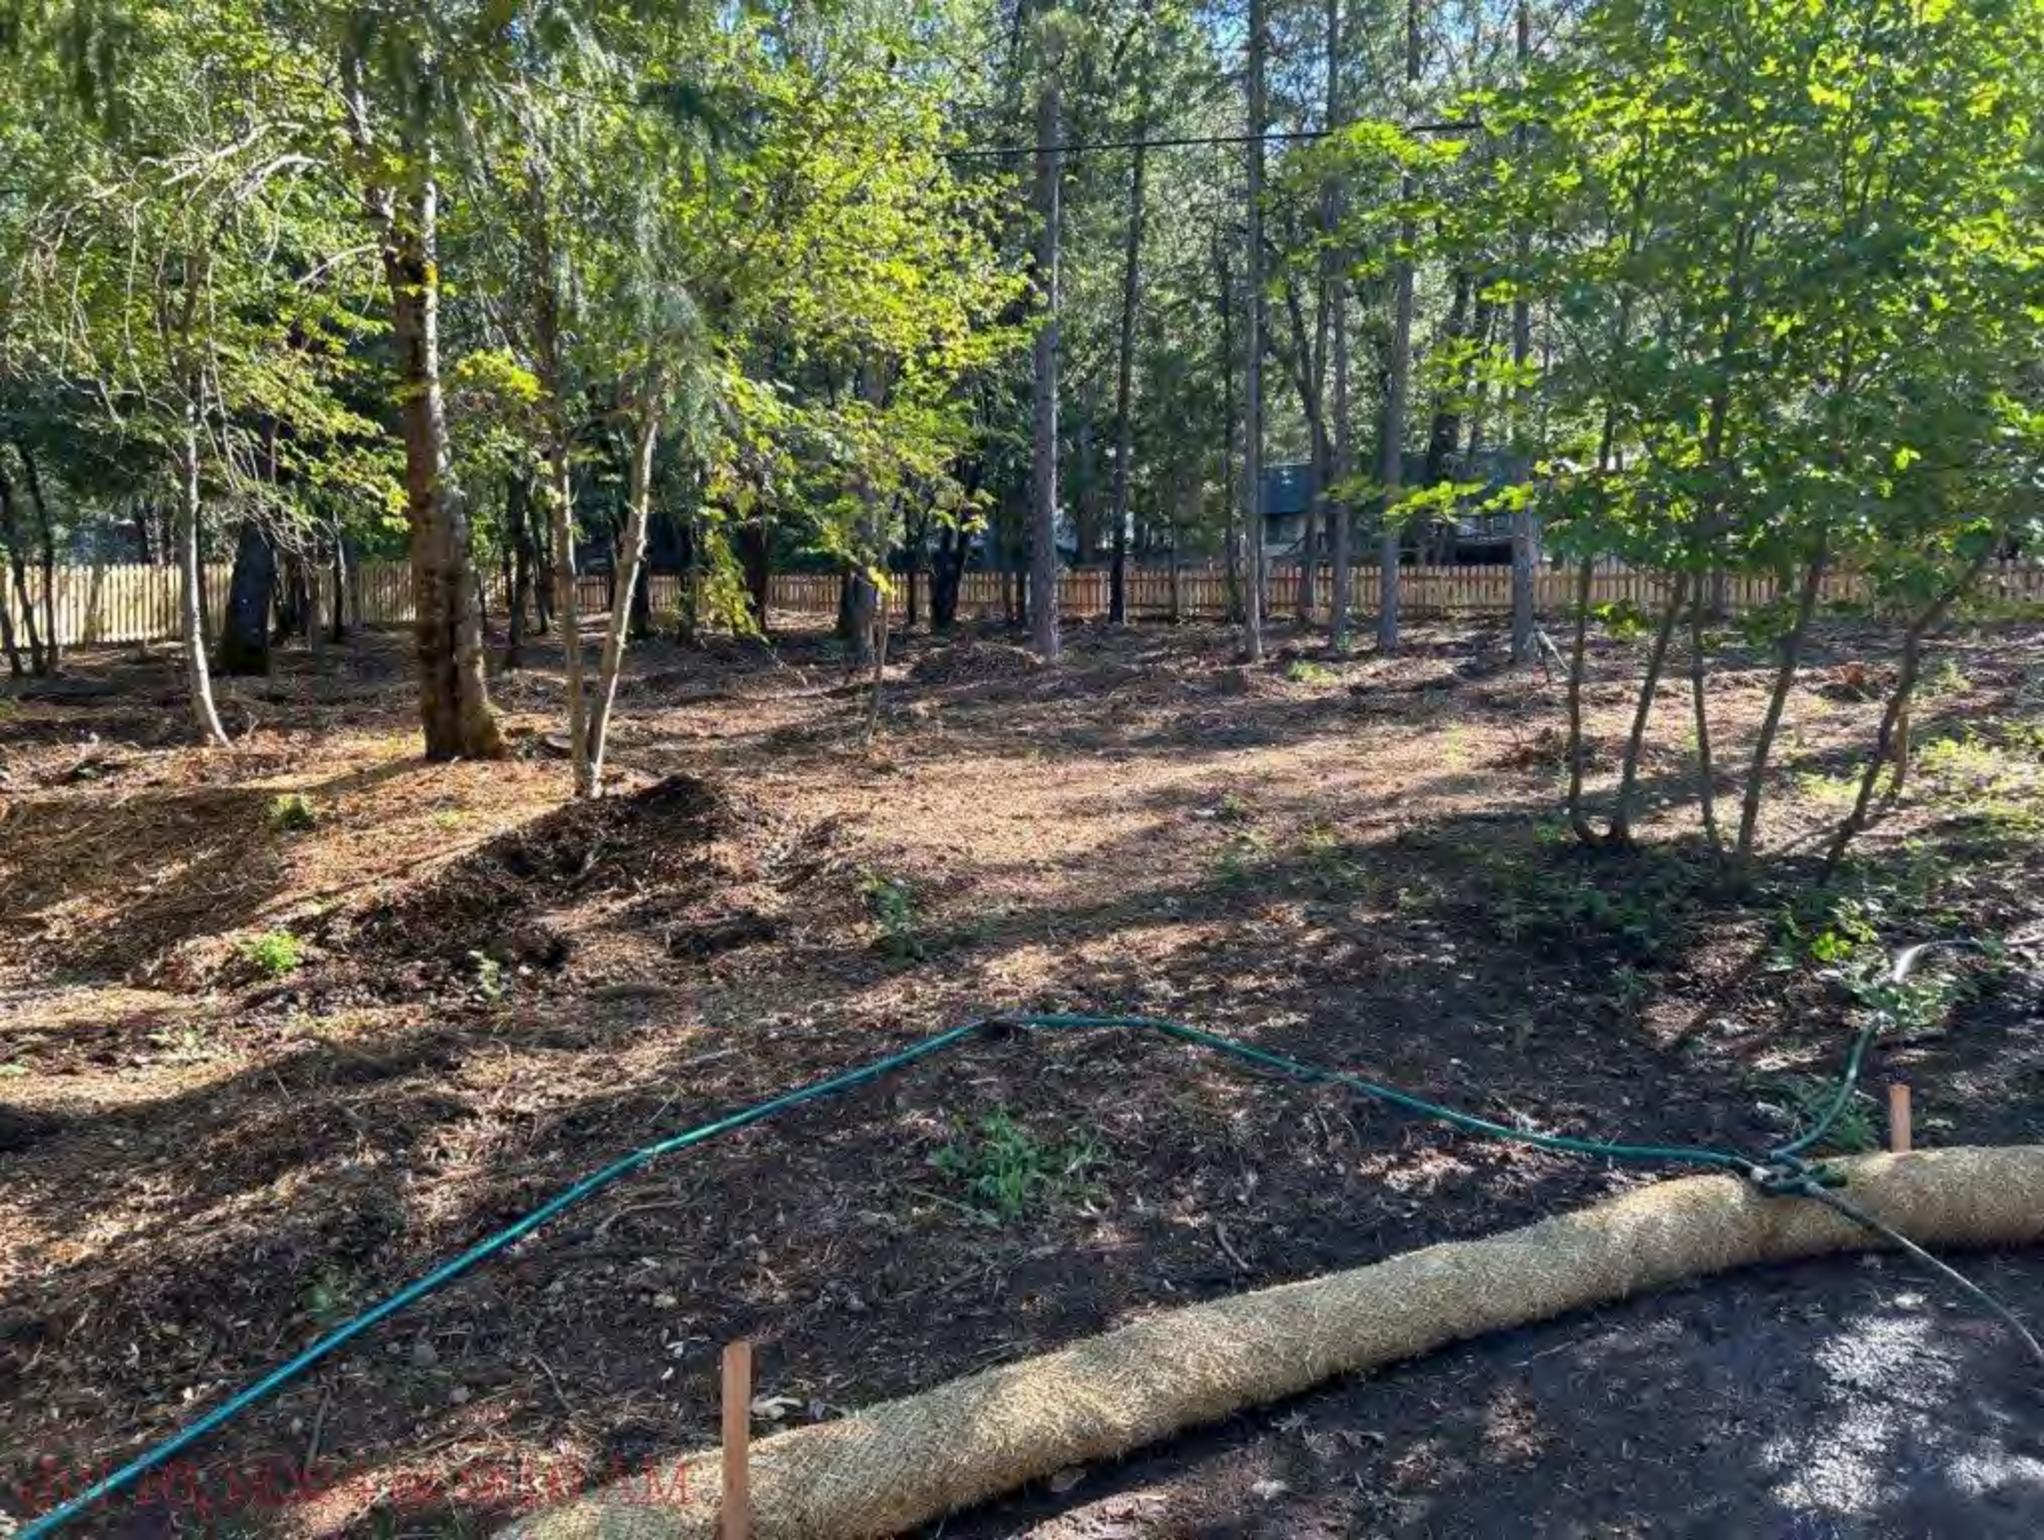
Observed was evidence of soil saturation, sprinklers and hoses on site with no detectable signs of sediment departure, erosion wattles had been installed around the perimeter of the downhill slopes of the project site. Perimeter fence elevation to the adjacent streets (east, west, and south side) of the project has been reduced to a 4' maximum. I have confirmed with Annje Dodd that prior of October 15th or 72 hours of any rain forecast event of 40% that further erosion control measures would need to be implemented around the perimeter; track out rock and concrete washout pit will need be required prior of the next phase of construction,
