## **Preliminary Foundation Report**

March 24, 2020  
CAInc No. 14-156.2

Subject: **Preliminary Foundation Report**  
Messick Road Bridge Replacement  
Existing Bridge No. 29C-274  
San Joaquin County, California

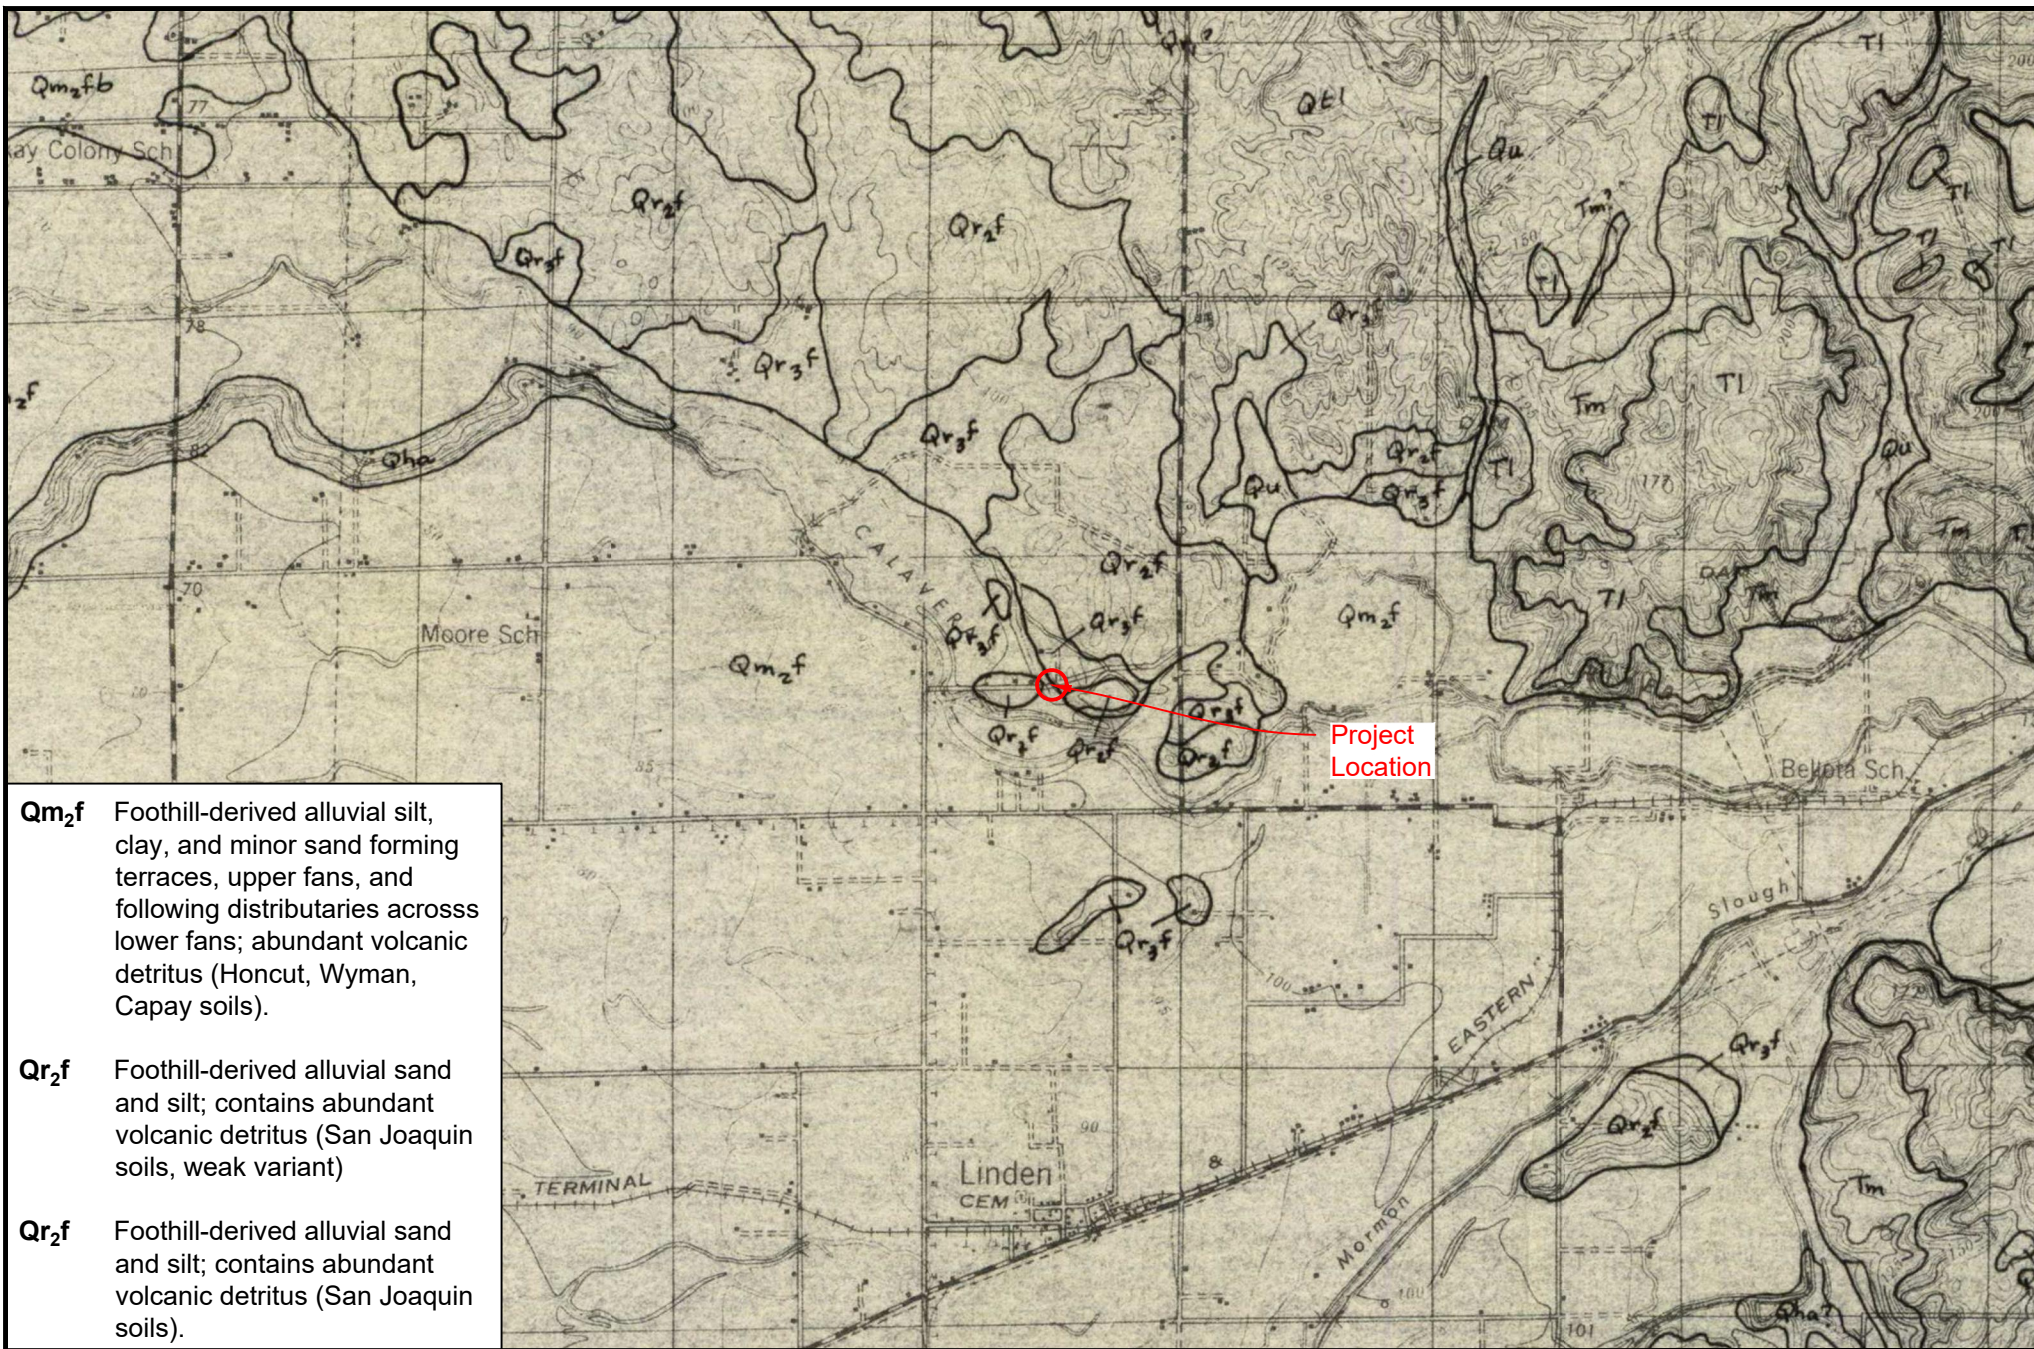
Figure 2  
Geology Map

Source: Marchand, D.E., and Bartow, J.A.. Preliminary geologic map of Cenozoic deposits of the Bellota quadrangle, California. Open-File Report of OF-79-664. 1:62,500. Reston, VA: United States Geologic Survey, 1979.

The project site is situated within the Great Valley geomorphic province of California, near the eastern edge of the Sacramento Valley. Based on mapping from 1979<sup>2</sup> the project site and vicinity are near the boundary of the Modesto and Riverbank Formations. The Modesto Formation in the site area is described as foothill-derived alluvial silt, clay and minor sand forming terraces, upper fans, and following distributaries across lower fans containing abundant volcanic detritus. The Riverbank Formation in the site area is described as foothill-derived alluvial sand and silt, containing abundant volcanic detritus.

The site geology is shown on Figure 2.

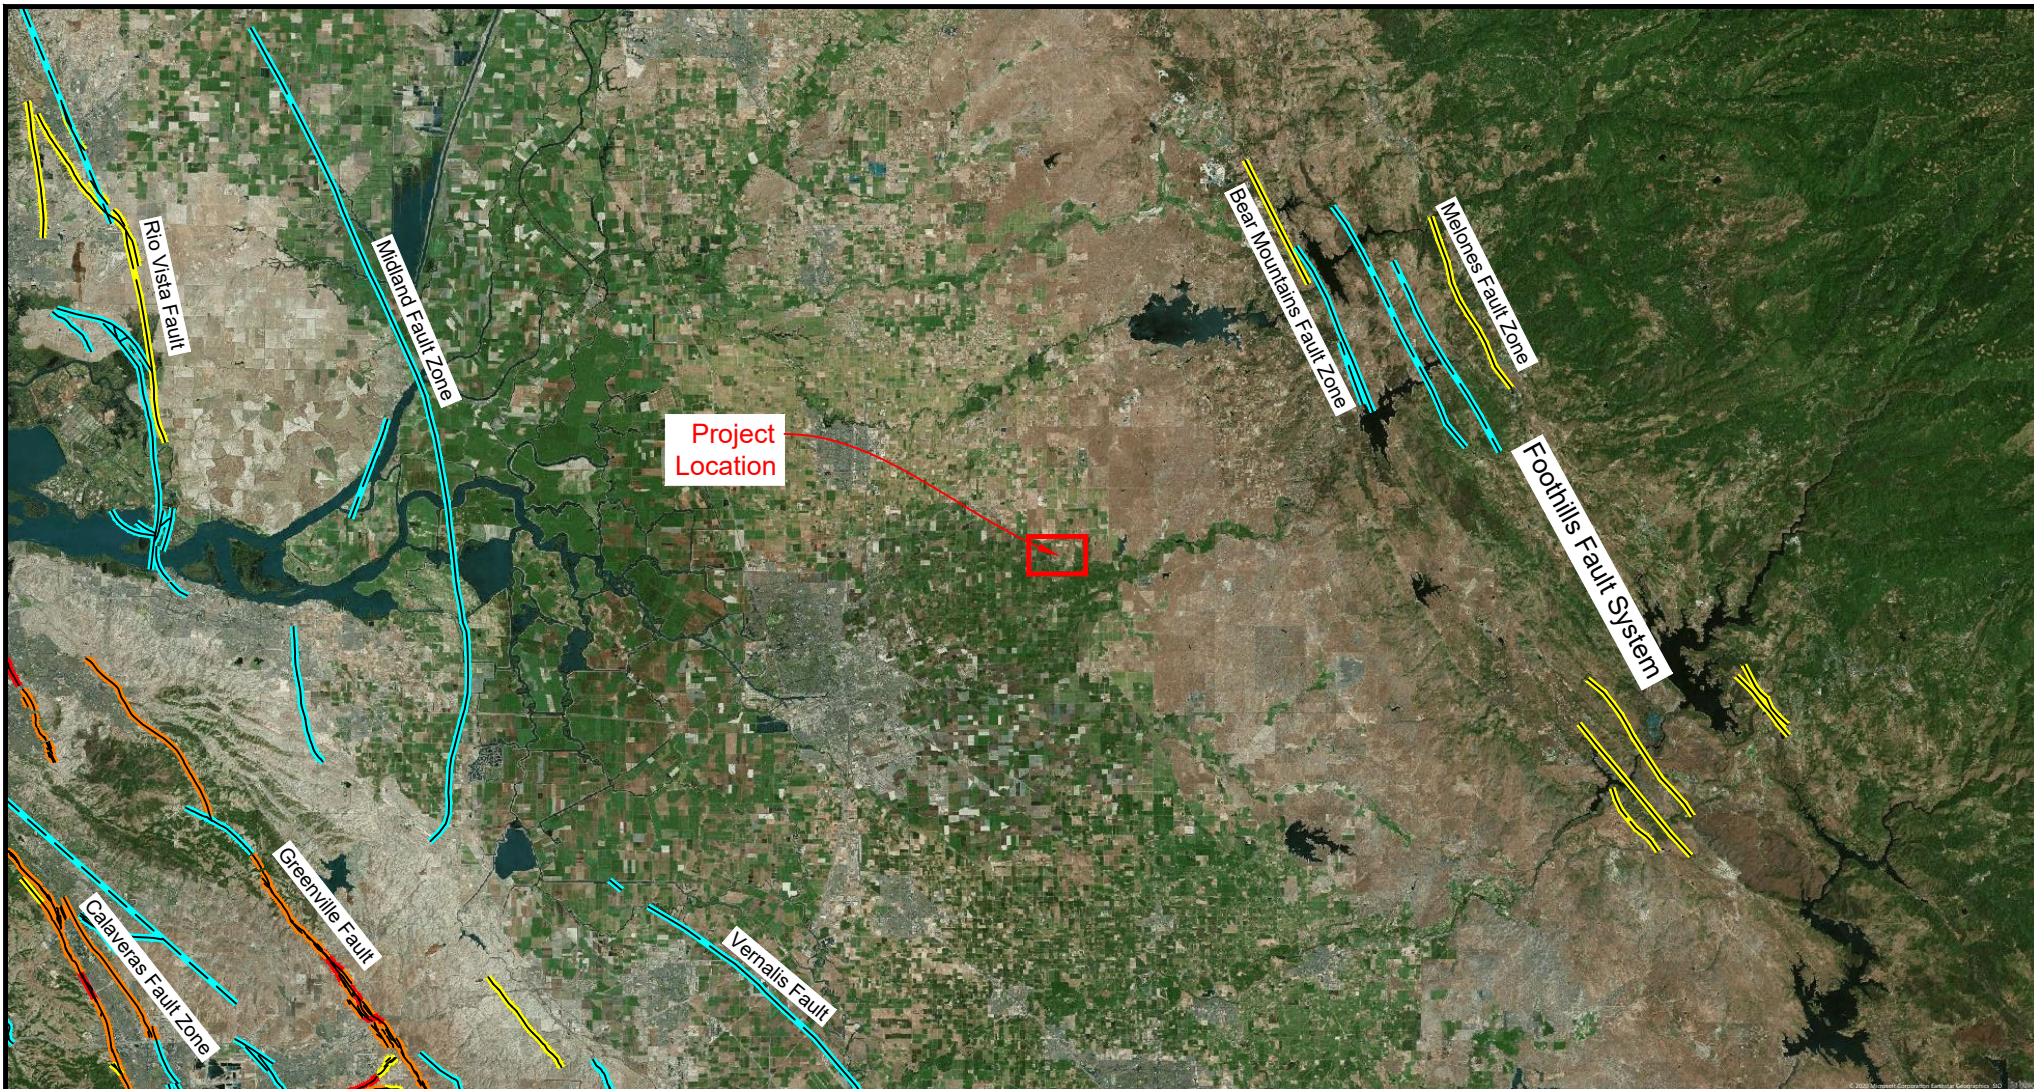
Figure 3  
Fault Activity Map

Fault Data: USGS GIS Data

The site does not lie within or adjacent to an Alquist–Priolo Earthquake Fault Zone and no known active faults are mapped within or through the project area. The closest fault considered in the ground motion analysis is the Great Valley Fault System, located approximately 30 miles from the site. Based on fault mapping by the US Geologic Survey, nearby Quaternary age faults include the Bear Mountain fault (16± miles to the northeast), the Melones Fault (17± miles to the northeast), and the Greenville Fault Zone (40± miles to the southwest). Based on this mapping we consider the potential for fault rupture at the site to be low. Nearby faults are shown on Figure 3.

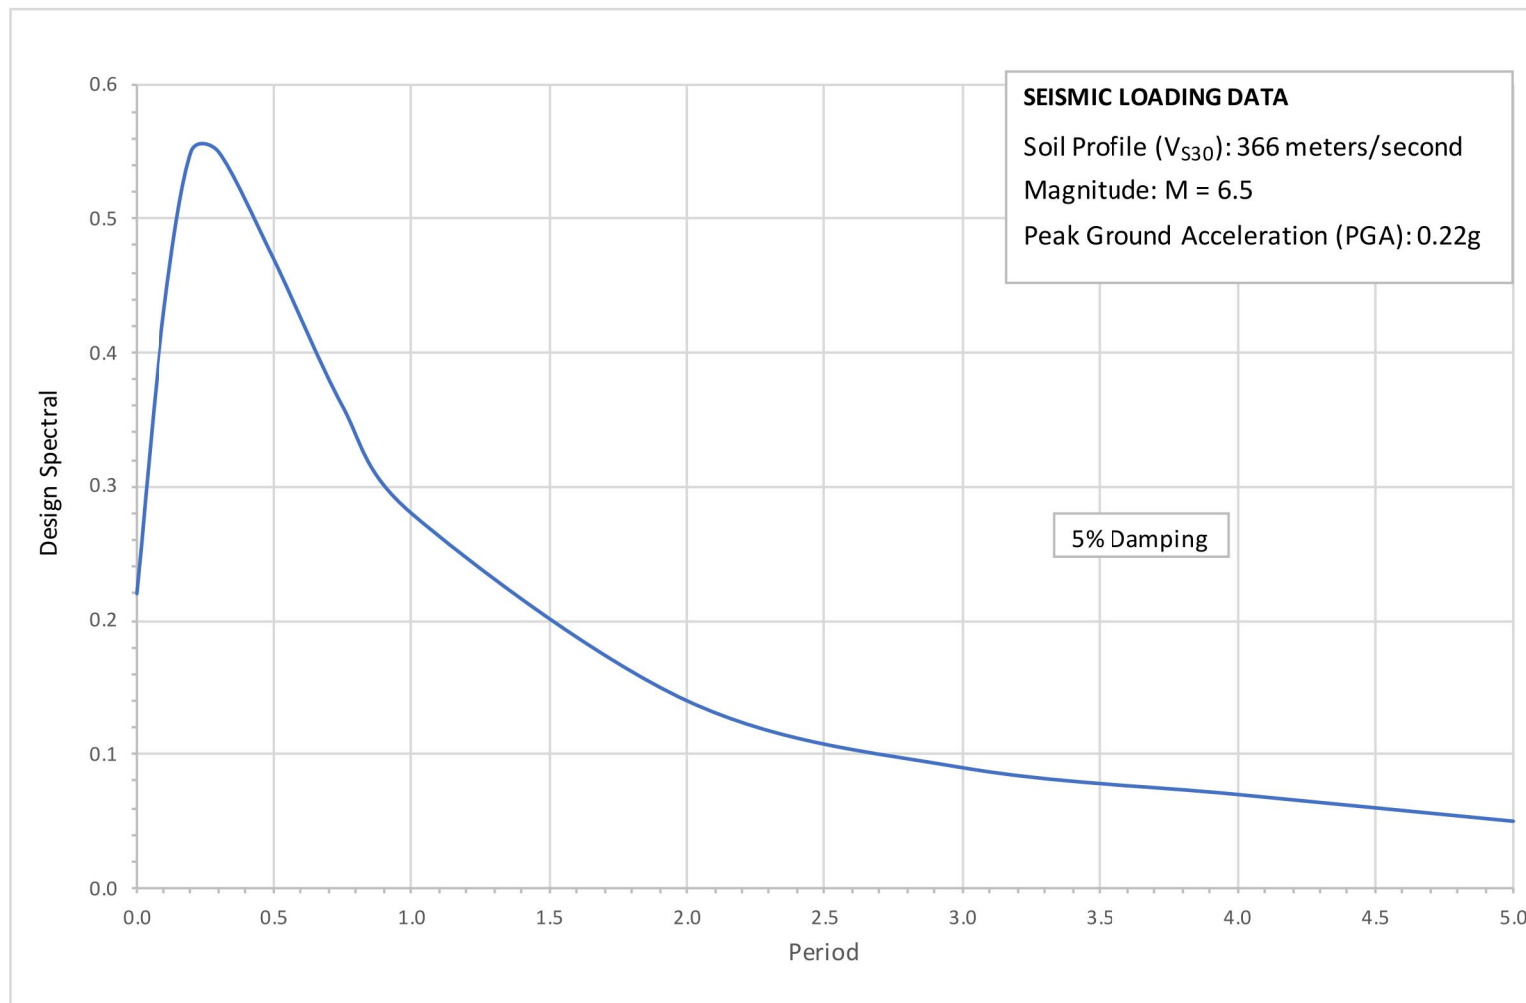
Figure 4  
 Preliminary ARS Curve

The USGS 2014 hazard data for a 975-year return period is reported along with adjustment factors required by Caltrans Seismic Design Criteria (SDC) V2.0.

Site Latitude: 38.0523  
 Site Longitude: -121.0875

The Caltrans ARS Online (v3.0.1)<sup>4</sup> web-based tool was used to calculate the probabilistic acceleration response spectra for the site based on criteria outlined in Appendix B of the April 2019 Caltrans Seismic Design Criteria (SDC) Version 2.0.

For our evaluation, we used latitude 38.0523° N and longitude 121.0875° W for the site coordinates and an estimated shear wave velocity ( $V_{S30}$ ) of 366 meters per second (about 1,200

feet per second) that corresponds to the boundary of “stiff soil” and “dense soil” (Soil Profile Type C/D) for the upper 100 ft of the soil profile.

The  $V_{S30}$  value was determined for this site based on the test boring data and correlations with SPT blow count N-values corrected for hammer efficiency using the equations outlined by Caltrans<sup>5</sup>.

The Design ARS Curve is shown on Figure 4.

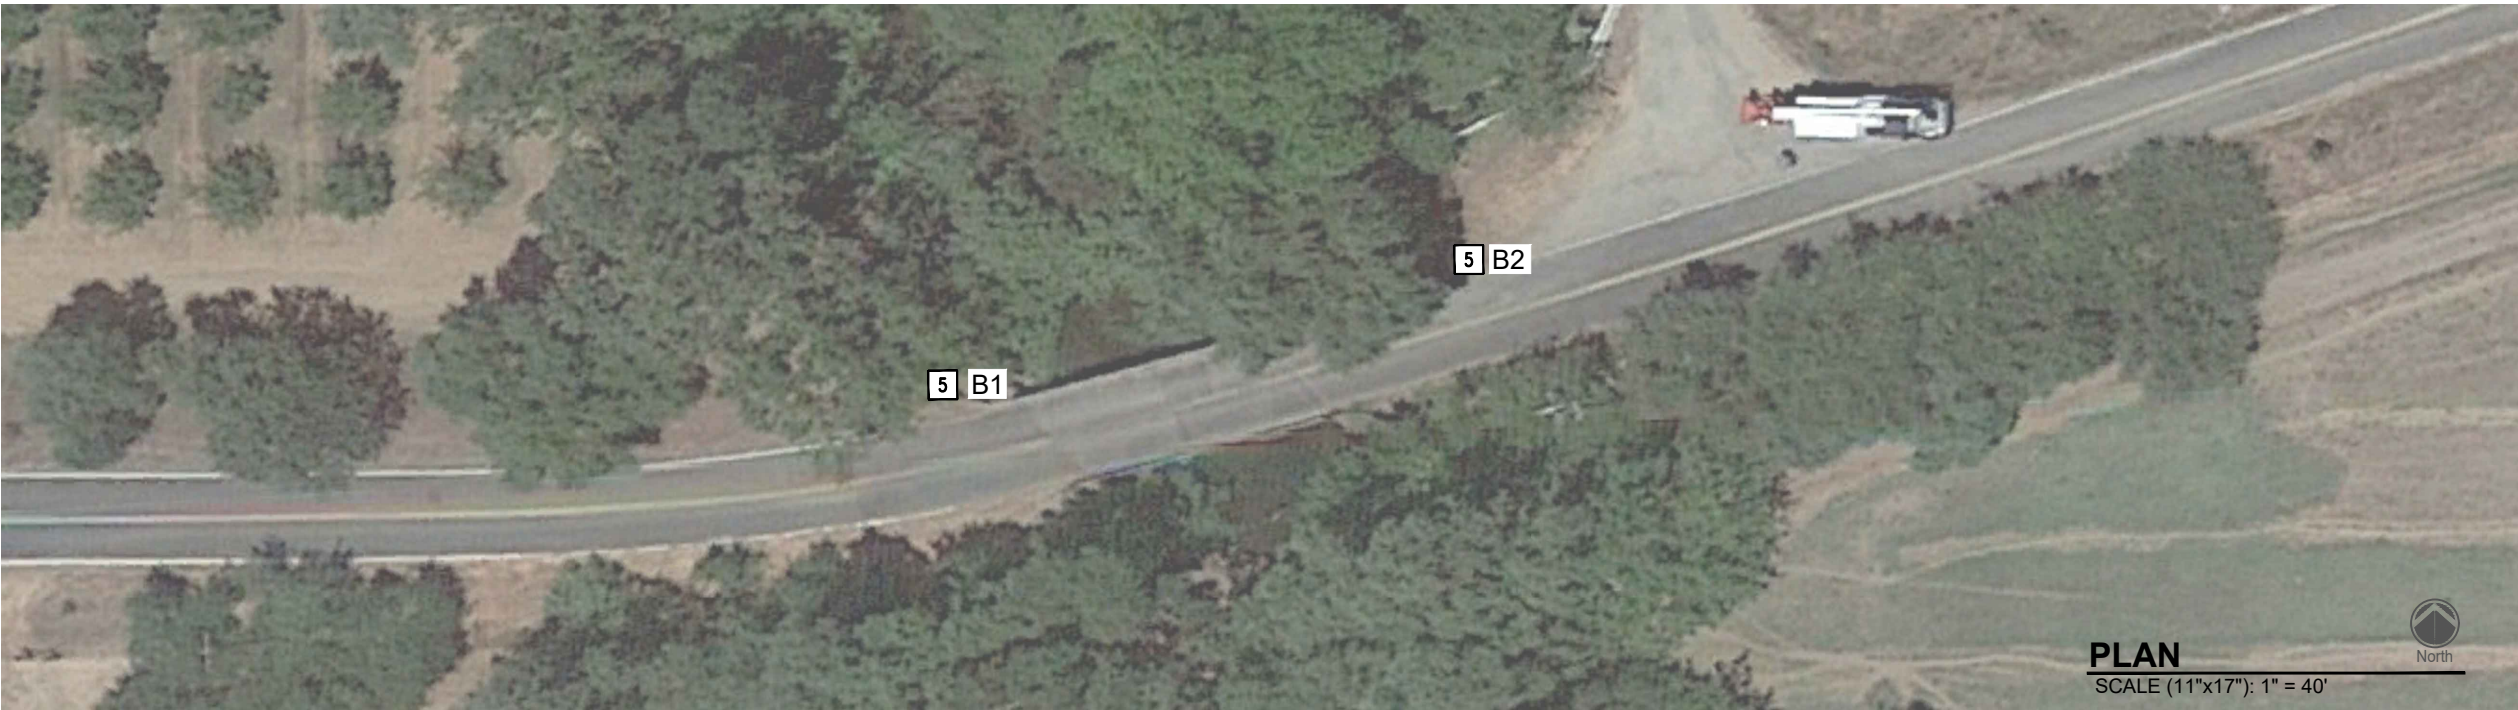
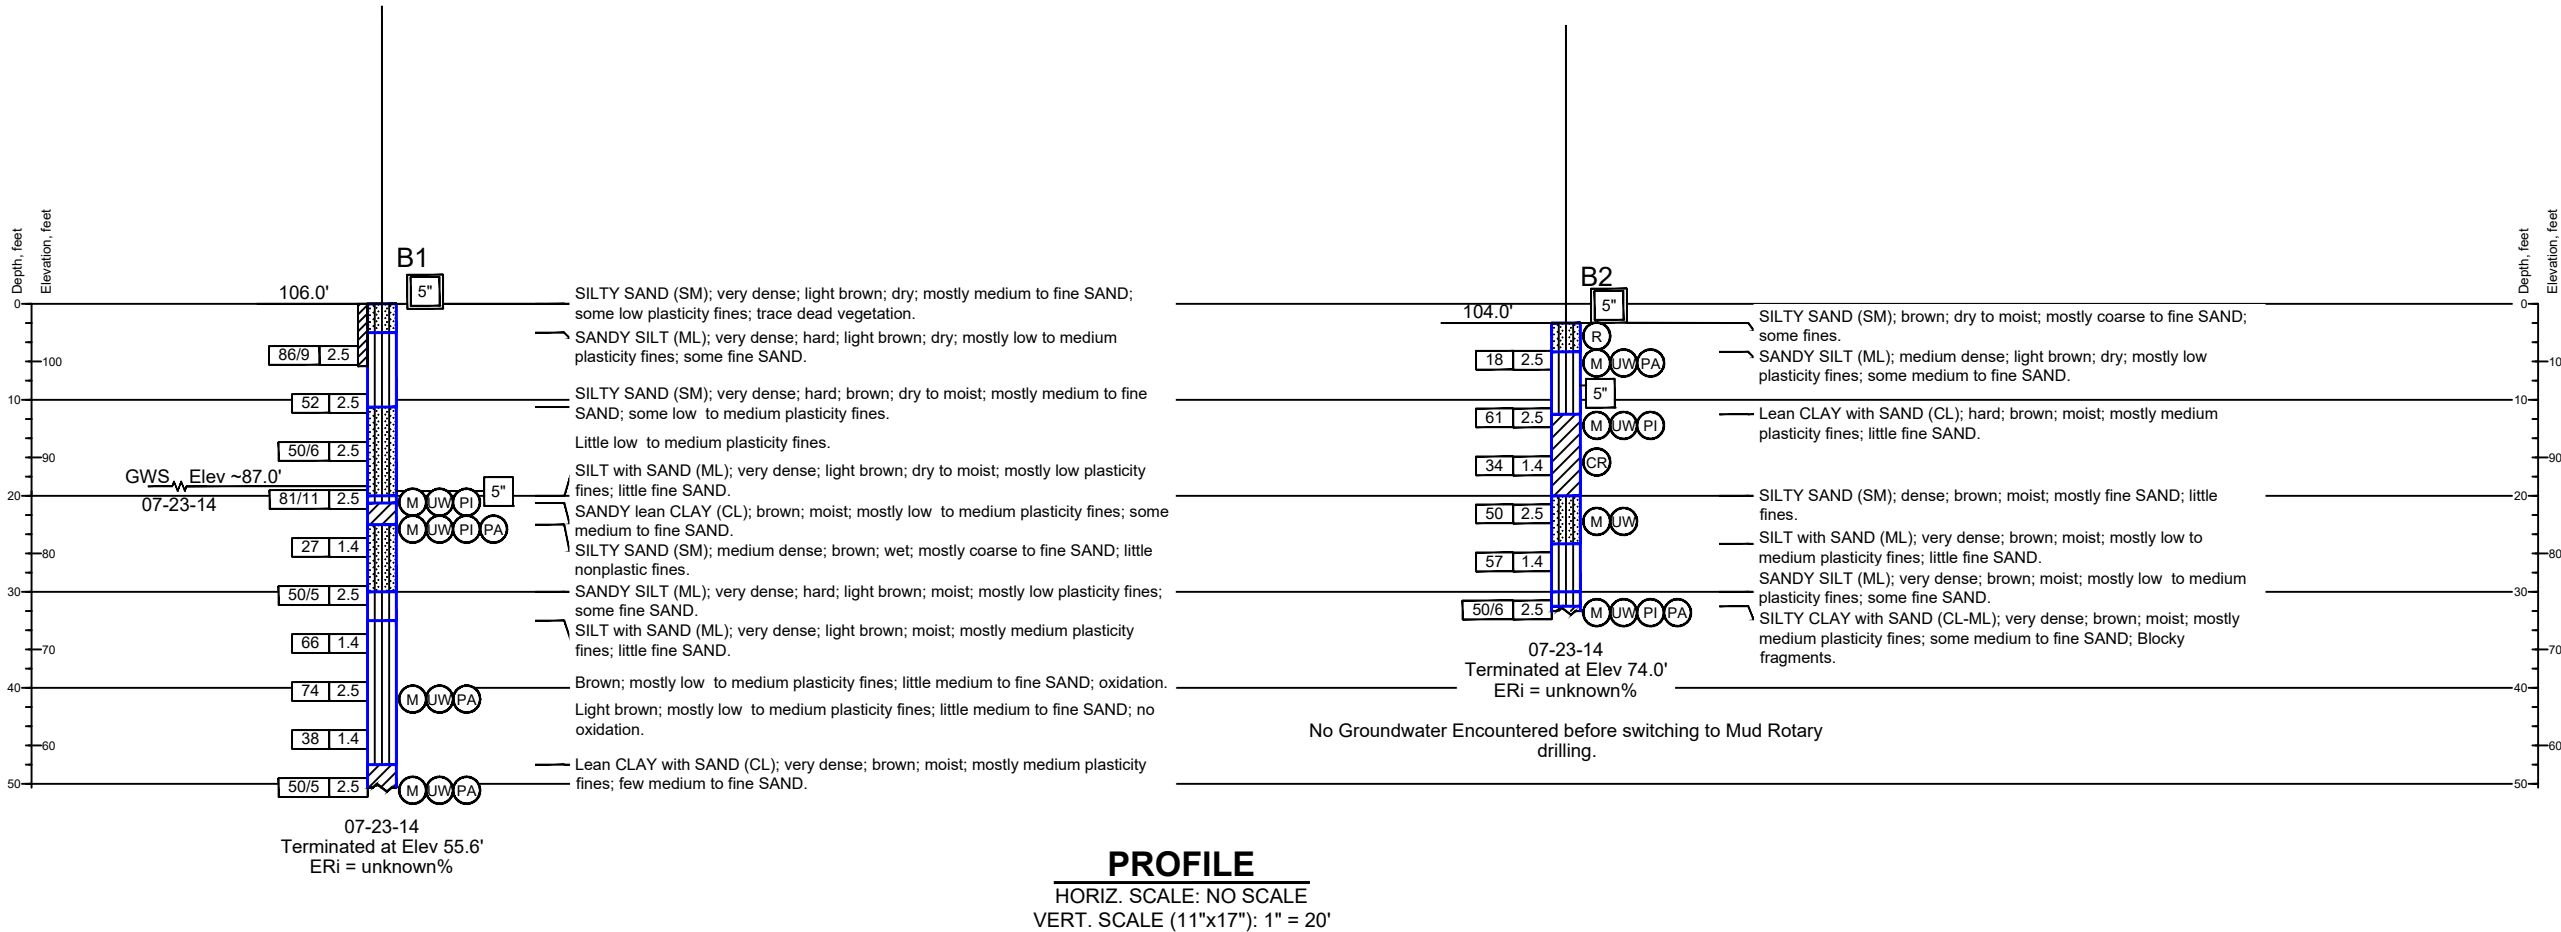
| FUNCTIONAL SUPERVISOR | | DRAWN BY: Logan Brown | | FIELD INVESTIGATION BY: Jonathan Wright/Shawn Leyva | | POST MILE<br>- | | PRELIMINARY LOG OF TEST BORINGS 1 of 5 | | | | | | | |

- Standard Penetration tests were performed in accordance with ASTM D 1586-99 using a hammer operated with an automated drop system. Drill rods were 1 5/8-inch diameter "A"-rods; sampler was driven with brass liners.

- "2.4 inch sampler": ID=2.4 inch, OD=2.9 inch. "2.0 inch sampler": ID=2.0 inch, OD=2.5 inch. Both driven in same manner as SPT ("1.4 inch") sampler.
- If laboratory tests are not shown as being performed, the soil descriptions presented on the LOTB are based solely on the visual practices described in this Manual.

In general, the two 1980 borings (at the existing bridge) indicated that the Messick Road Bridge site is underlain by loose sand and silty sand to approximately 8 to 14 feet below the bridge deck. The loose sand extends to approximately elev 98.5 (west) to 92.5 (center and east) feet. The upper 8 to 12 feet of this loose sand was abutment backfill and channel deposits, immediately adjacent the abutments. The two 2014 borings (within 40 feet of the existing bridge) indicated the loose sands extend from the ground surface to 2 to 3 feet bgs (approximately elev 102 to 103 feet). Underlying the near-surface loose sand, we encountered medium dense to very dense silty sand, hard sandy silt, and hard clay with sand to the maximum depth explored of 50 feet bgs (elev 56 feet).

The exploration locations, more detailed soil descriptions, and legends are shown on the attached LOTBs.

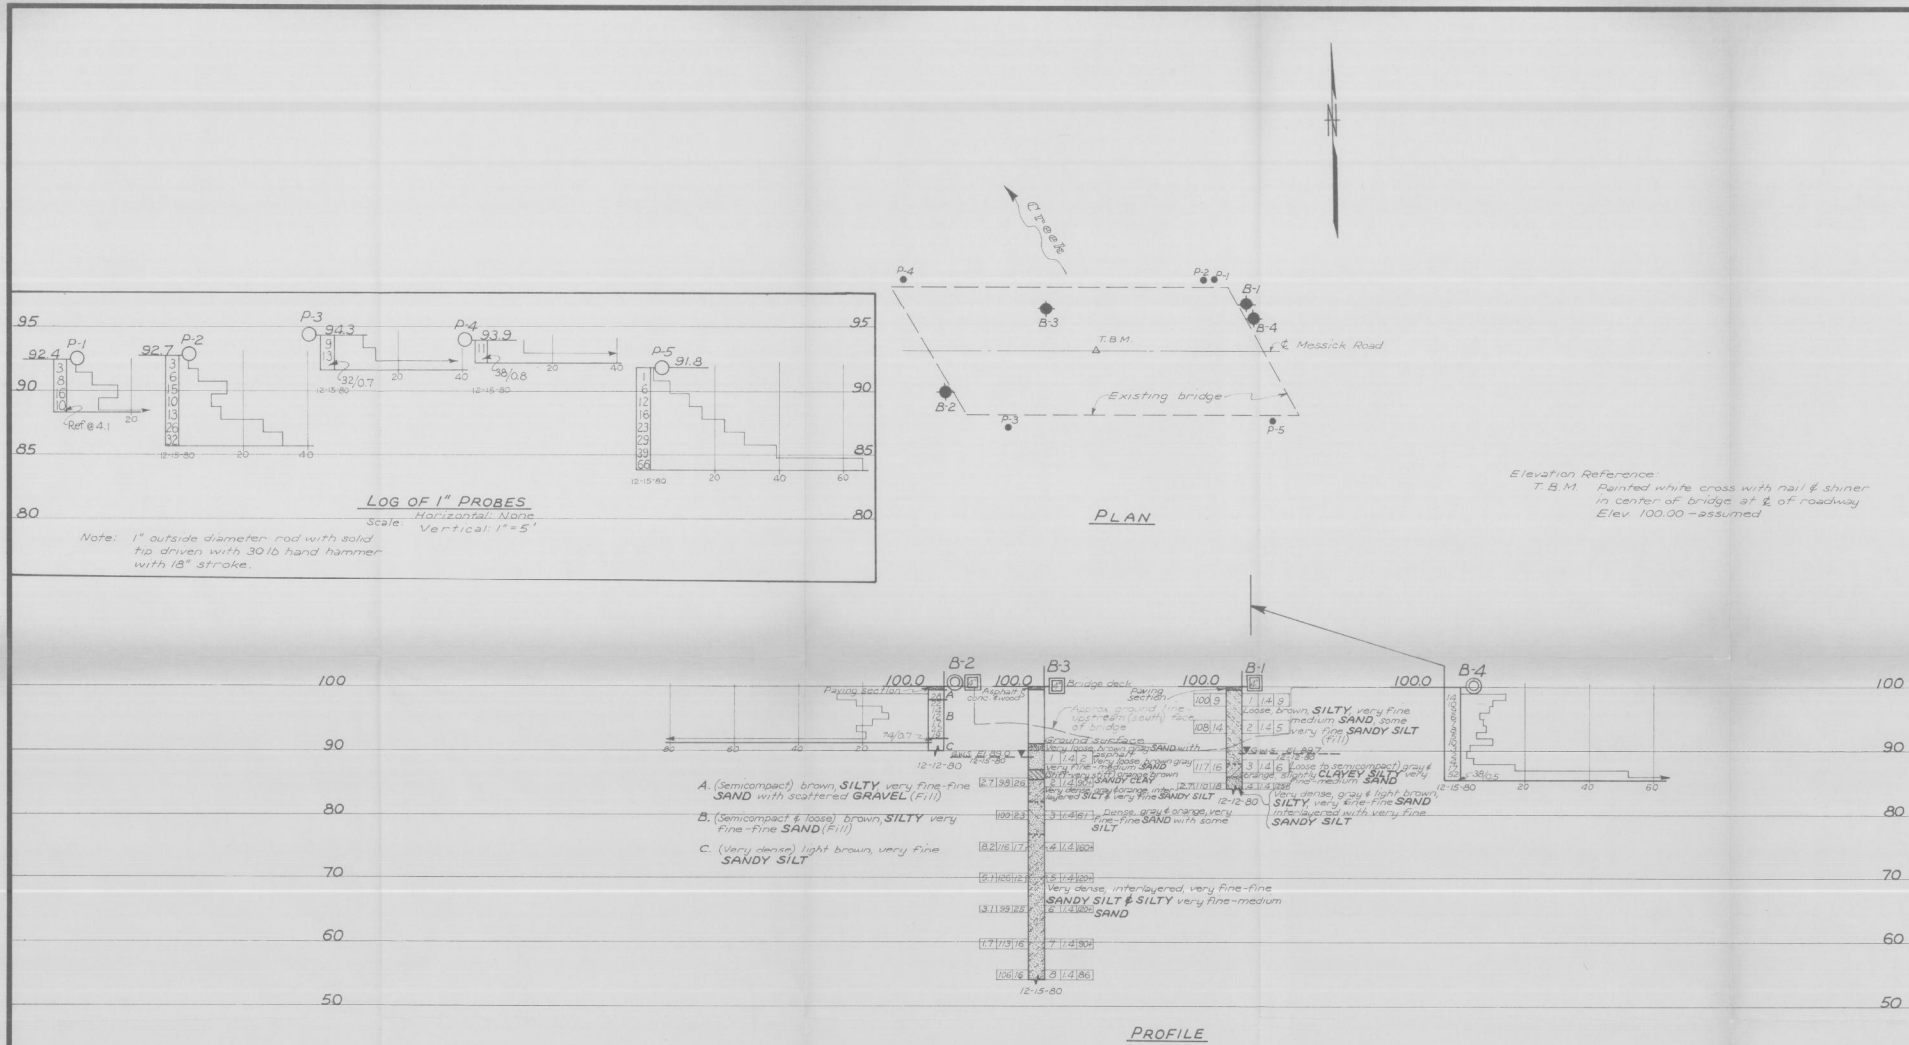
- This LOTB sheet was prepared in accordance with the Caltrans Soil & Rock Logging, Classification, and Presentation Manual (2010)
