# PHASE I ENVIRONMENTAL SITE ASSESSMENT

# 501 Ocean Bluff Way

Encinitas, California 92024

HILLMANN PROJECT NUMBER: C3-9327

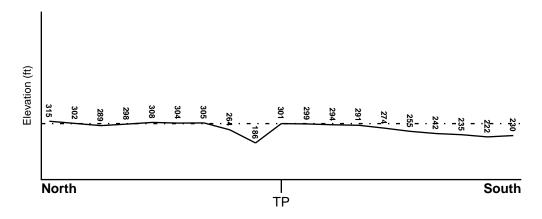
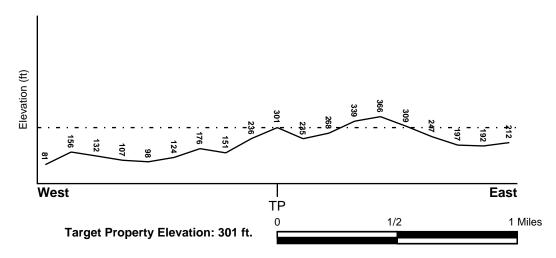
#### SURROUNDING TOPOGRAPHY: ELEVATION PROFILES

General Topographic Gradient: General West

Source: Topography has been determined from the USGS 7.5' Digital Elevation Model and should be evaluated on a relative (not an absolute) basis. Relative elevation information between sites of close proximity should be field verified.
