Draft Initial Study and Negative Declaration for the Slip-Out Repair and Bank Stabilization Near 1780 Higgins Canyon Road Project, San Mateo County, California

DECEMBER 2024

SWCA Environmental Consultants

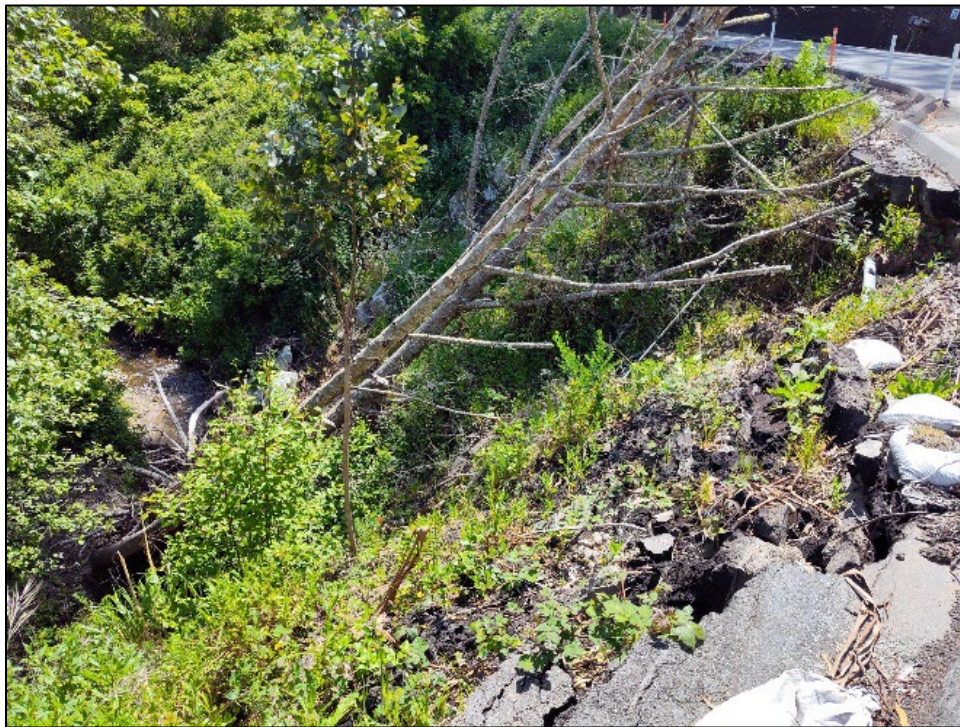
Figure 1-3. Existing Conditions: Overview of slip zone and creek, facing east.

The County of San Mateo Department of Public Works (County) is proposing a slip-out repair project near 1780 Higgins Canyon Road that would repair the damaged road and restore the bed and failed bank of Mills Creek. Landslides occurred in 2021 and 2022 and then worsened in 2023 near 1780 Higgins Canyon Road in unincorporated San Mateo County near the city of Half Moon Bay, California (Figures 1-1 and 1-2). The landslide area is approximately 115 feet long and extends downslope from the road surface approximately 28 feet. The landslide was likely due to the saturated slope materials in combination with erosion from elevated creek flows. The landslide has resulted in 12 to 24 inches of pavement failure along the outboard shoulder of the roadway (Figure 1-3).

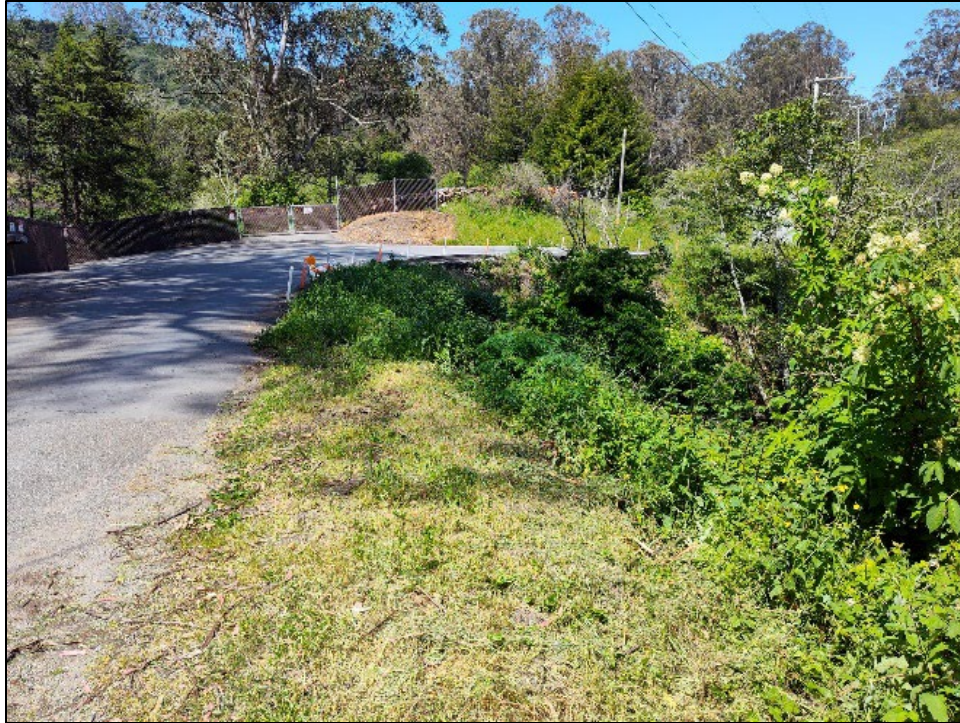
**Figure 2-1. View of current conditions of the road and slip, facing west.
Photo taken May 1, 2024.**

The project work would occur in Mills Creek adjacent to the roadway and on the roadway itself. Mills Creek is a heavily vegetated corridor adjacent to Higgins Canyon Road in the project area (Figures 2-1 through 2-3). The project would require the removal of 10 existing trees as well as vegetation in the creek and on the banks of the area to be repaired. As discussed in Section 1.4, *Project Restoration/Revegetation Plan*, the banks of Mills Creek above the OHWM would be revegetated with native species found both upstream and downstream of the project area, including trees planted as live pole plantings in the revetments (see Figure 1-5). The revegetated area would be visible at first, but riparian growth would quickly fill in the corridor after construction. The work in the roadway would restore the slip-out area and repave the portion of road in the project area, add a gravel shoulder and guard rail. The new roadway, gravel shoulder, and guard rail would be visible but visually consistent with the rest of the roadway. The finished roadway would not appear appreciably different than the roadway on either side of the repair. Therefore, the project would not substantially damage scenic resources and this impact would be less than significant.

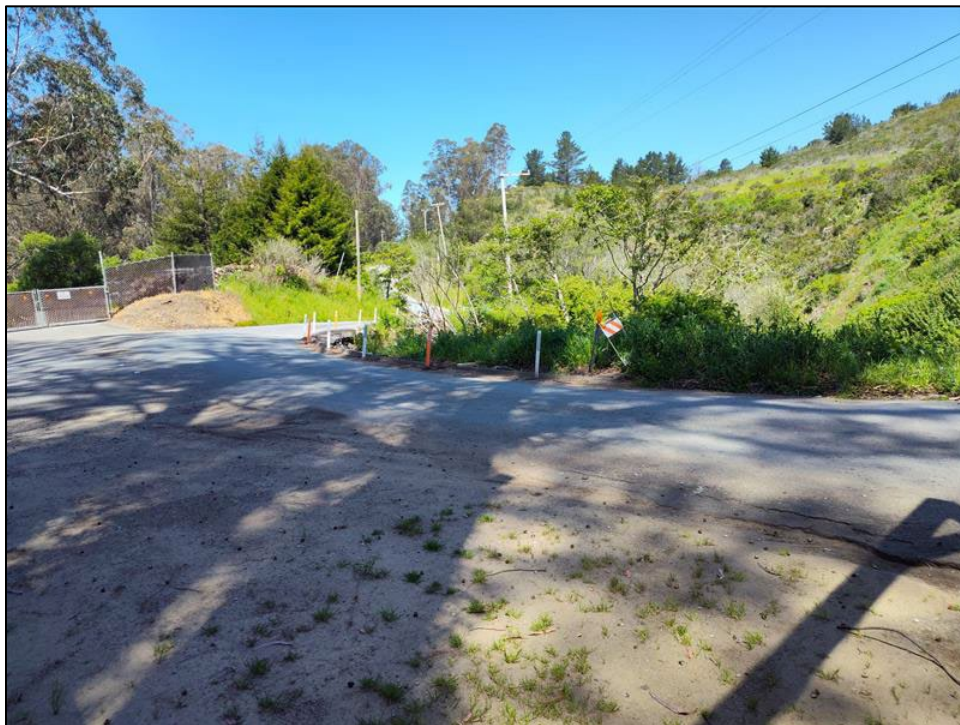
**Figure 2-2. View from the east border showing western approach, facing west.
Photo taken May 1, 2024.**

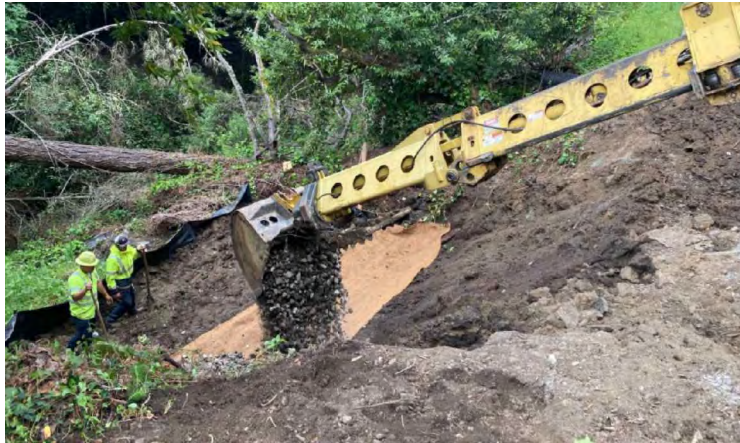
- STEP 1** : EXCAVATE TO GRADES REQUIRED
STEP 2 : INSTALL LIVE POLE PLANTING TUBE
STEP 3 : INSTALL UNIVERSAL GRAVEL FILTER (NOTE: PHOTO INCLUDES A COIR BLANKET AT SOIL INTERFACE WHICH IS NOT REQUIRED)

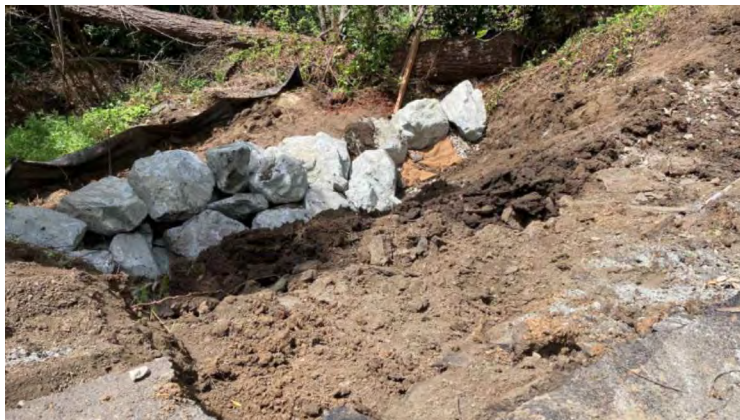
- STEP 4** : INSTALL INNER REVETMENT LAYER UP NO MORE THAN 5 VERTICAL FEET
STEP 5 : INSTALL VEGETATED BOULDER REVETMENT LAYER UP TO EXTENT OF INNER REVETMENT LAYER INTERLOCKING WITH INNER REVETMENT LAYER

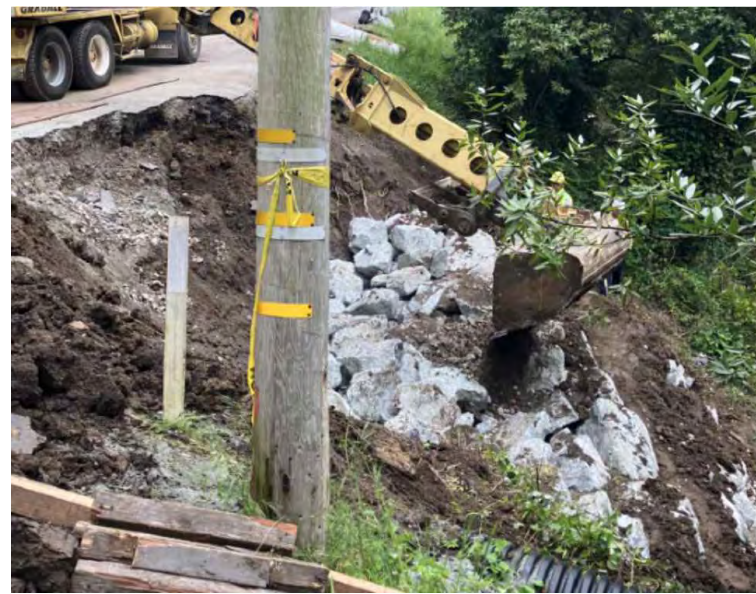
- STEP 6** : BACKFILL VOIDS OF VEGETATED BOULDER REVETMENT WITH ENGINEERED REVETMENT FILL

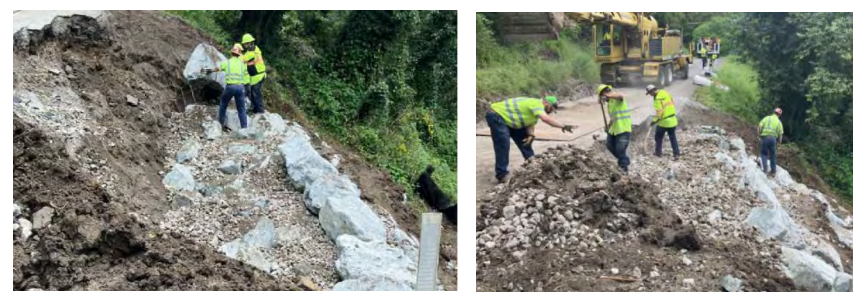
- STEP 7** : CONTINUE INNER REVETMENT LAYER AND VEGETATED BOULDER REVETMENT INSTALLATION 5 VERTICAL FEET AT A TIME, BACKFILLING THE VEGETATED BOULDER REVETMENT VOIDS AS WORK PROGRESSES

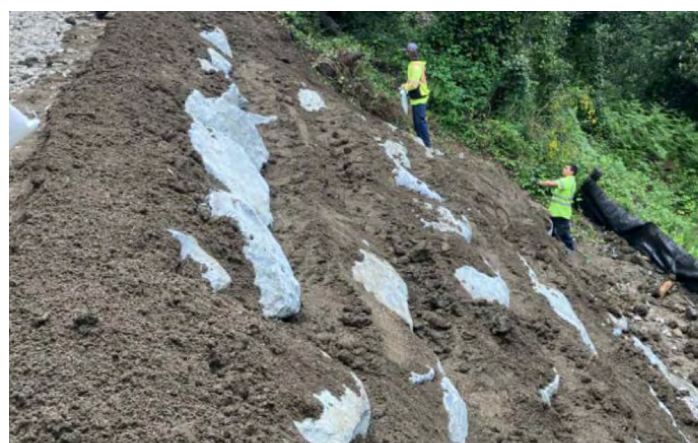
- STEP 8** : PLACE TOPSOIL LAYER OVER VEGETATED BOULDER REVETMENT LAYER

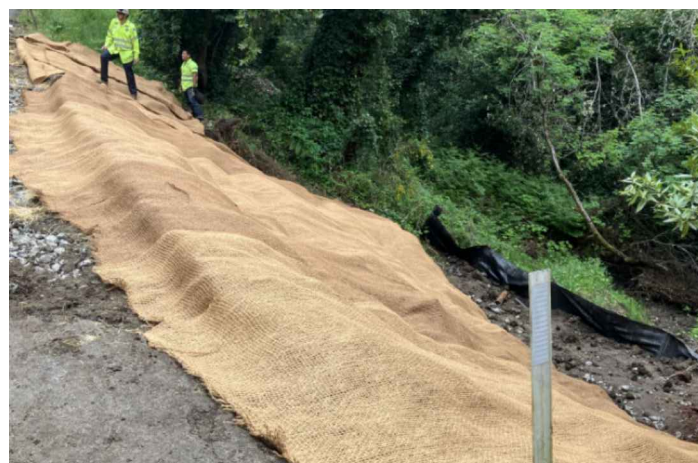
- STEP 9** : PLACE BIODEGRADABLE FABRIC OVER FINAL GRADE

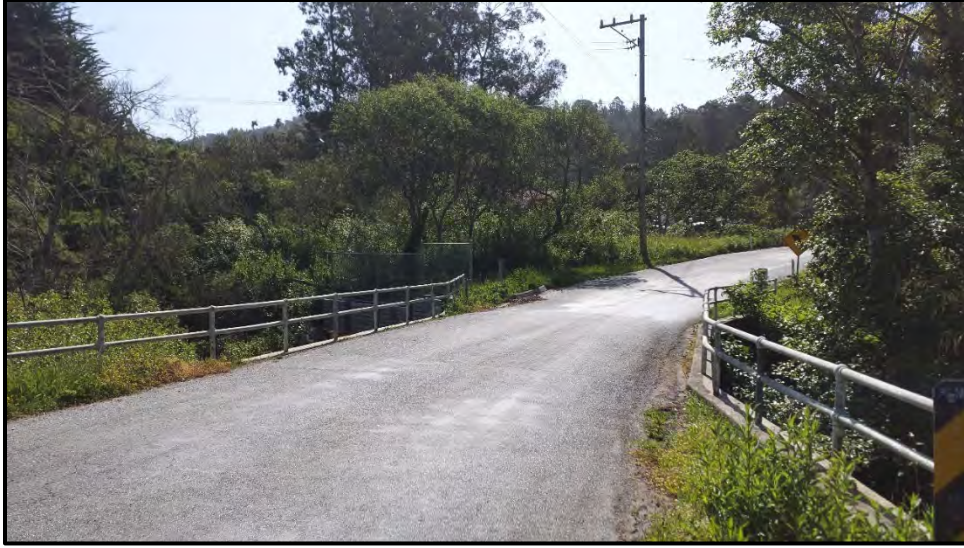
Photograph A-1. Higgins Canyon Road bridge over Mills Creek just outside of the project area; view facing southeast. Photograph taken May 2, 2024.

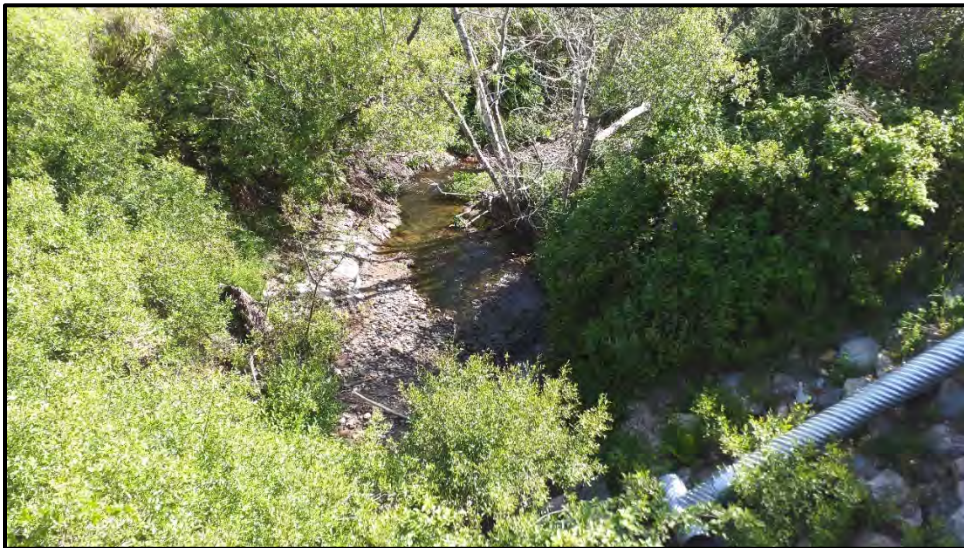
Photograph A-2. Mills Creek from atop Higgins Canyon Road bridge; view facing upstream (east). Photograph taken May 2, 2024.

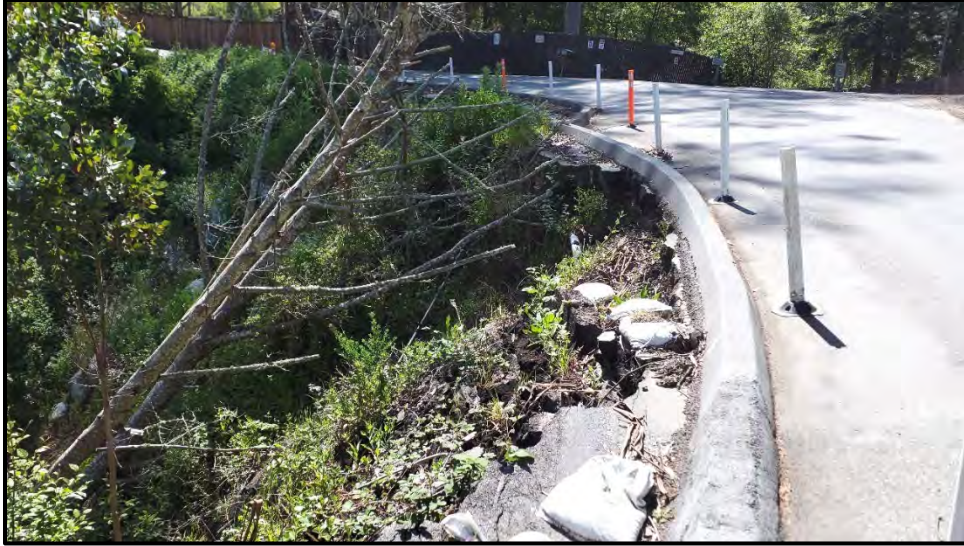
Photograph A-3. Slide along north shoulder of Higgins Canyon Road; view facing southeast. Photograph taken May 2, 2024.

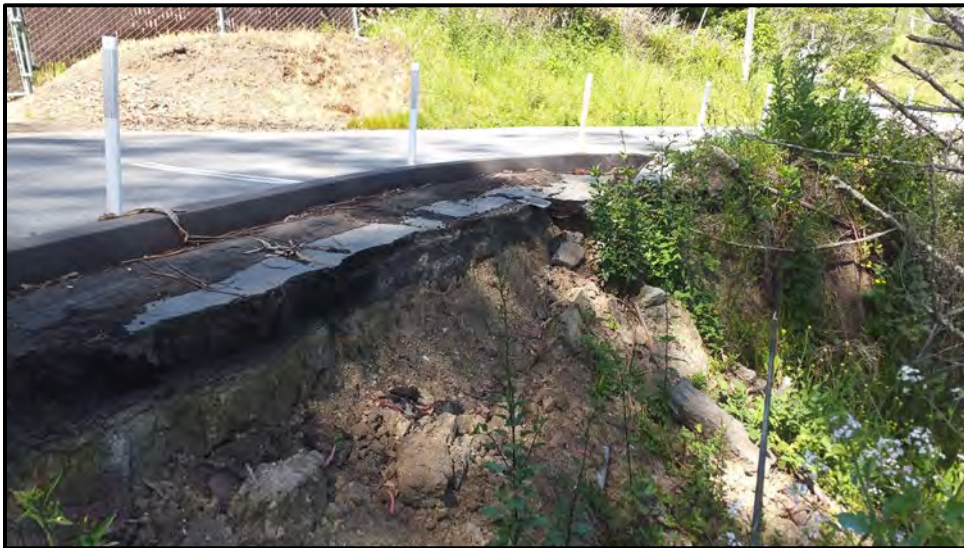
Photograph A-4. Slide along north shoulder of Higgins Canyon Road; view facing west. Photograph taken May 2, 2024.

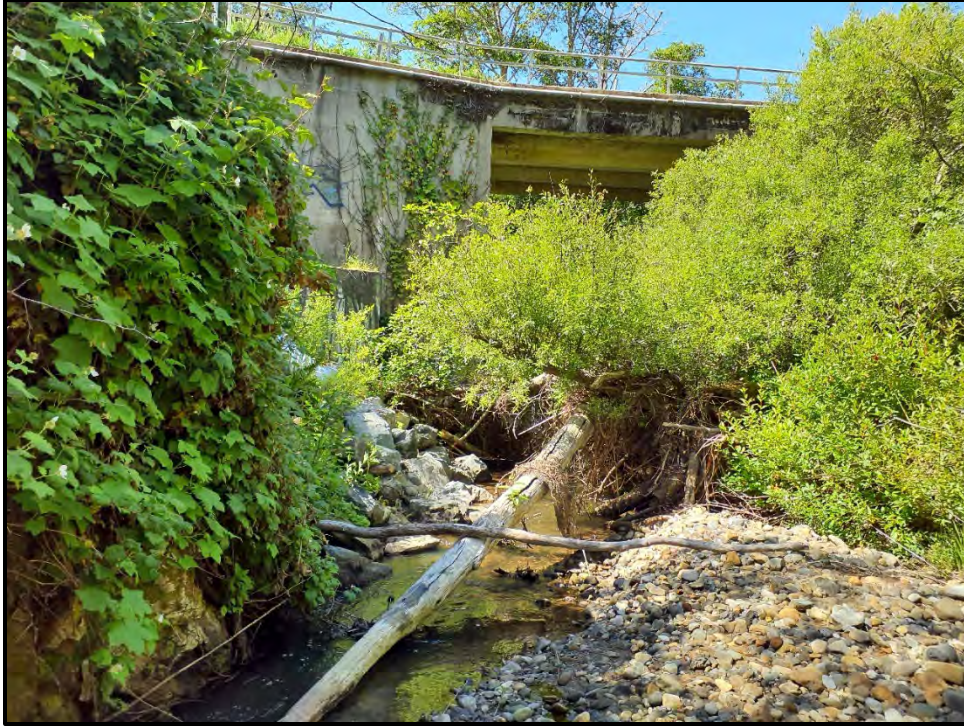
Photograph A-5. Higgins Canyon Road bridge over Mills Creek; view facing west. Photograph taken May 2, 2024.

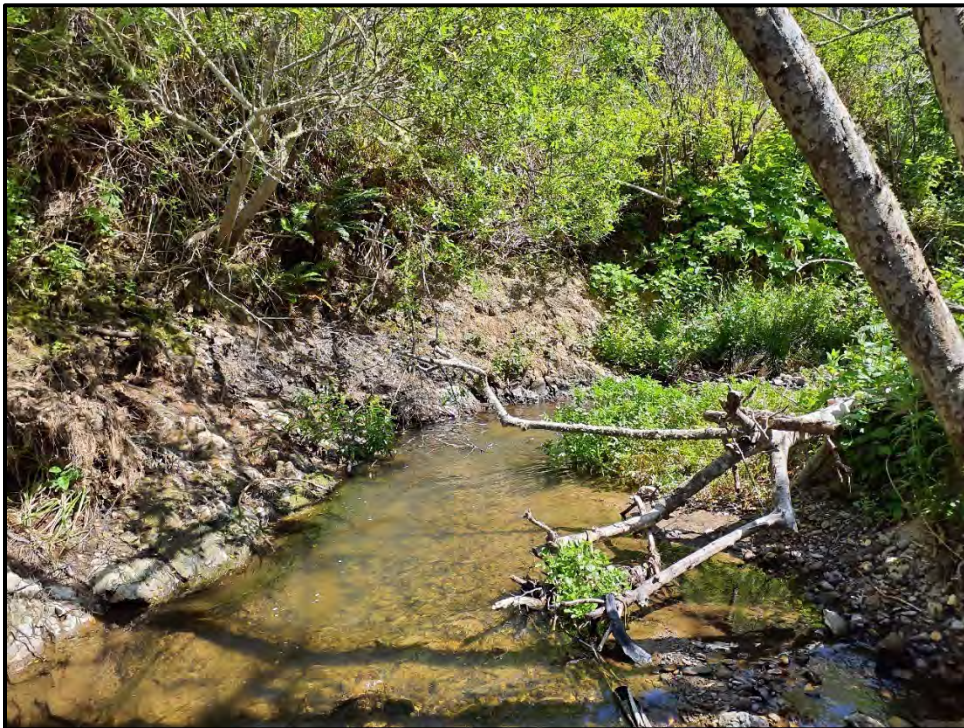
Photograph A-6. Mills Creek stream channel near the northern end of the project area; view facing upstream (northeast). Photograph taken May 2, 2024.

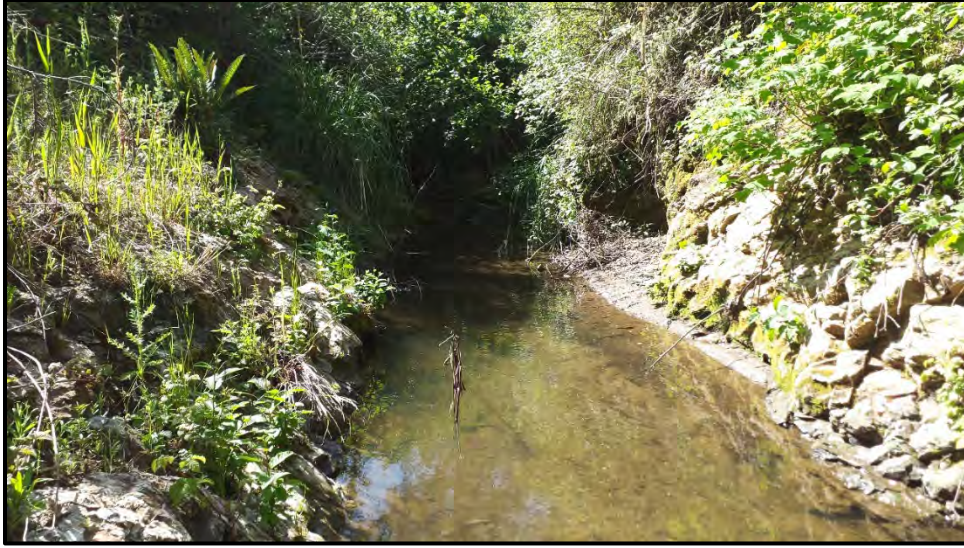
Photograph A-7. Mills Creek stream channel along the northwestern edge of the project area; view facing southeast. Photograph taken May 2, 2024.

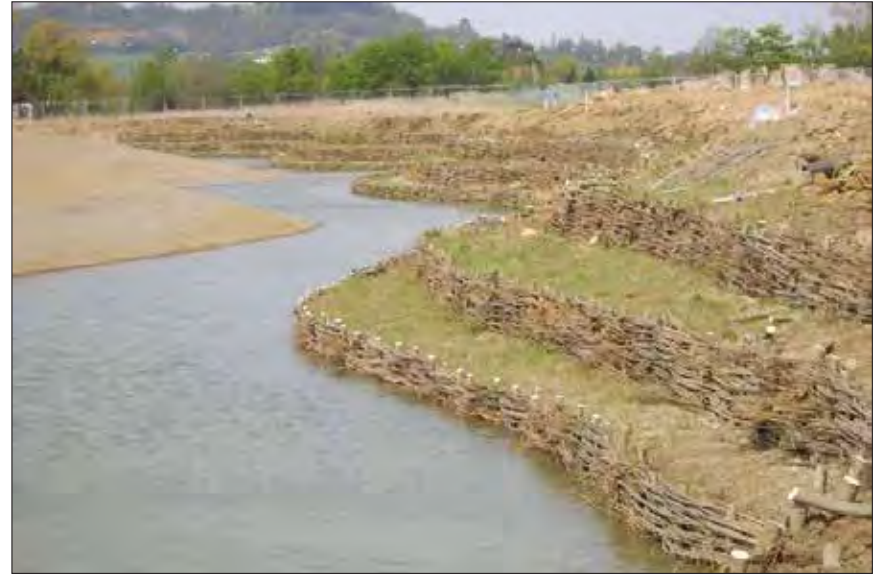
*THESE ARE FOR CONCEPTUAL PURPOSES ONLY. LOG DIAMETER/LENGTH, EMBEDMENT DEPTH, AND NUMBER/TYPE OF CONNECTORS ARE DEPENDENT UPON SITE CONDITIONS AND ENGINEERING SPECIFICATIONS.

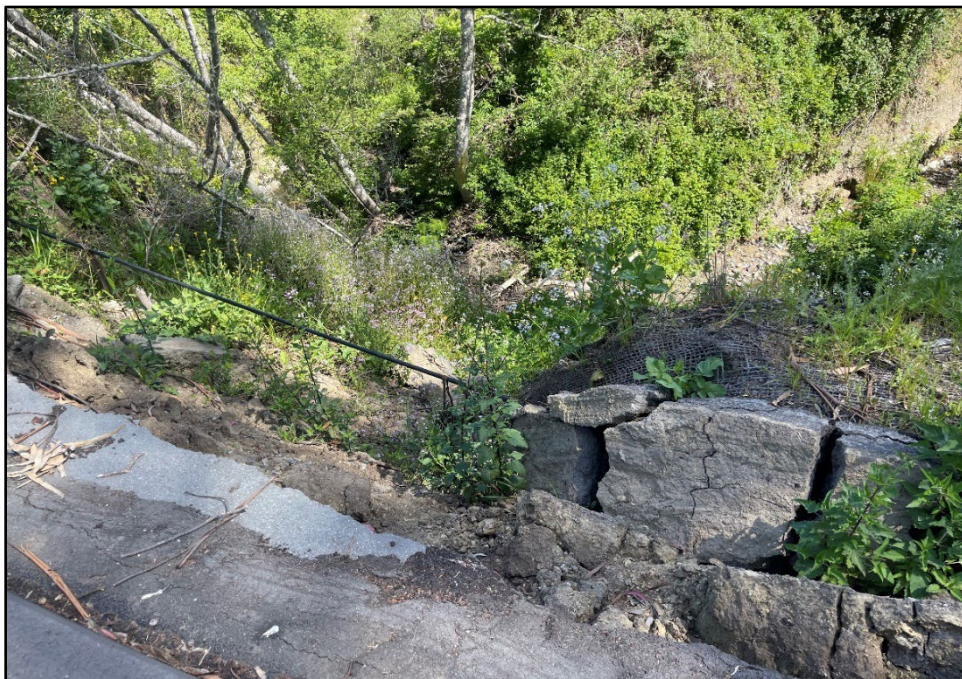
Photograph A-2. Location of the slip-out within the survey area; view facing north. Photograph taken May 2, 2024.

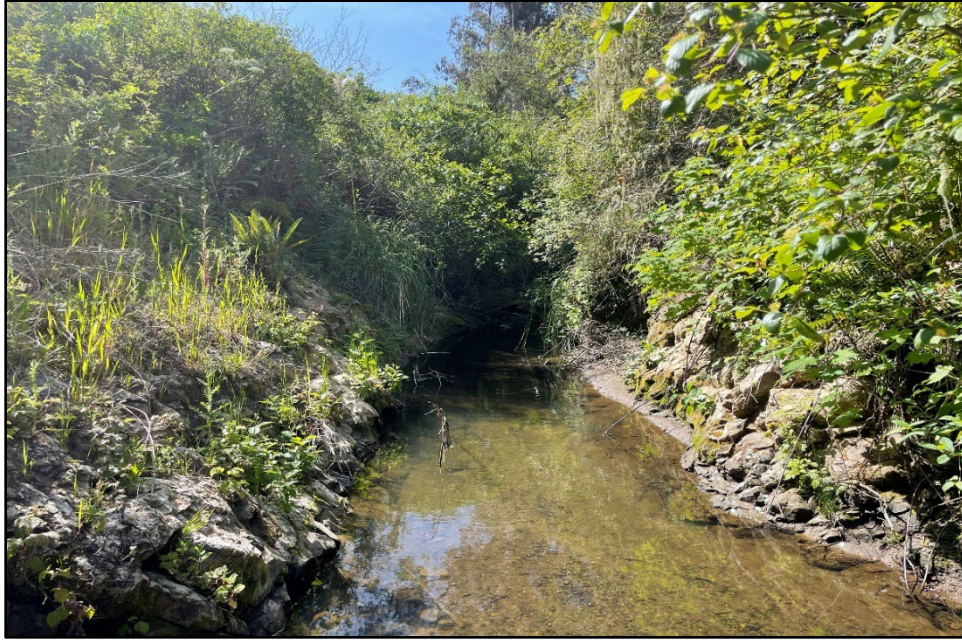
Photograph A-3. Representative conditions within the Mills Creek stream channel; view facing southeast. Photograph taken May 2, 2024.

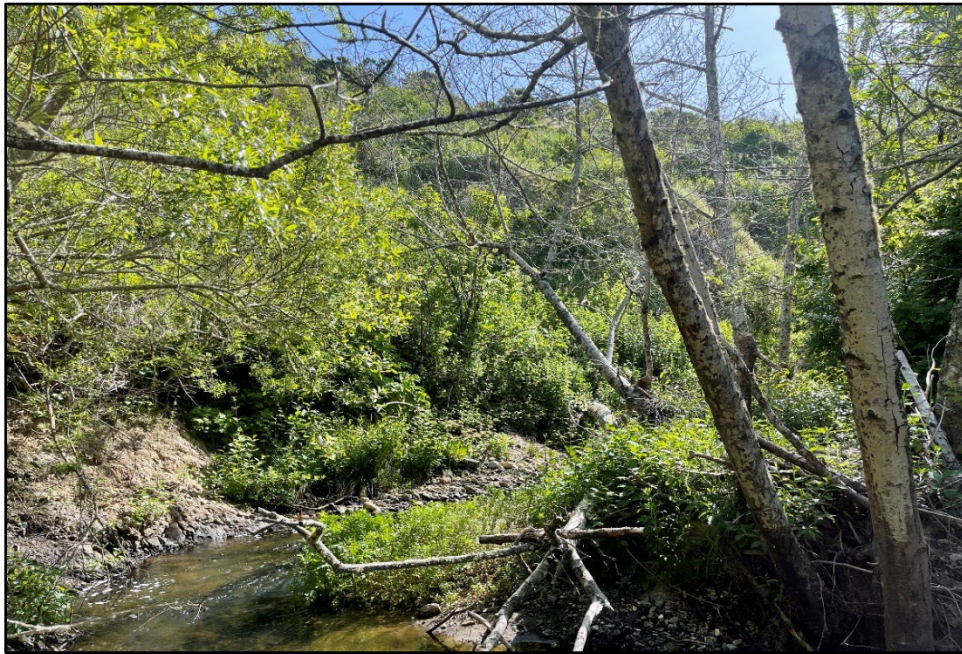
Photograph A-4. Representative conditions in the Mills Creek stream channel; view facing northeast. Photograph taken May 2, 2024.

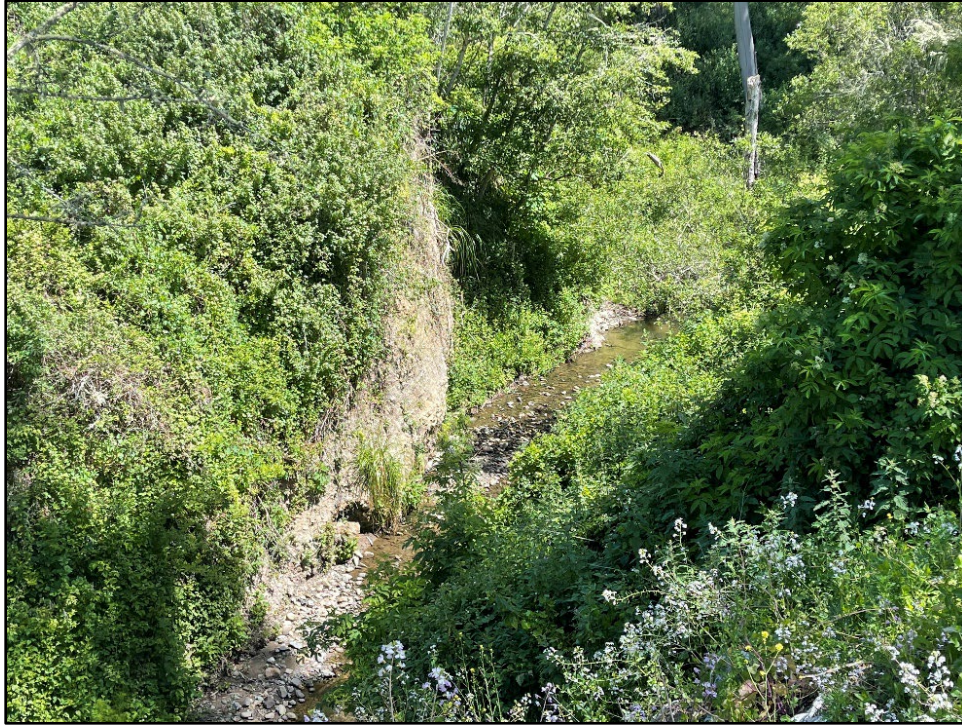
Photograph A-5. Steep incising on Mills Creek stream channel; view facing northeast. Photograph taken May 2, 2024.

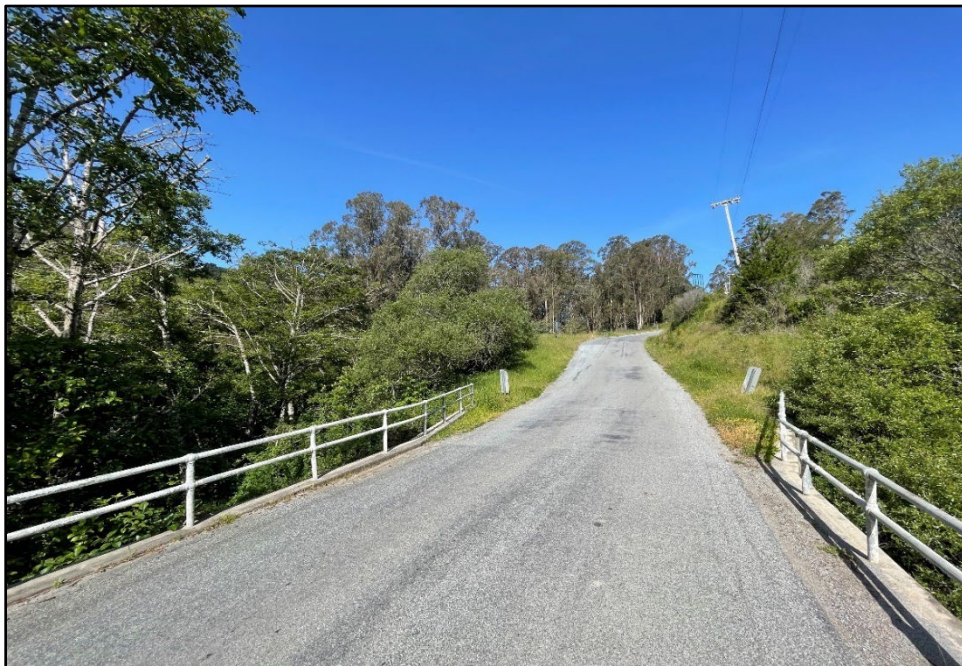
Photograph A-6. Higgins Canyon Road bridge, riparian canopy, and ruderal disturbed vegetation along the road margins within the survey area; view facing northwest. Photograph taken May 2, 2024.

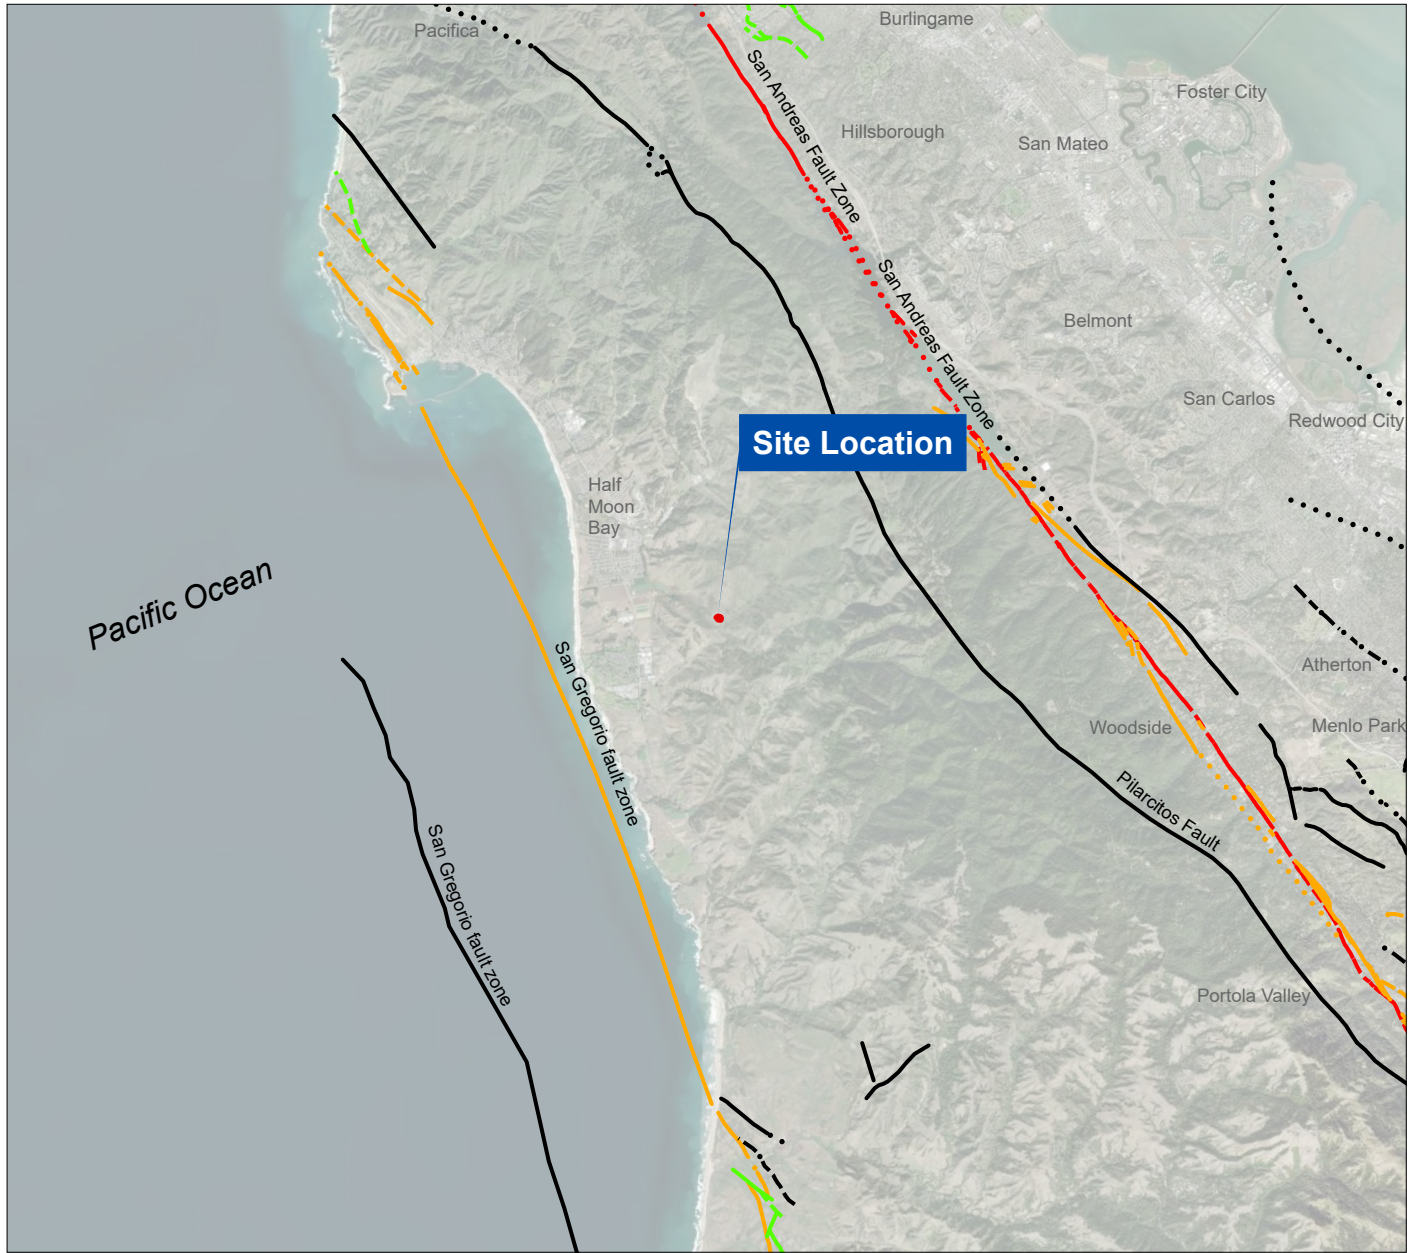
FIGURE 3

1. FAULT LOCATIONS FROM US GEOLOGICAL SURVEY QUATERNARY FAULTS AND FOLDS DATABASE, ACCESSED ONLINE ON 30 JULY 2021.

The geologic setting is shown on the Regional Geology Map, Figure 3.

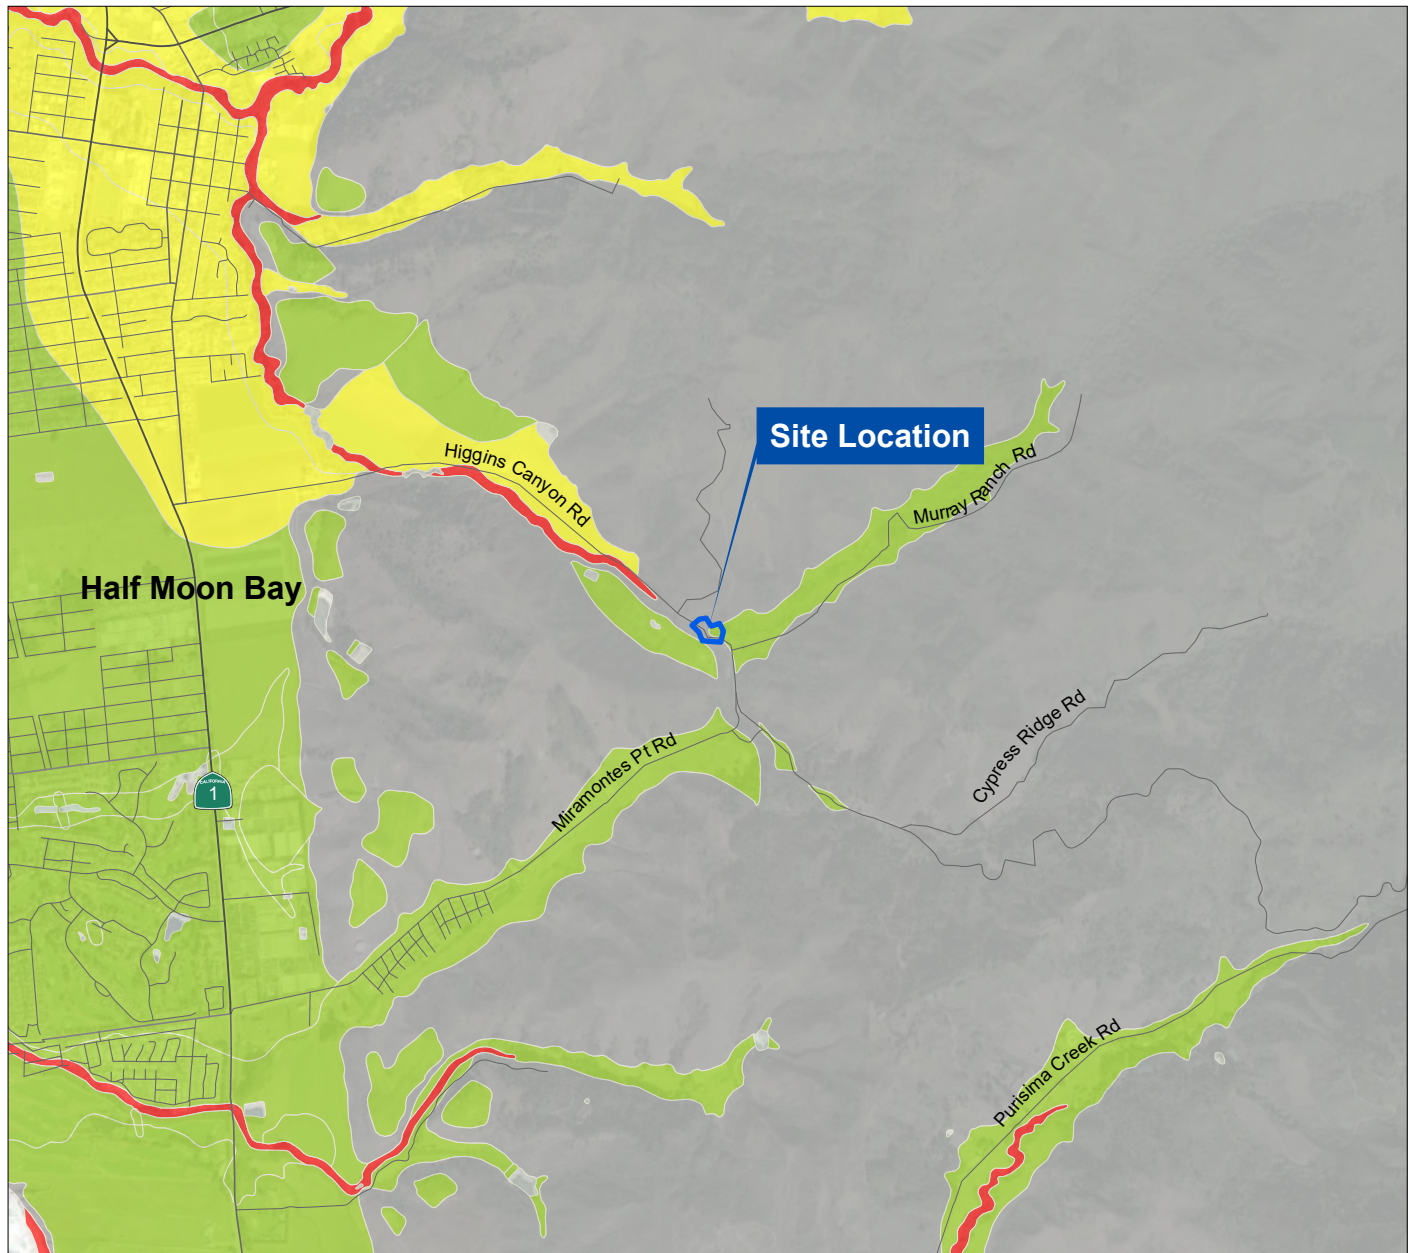
FIGURE 5

1. RELATIVE LIQUEFACTION SUSCEPTIBILITY FROM WITTER (2006).

Witter and others (2006) have generated a map showing liquefaction susceptibility for the San Francisco Bay Area with a 5-class scale that includes very low (essentially in bedrock areas), low, moderate, high, and very high liquefaction susceptibility classes. Witter and others (2006) map the soil underlying the project site as having very low to low liquefaction susceptibility (Figure 5).

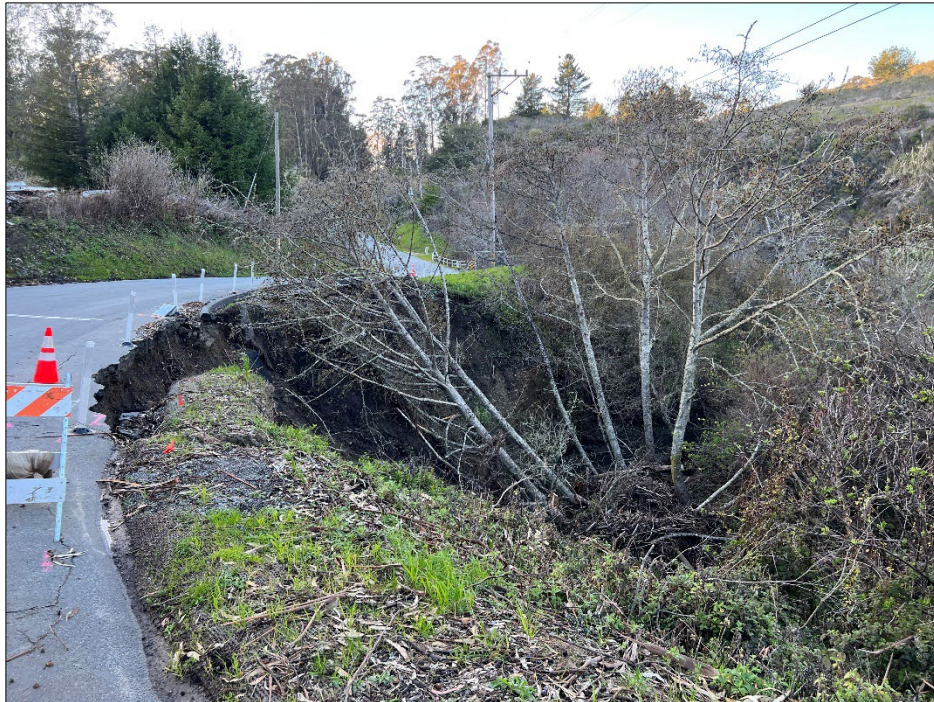
Photo 1: Northwest-facing view of the slip-out area. The photo was taken on March 8th, 2023.

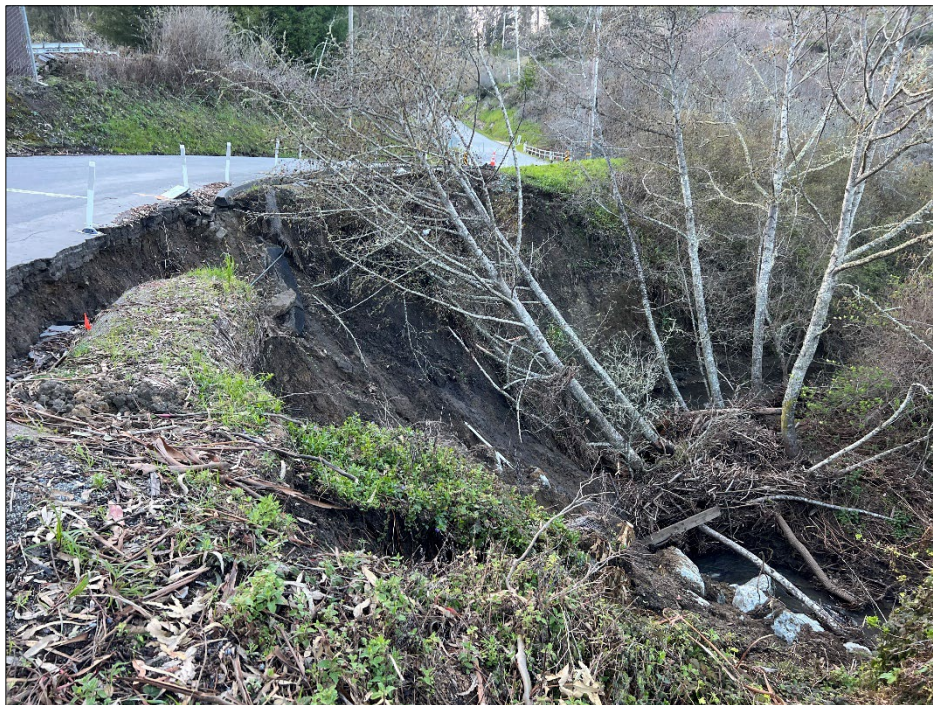
Photo 2: West-facing view of the slip-out area. The photo was taken on March 8th, 2023.

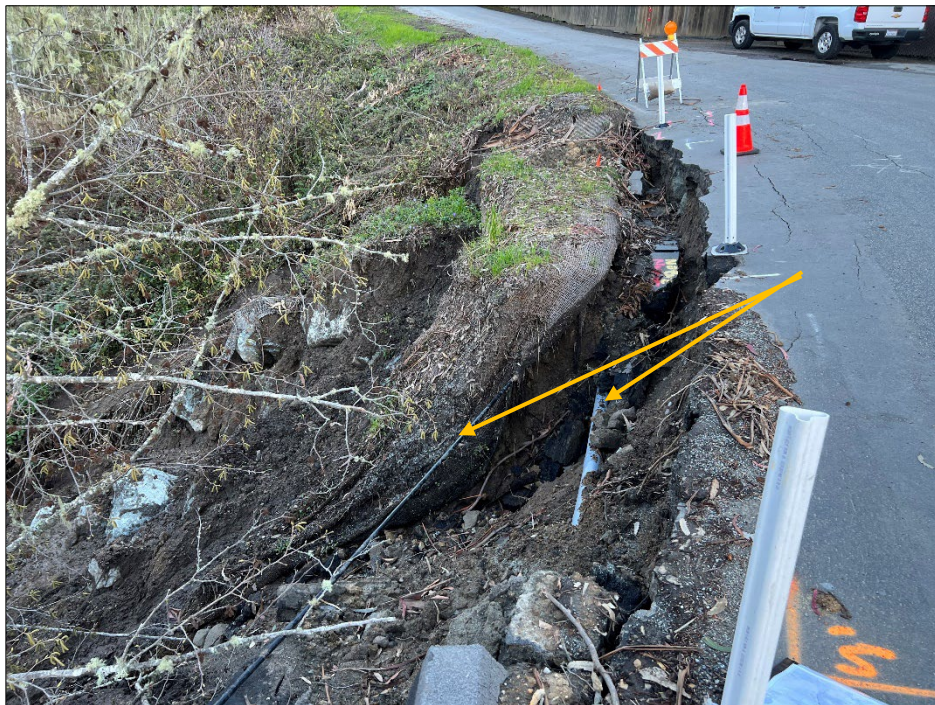
Photo 4: East-facing view of the slip-out area. Note the two exposed utility lines in the scarp area. The photo was taken on March 8th, 2023.

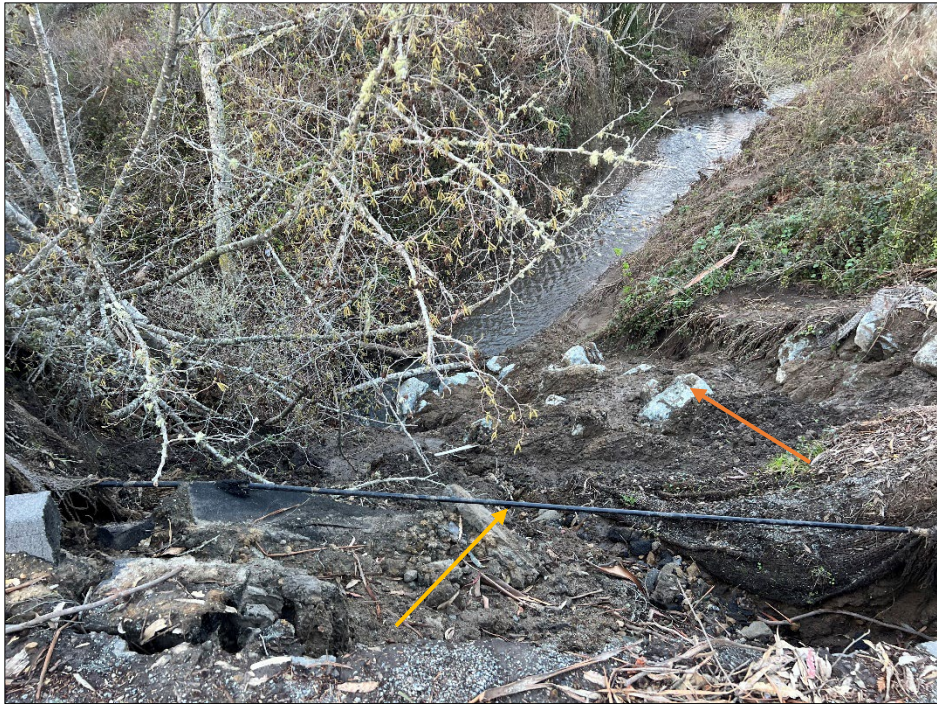
Photo 5: Northeast-facing view of the slip-out area. Note the exposed utility line (see yellow arrow). Also note exposed riprap in slope fill (orange arrow). The photo was taken on March 8th, 2023.

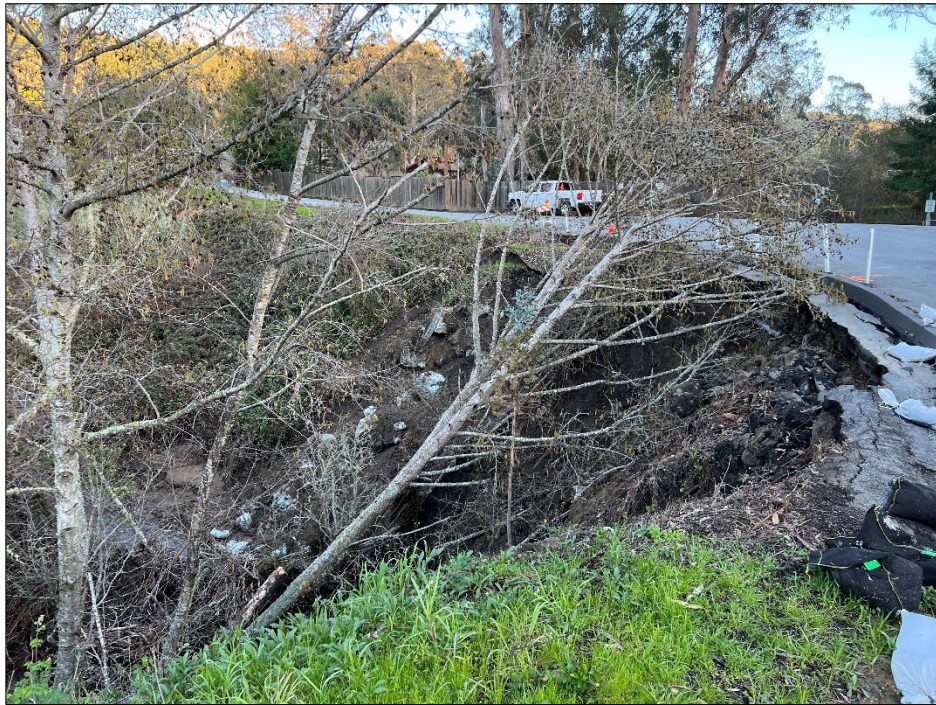
Photo 6: Southeast-facing view of the slip-out area. The photo was taken on March 8th, 2023.

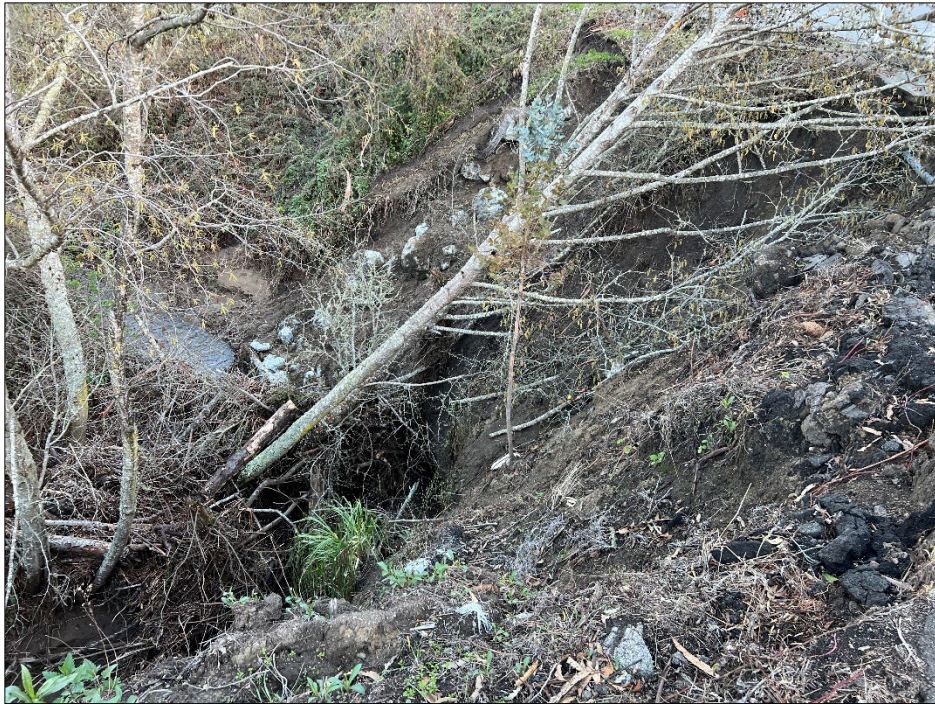
Photo 7: East-facing view of the slip-out area. The photo was taken on March 8th, 2023.

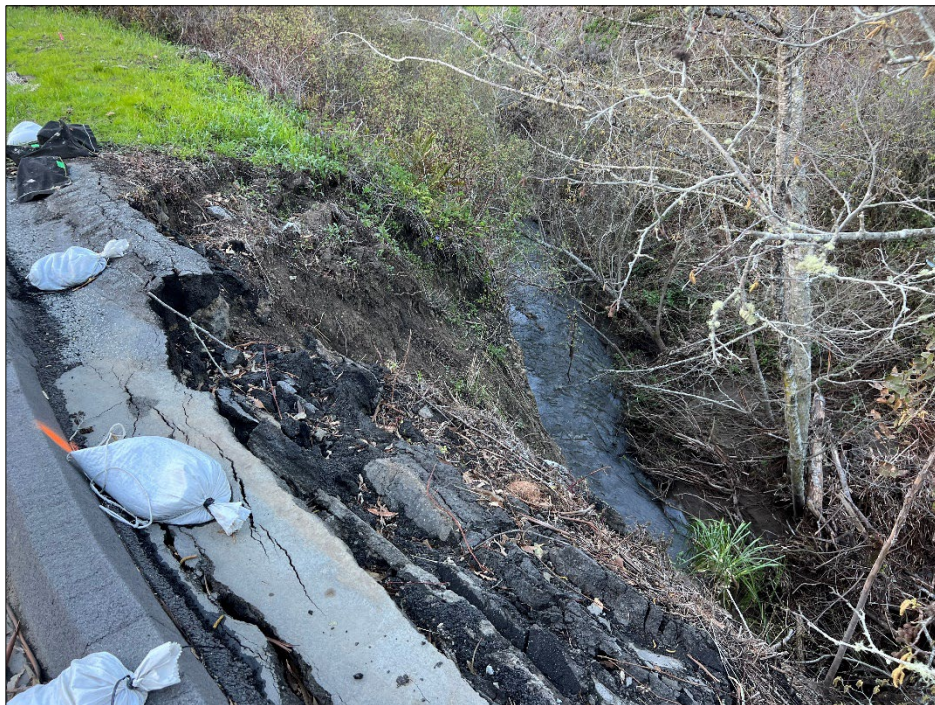
Photo 8: Northwest-facing view of the slip-out area. The photo was taken on March 8th, 2023.
