March 3, 2023 (Revised March 29, 2024)

Landslide Hazard Evaluation  
230 Long Ranch Road LLC Vineyard Development  
230 Long Ranch Road  
St. Helena, California

Project Number: 7512.02.09.2

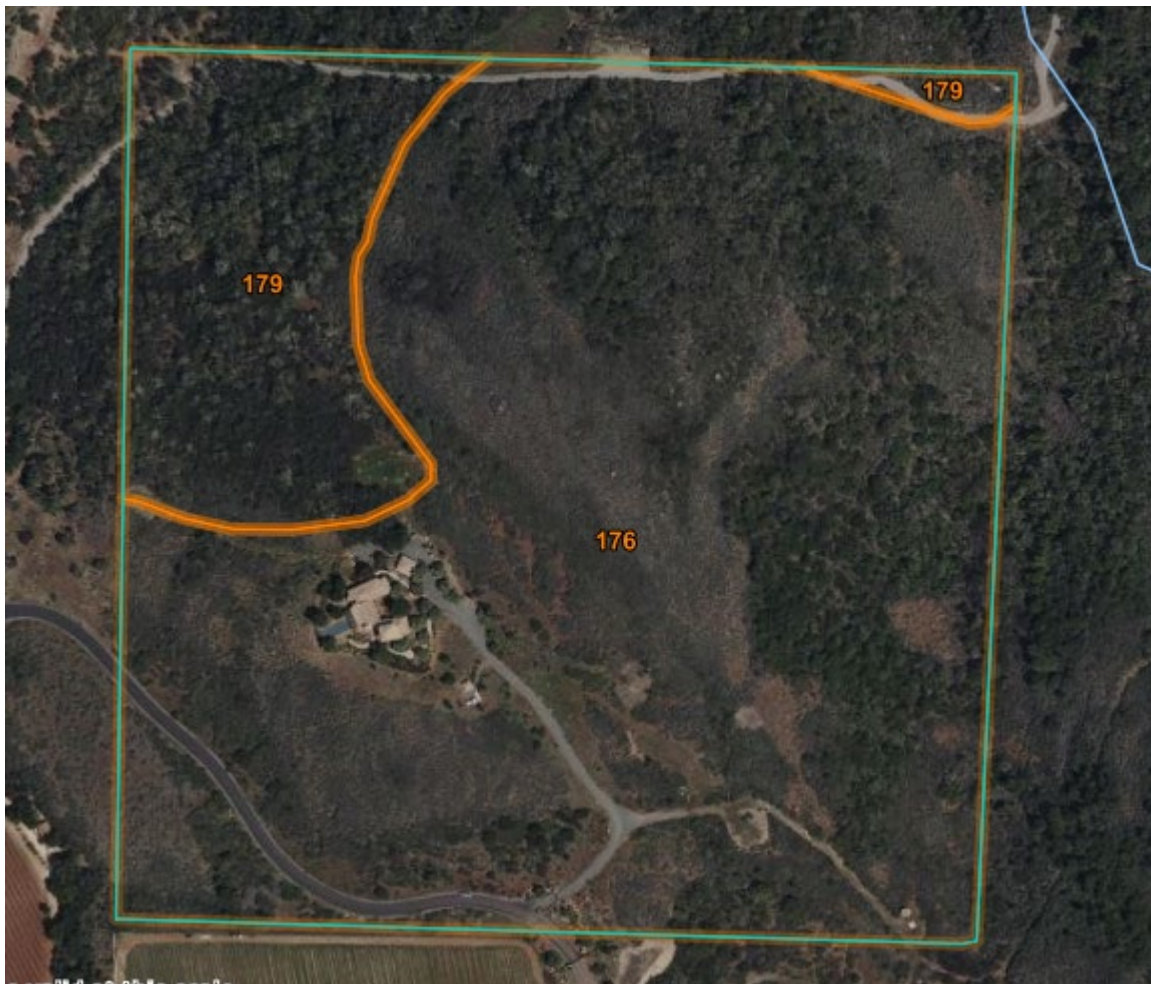
Based on our geologic review we compiled the image and table below indicating the soil types and depth of materials. This information was collected from the NRCS Web Soil Survey listed above.
