# Amazon San Jose Arborist Report

September  
2020

This report was prepared to evaluate all trees on the property, located throughout the project site at 1605 S 7th Street, San Jose California. The surveyed area is based on documents provided by the aforementioned client, including the site development plans.

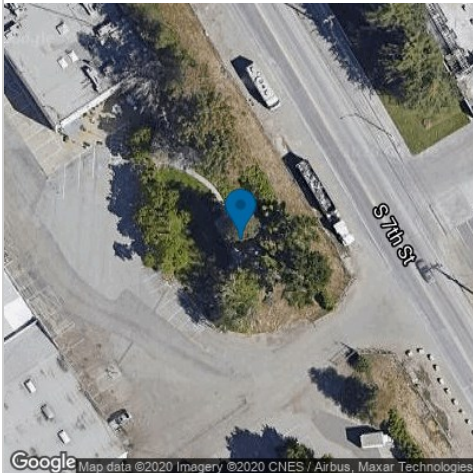
Redwood ID# 10  
Redwood  
Height: 46'-60' DBH: 32.5  
Health: 80% - Good

Canopy 15-20'  
Canopy is low

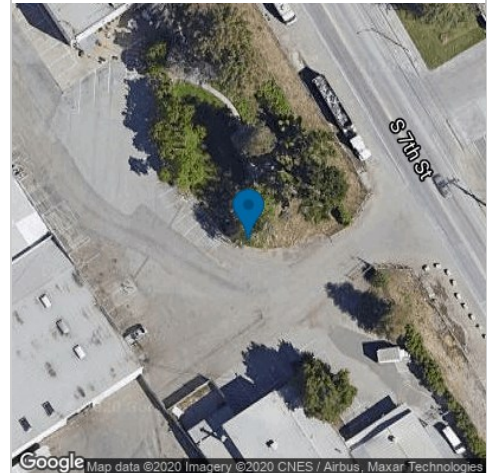
*Birch, European White* ID# 15  
*Birch, European White*  
 Height: 16'-30' DBH: 10.5  
 Health: 80% - Good

Canopy 15-20'  
 Canopy is low

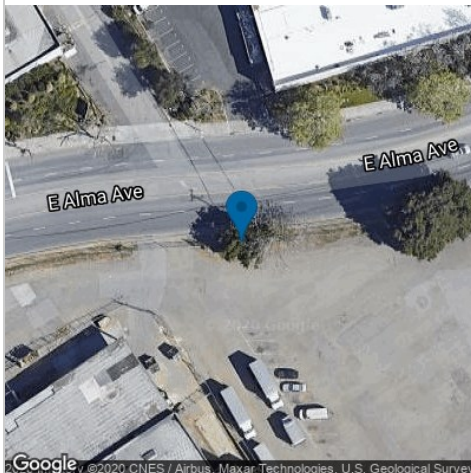
Oak, Coast Live ID# 23  
Oak, Coast Live  
Height: 1'-15' DBH: 18.5  
Health: 60% - Fair

Canopy 15-20'  
Canopy was topped due to line clearance, structure is poor

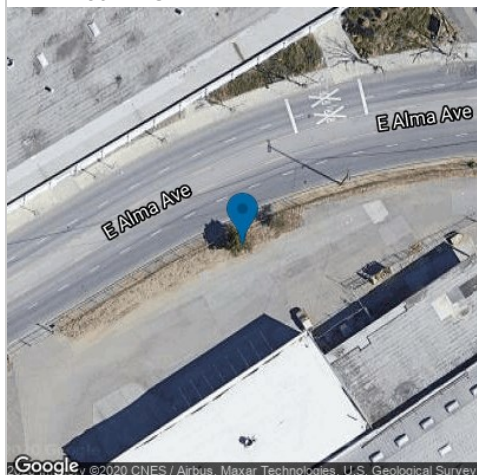
*Pear, Evergreen* ID# 27  
*Pear, Evergreen*  
Height: 16'-30' DBH: 10  
Health: 80% - Good

Canopy 5-10'  
Canopy is dense and was topped for line clearance

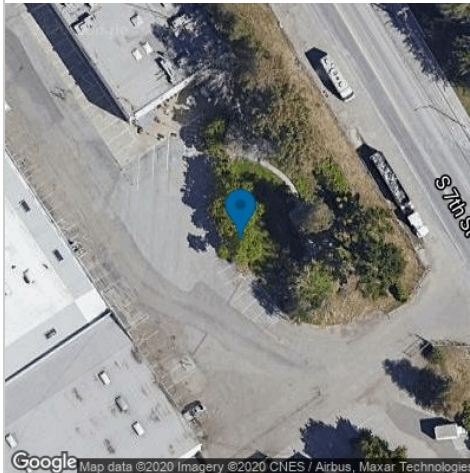
Canopy 15-20'  
Heavy limbs present
