LOS ANGELES RIVER PHASE IV BIKE PATH PROJECT

Park Tree Inventory Report

Prepared for
City of Los Angeles Department of Public Works
- Bureau of Engineering

February 2025

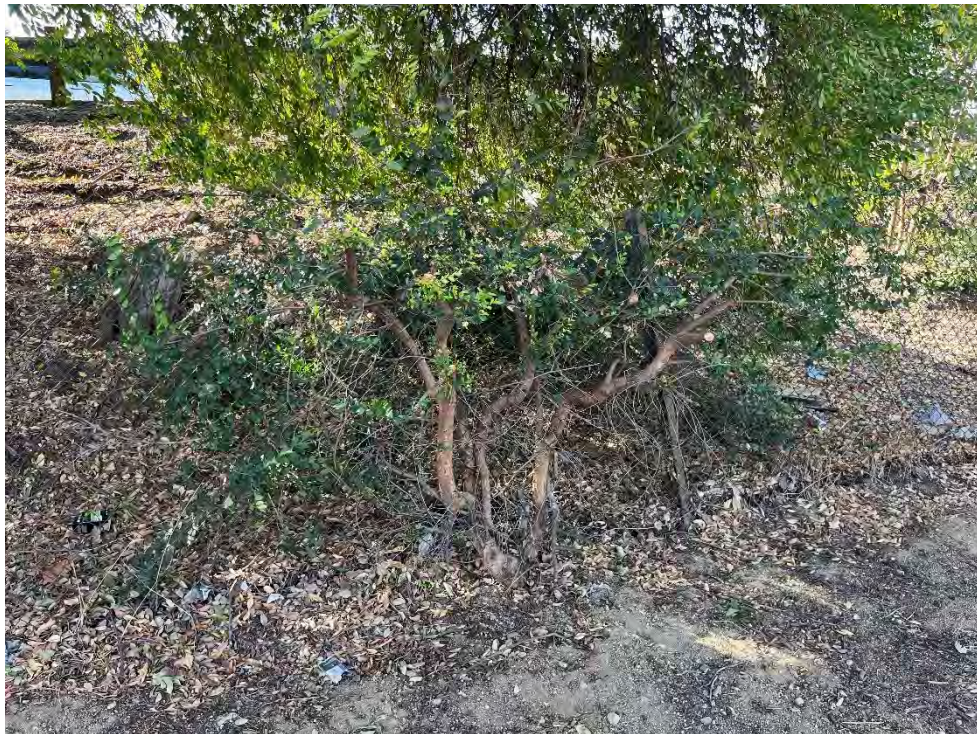
Photo 191: View of Tree Number 191, facing southwest.

191	Chinese Elm	<i>Ulmus parvifolia</i>	9, 8	16	15	18	14	12	10	12	10	10	C	C	C	C	Caltrans	Caltrans - Unprotected	Removal	
192	Chinese Elm	<i>Ulmus parvifolia</i>	2, 1.5, 1	6	3	4	3	4	5	6	4	3	D	D	D	D	Caltrans	Caltrans - Unprotected	Removal	Hacked. Fence entwined.
193	Brisbane Box	<i>Lophostemon confertus</i>	1, 1, 1.5	9	3	4	4	4	4	3	2	2	C	B	B	C	Caltrans	Caltrans - Unprotected	Not Impacted	
194	Gum	<i>Eucalyptus species</i>	7, 7	15	12	15	10	8	8	16	16	10	C	D	D	C	Caltrans	Caltrans - Unprotected	Encroached	Broken trunk on west.
195	Coast Live Oak	<i>Quercus agrifolia</i>	6, 6	16	8	10	8	8	6	6	6	6	B	C	C	B	Caltrans	Caltrans - Ordinance	Encroached	
196	Western Sycamore	<i>Platanus racemosa</i>	10	20	10	12	12	12	10	15	15	10	C	B	B	C	Caltrans	Caltrans - Ordinance	Not Impacted	
197	Brisbane Box	<i>Lophostemon confertus</i>	3	9	2	2	2	2	2	3	3	2	B	B	B	B	Caltrans	Caltrans - Unprotected	Not Impacted	
198	Blue Gum	<i>Eucalyptus globulus</i>	6, 7, 7, 8, 8, 9	23	8	9	12	12	12	14	15	10	C	C	C	C	Caltrans	Caltrans - Unprotected	Not Impacted	Topped.

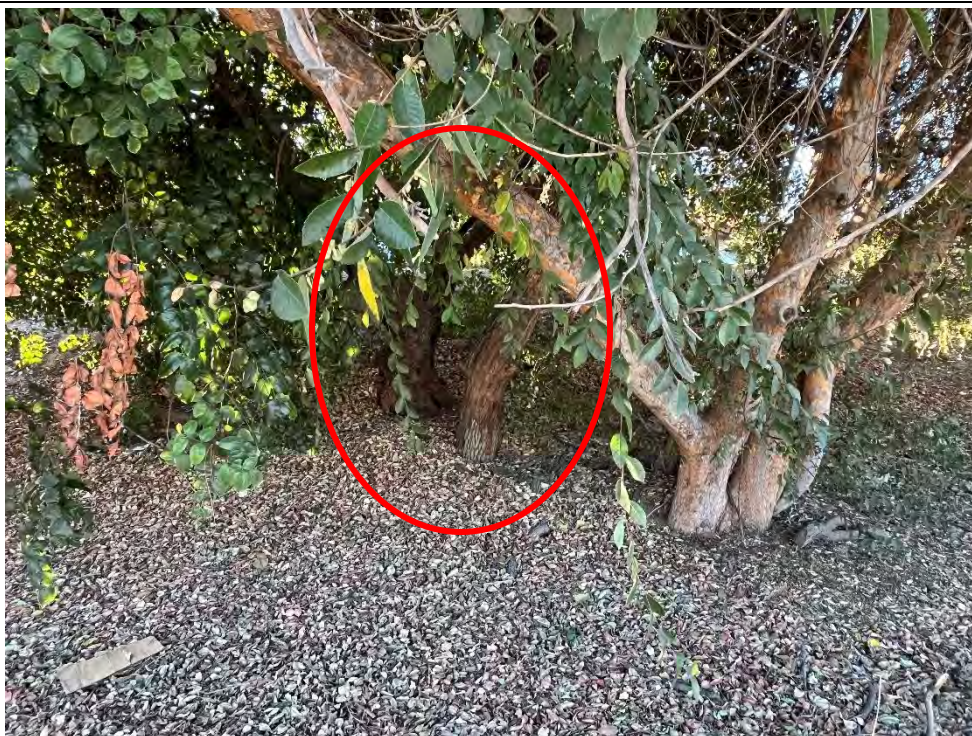
Photo 248: View of Tree Numbers 248-250 (L to R) with overlapping canopies, facing southwest.

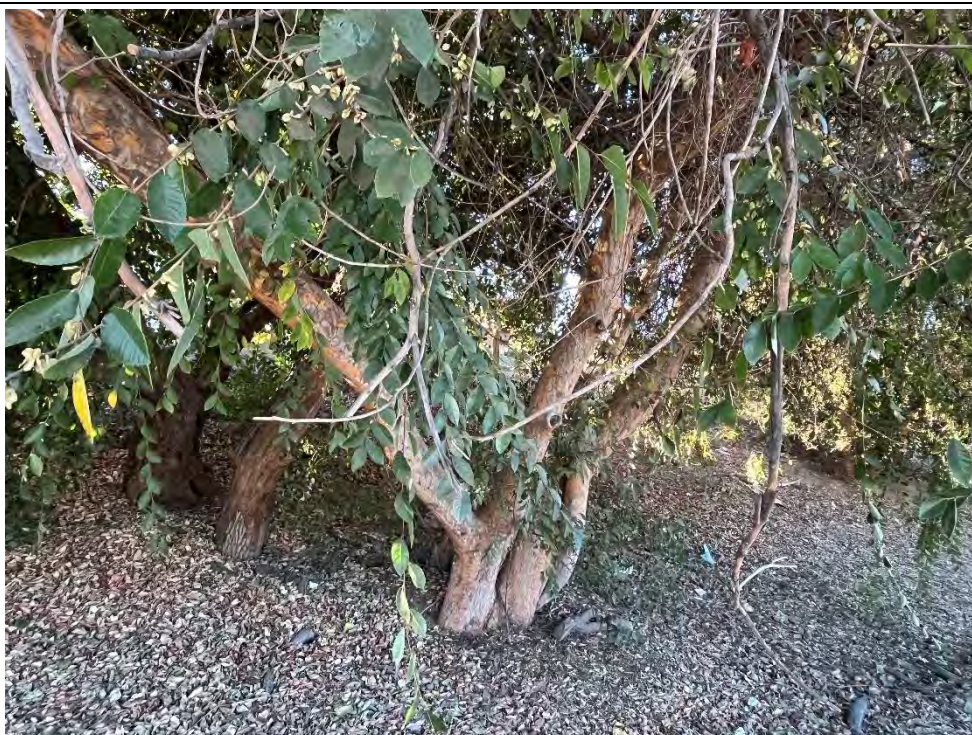
Photo 249: View of Tree Number 249, facing southwest.

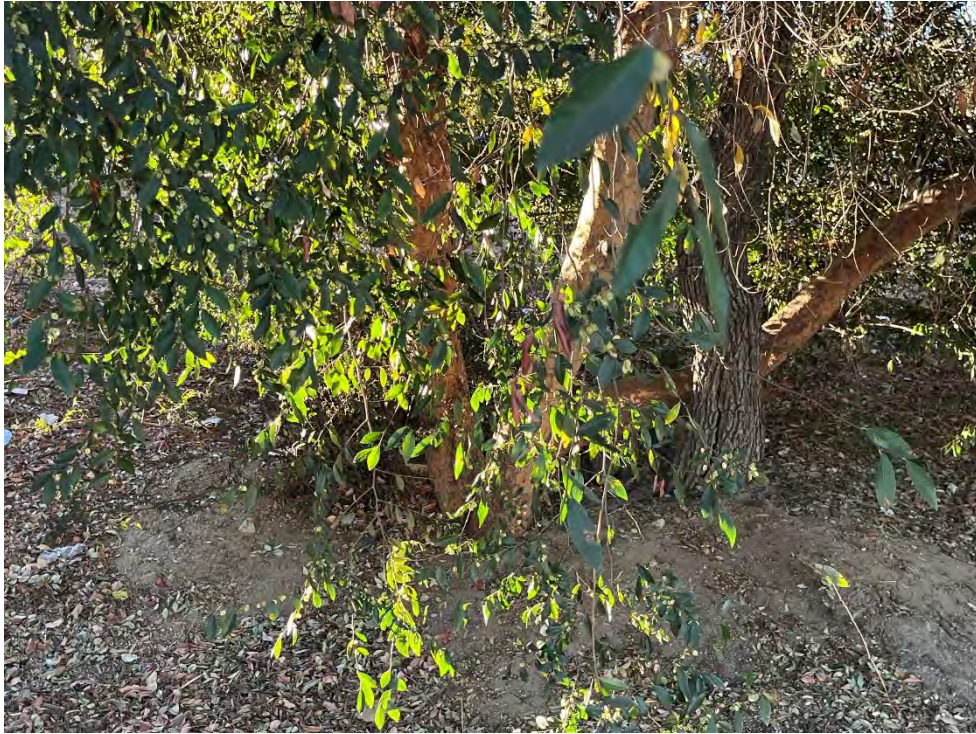
Photo 250: View of Tree Number 250, facing southwest.

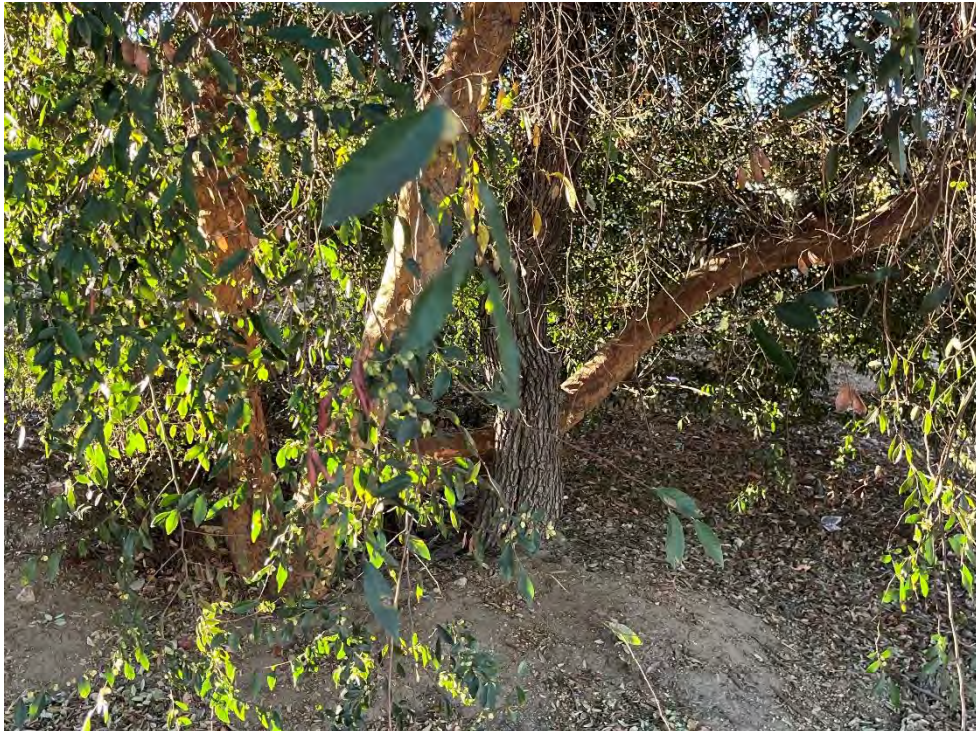
Photo 251: View of Tree Number 251, facing southwest.

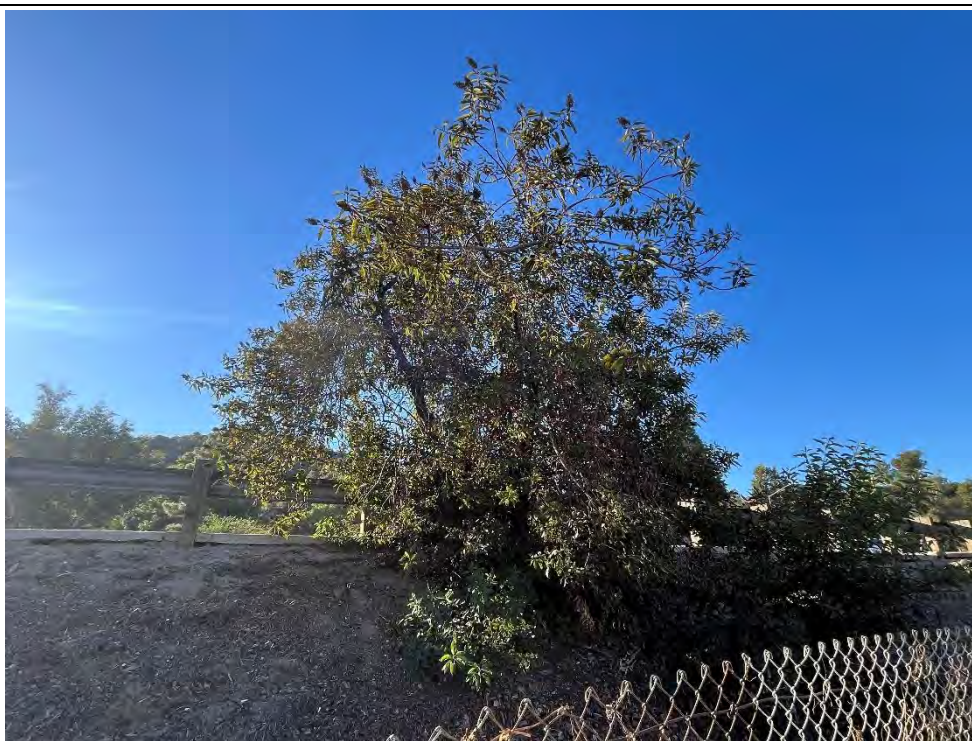
Photo 252: View of Tree Number 252, facing southwest.

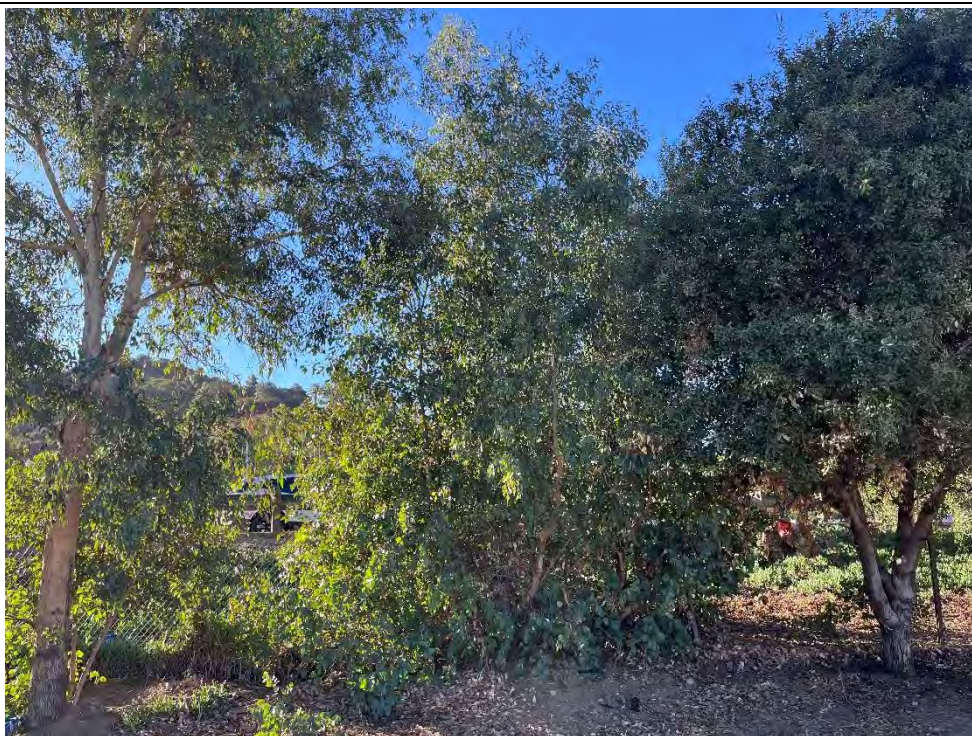
Photo 253: View of Tree Number 253, facing southwest.

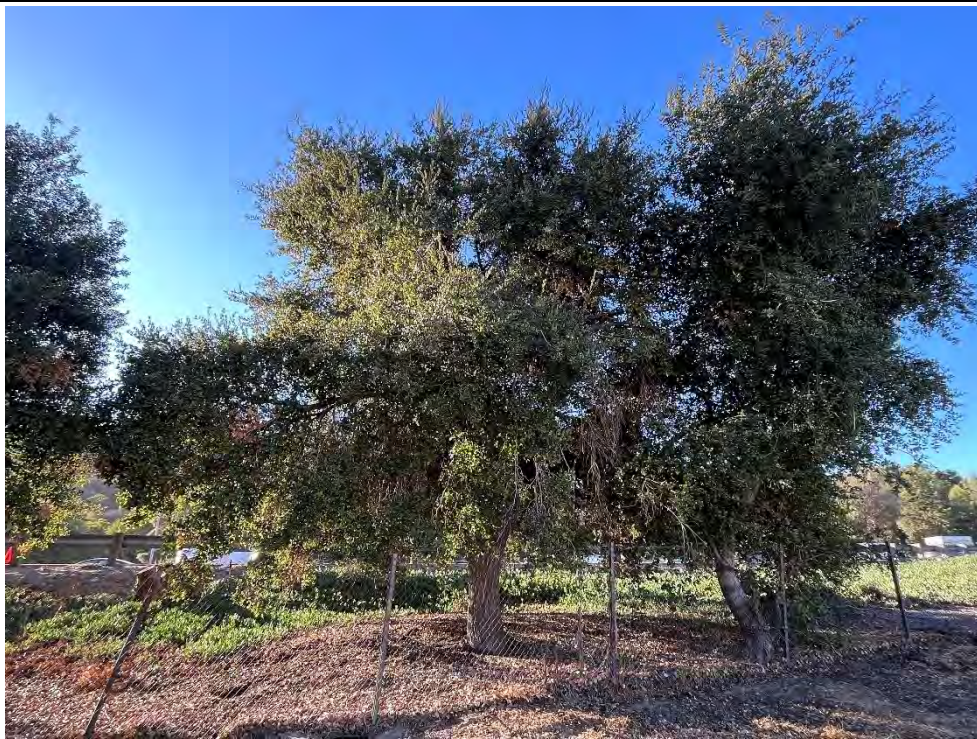
Photo 254: View of Tree Number 254, facing southwest.

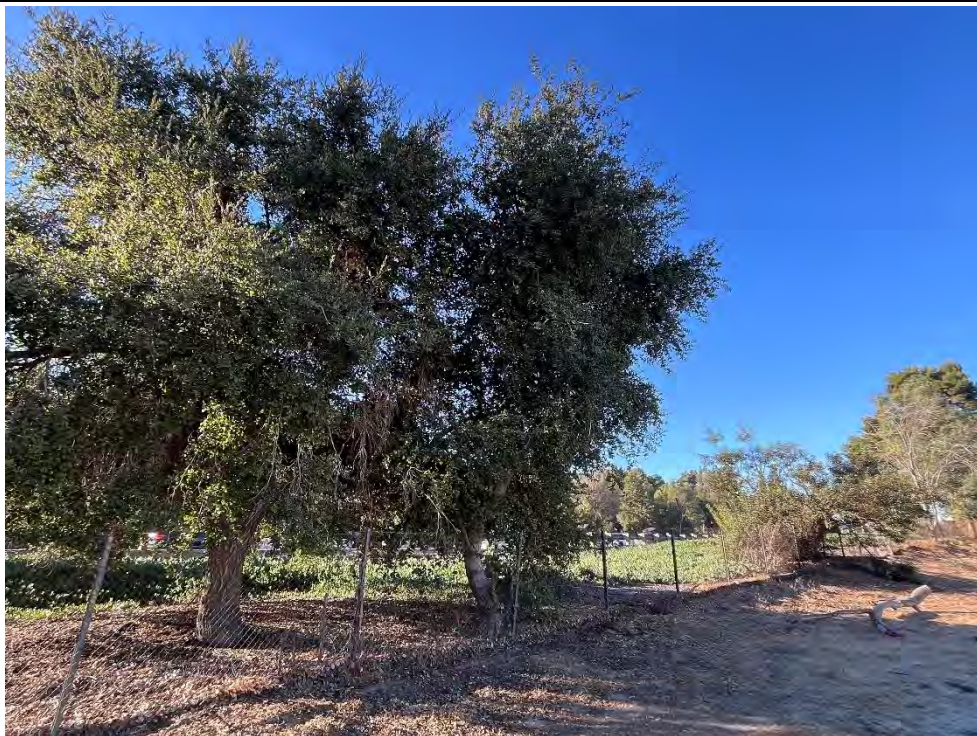
Photo 255: View of Tree Number 255, facing southwest.

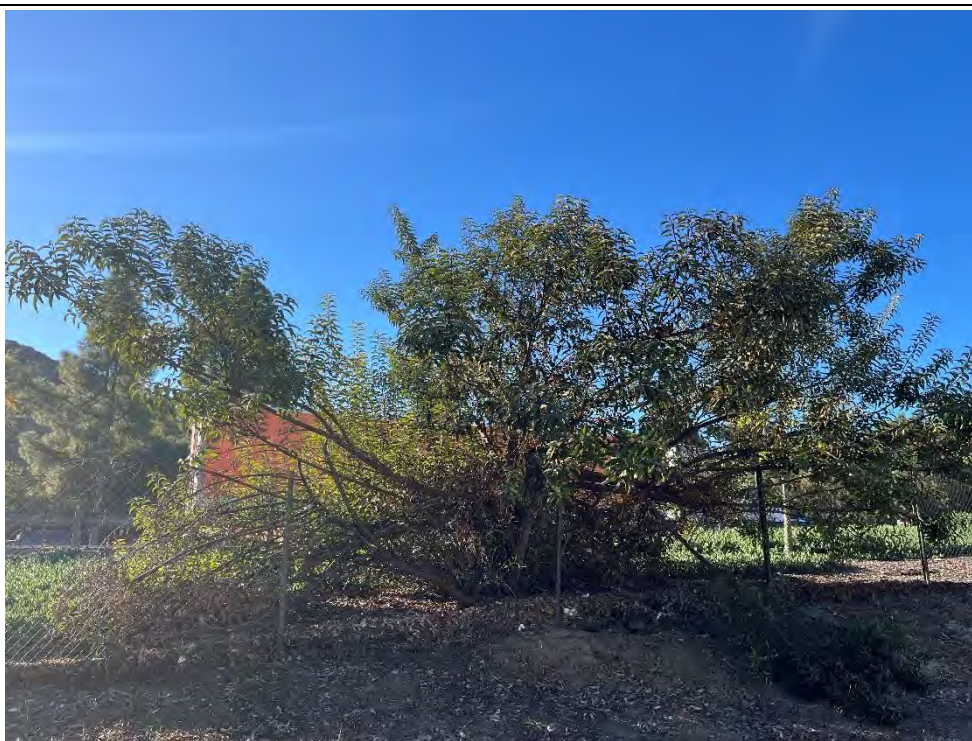
Photo 256: View of Tree Number 256, facing southwest.

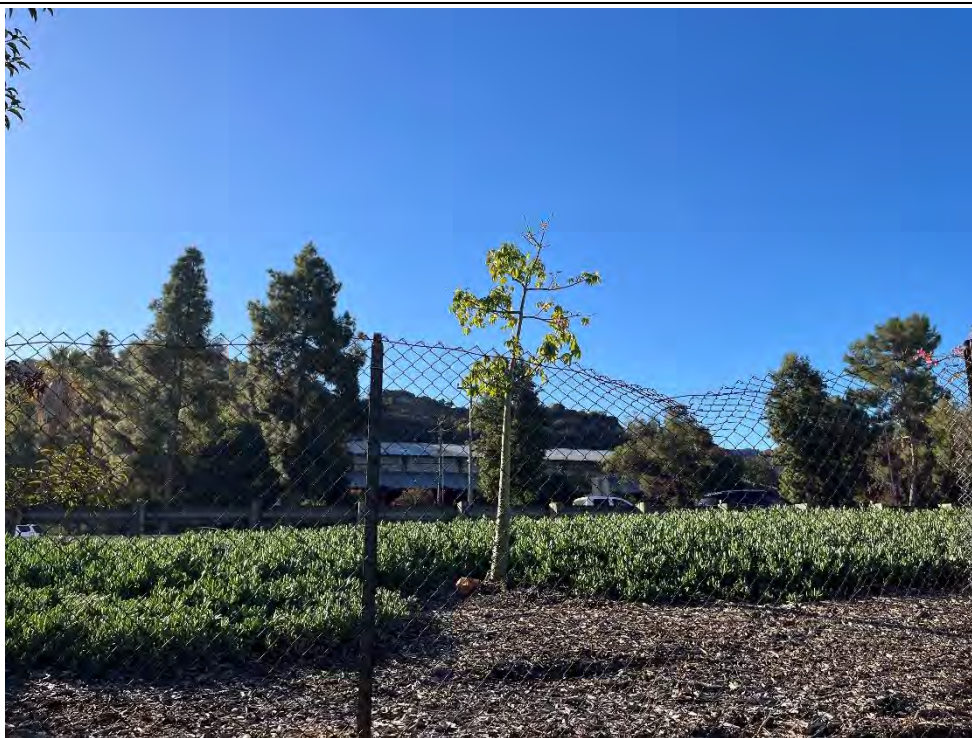
Photo 257: View of Tree Number 257, facing south.

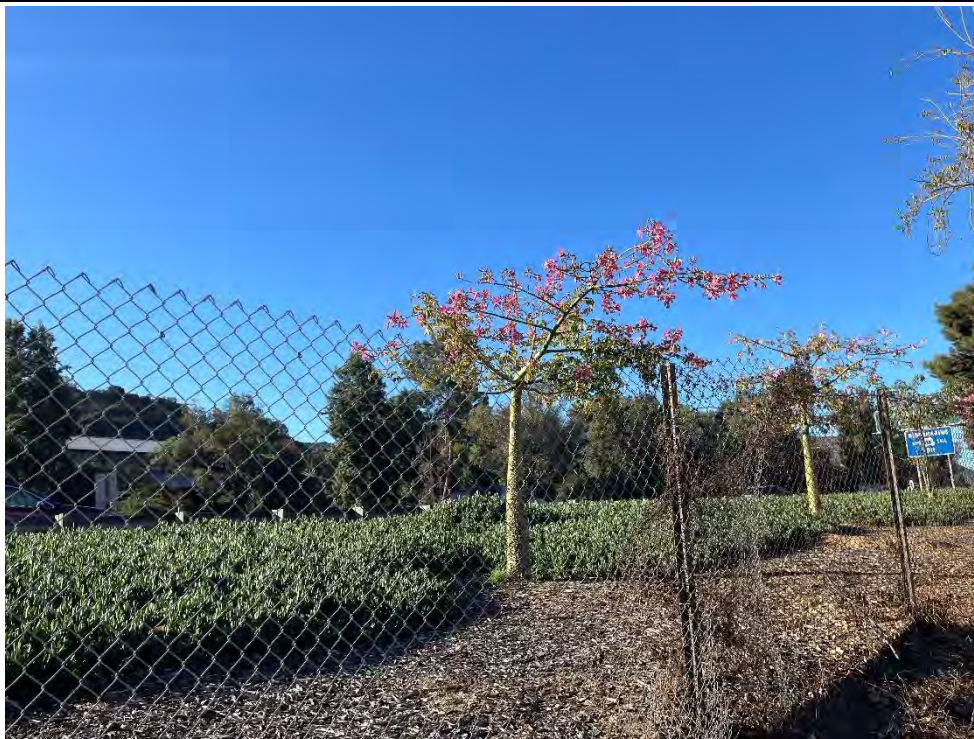
Photo 258: View of Tree Number 258, facing south.

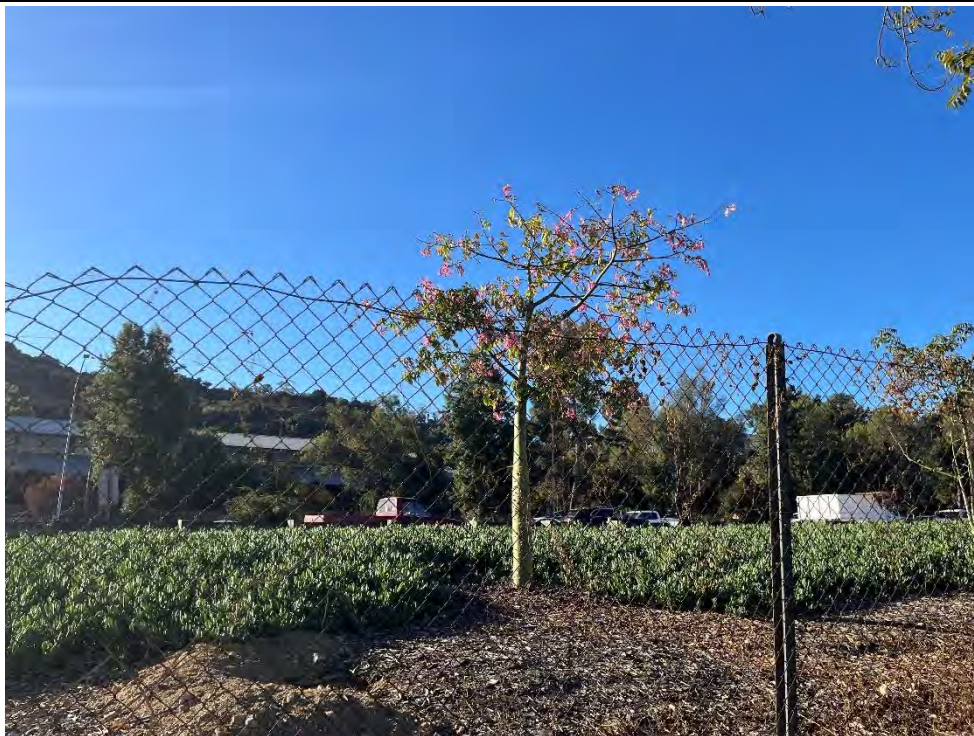
Photo 259: View of Tree Number 259, facing southwest.

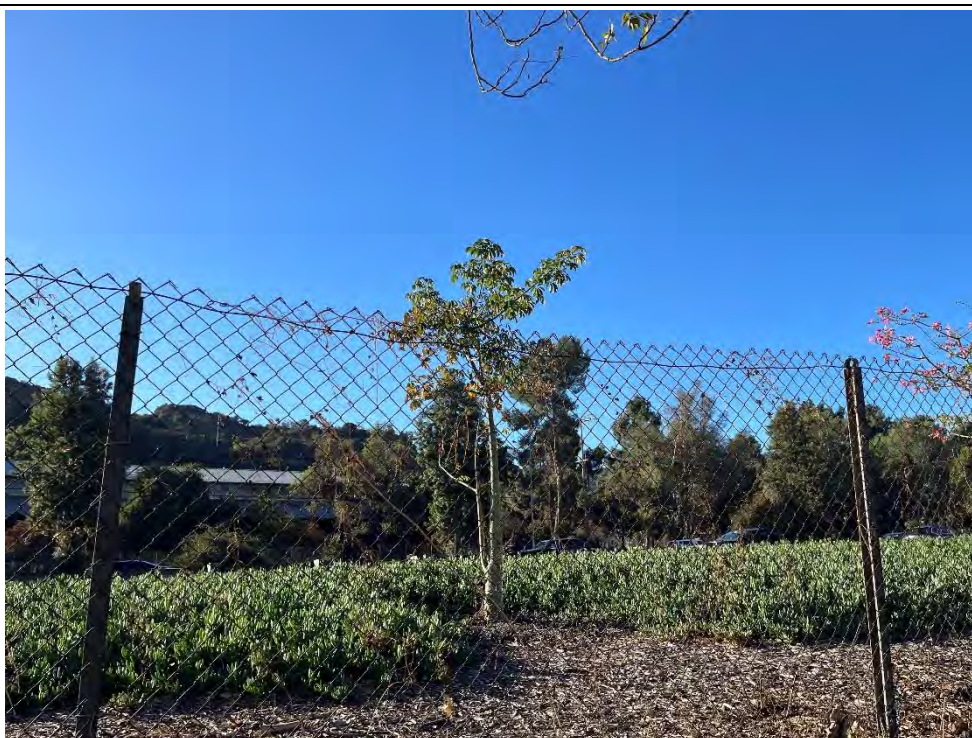
Photo 260: View of Tree Number 260, facing south.

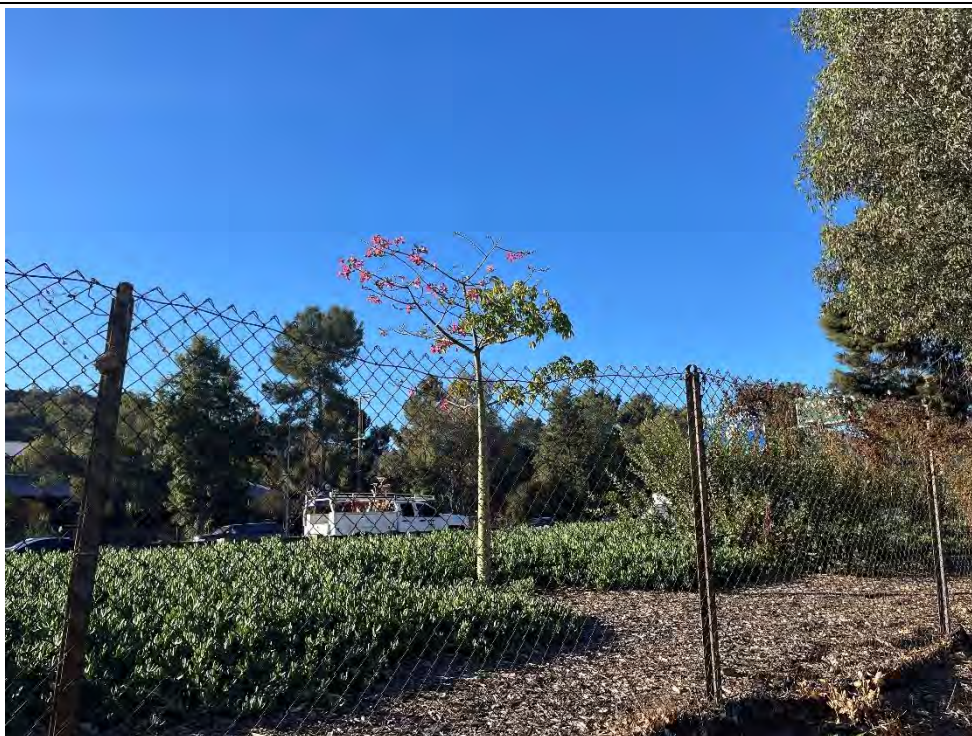
Photo 261: View of Tree Number 261, facing southwest.

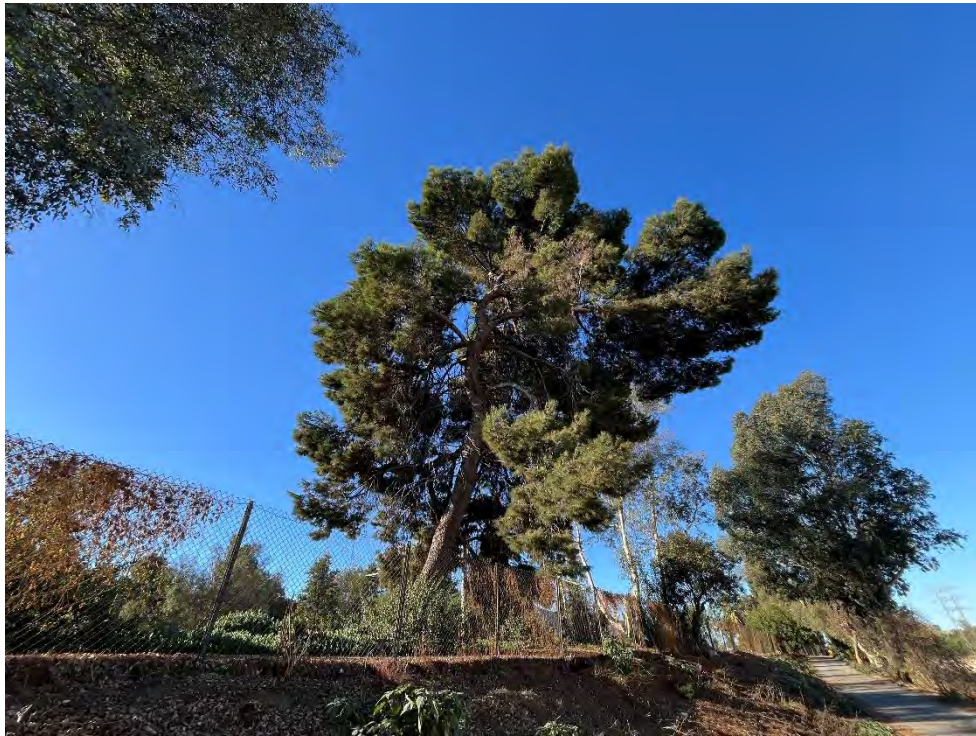
Photo 262: View of Tree Number 262, facing southwest.

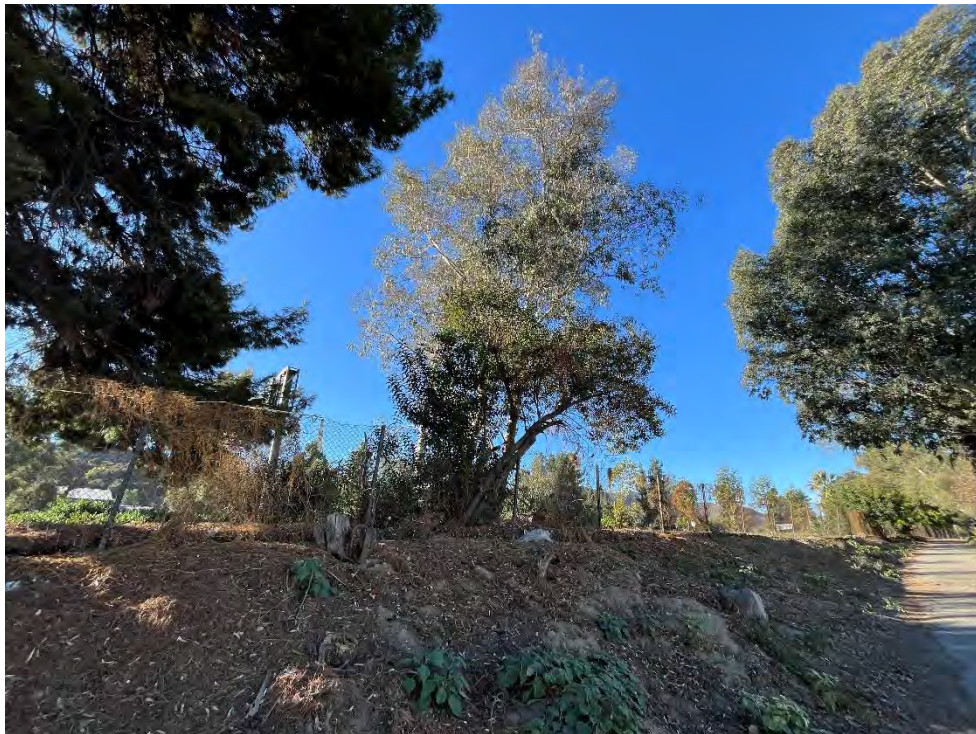
Photo 263: View of Tree Number 263, facing southwest.

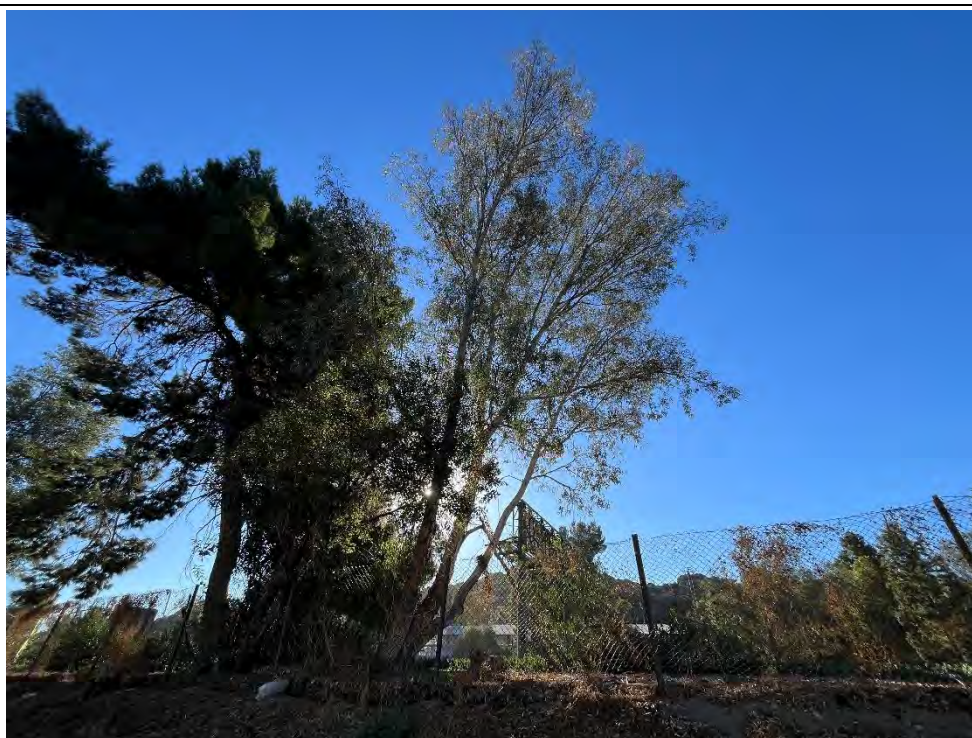
Photo 264: View of Tree Number 264, facing southwest.

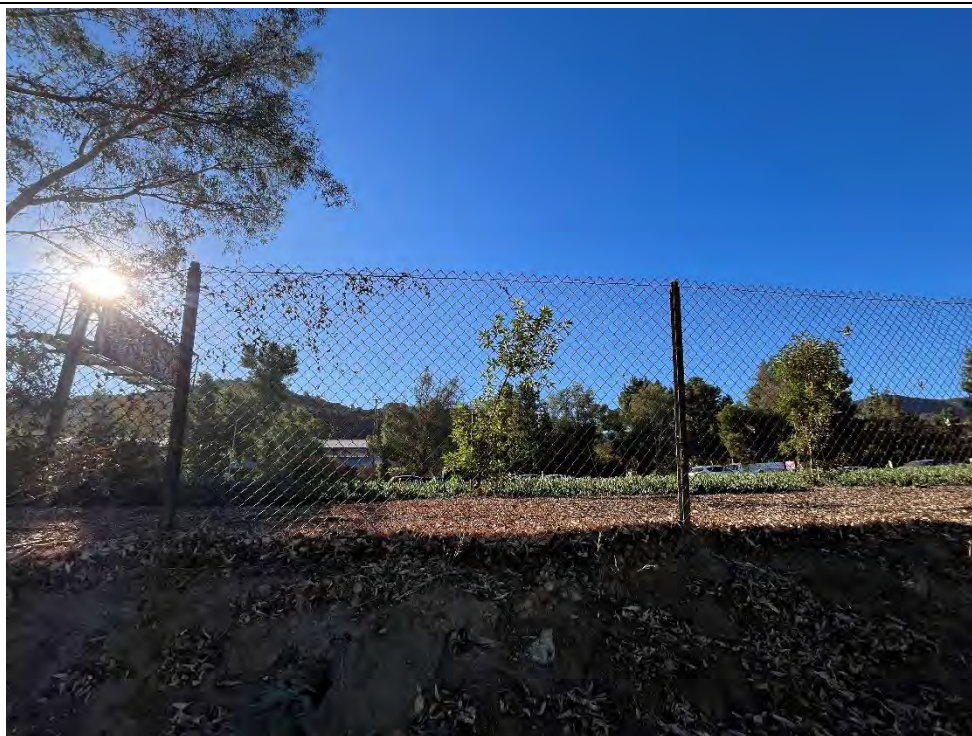
Photo 265: View of Tree Number 265, facing southeast.

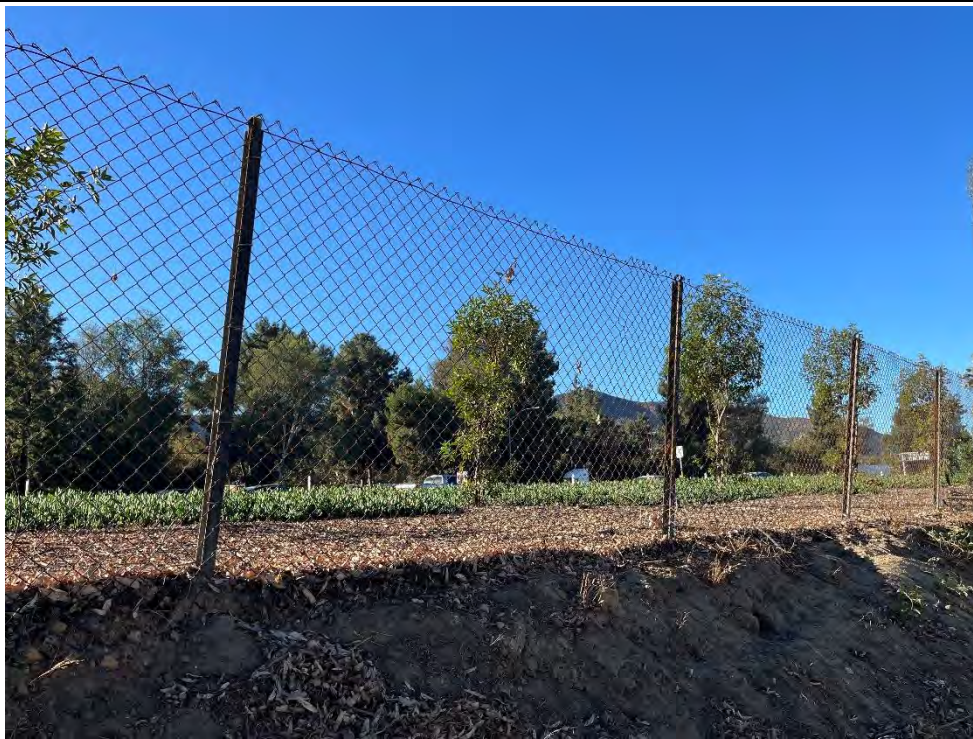
Photo 266: View of Tree Number 266, facing southeast.

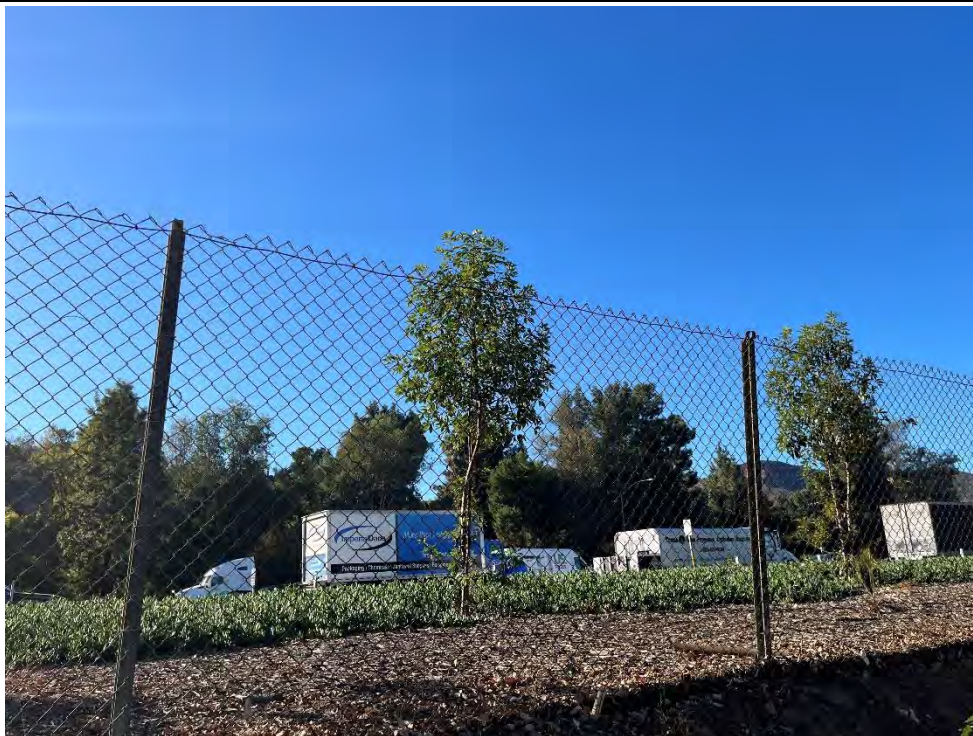
Photo 267: View of Tree Number 267, facing southwest.

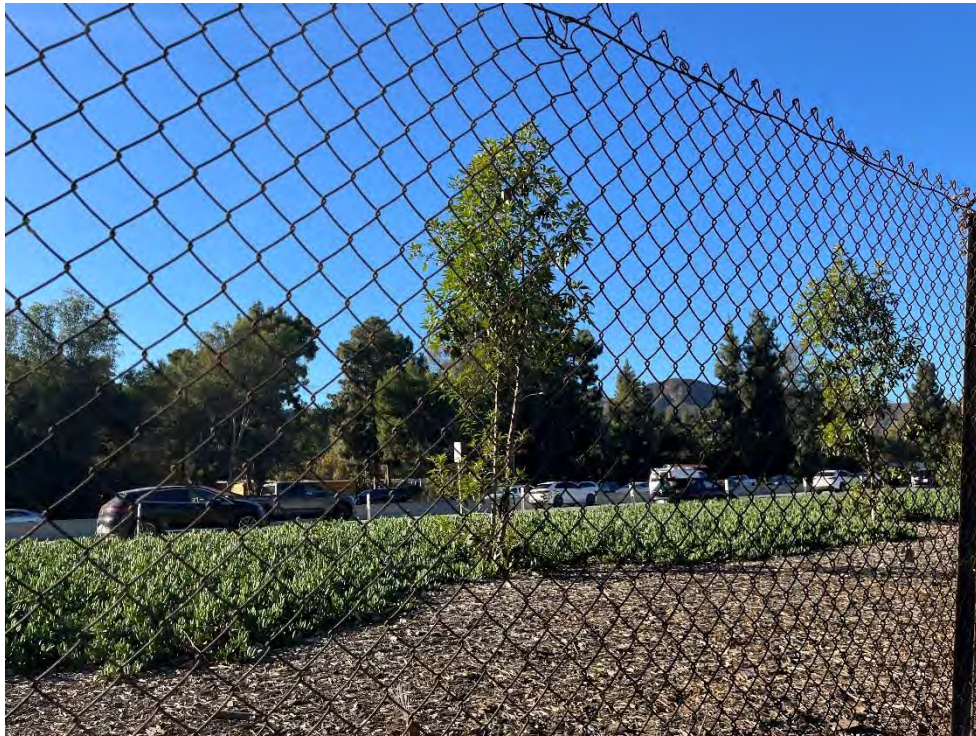
Photo 268: View of Tree Number 268, facing southwest.

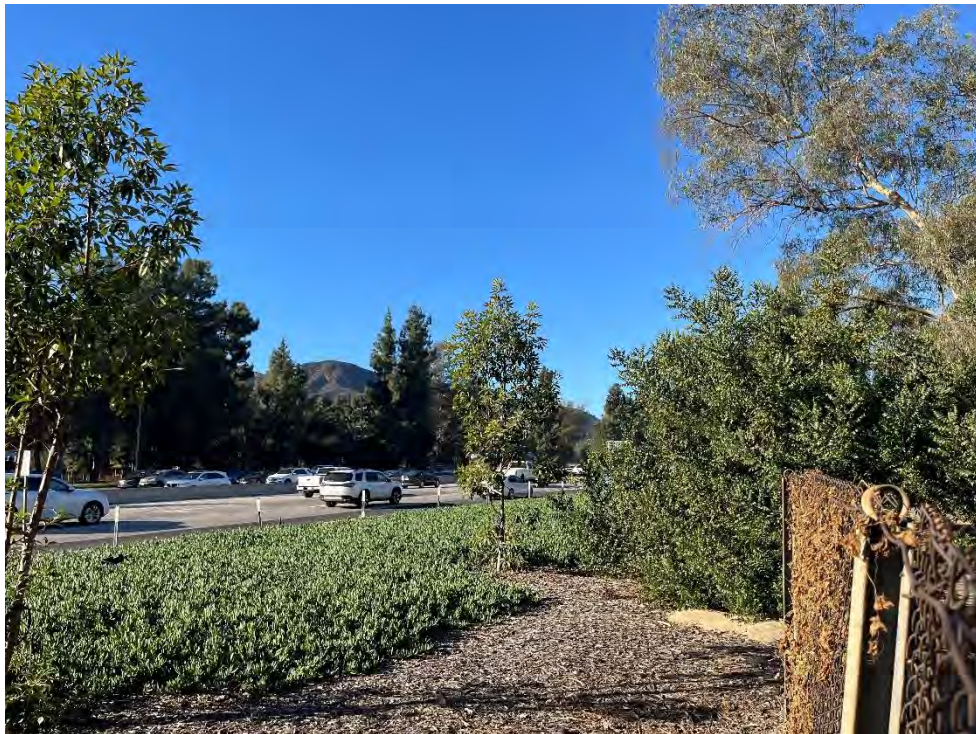
Photo 269: View of Tree Number 269, facing southwest.

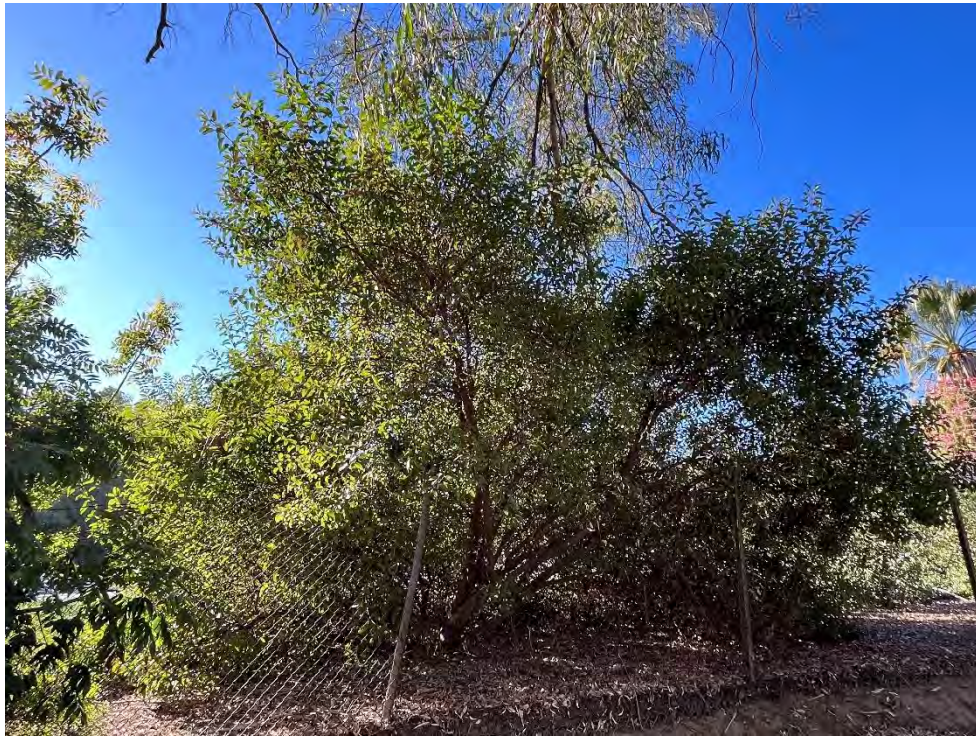
Photo 270: View of Tree Number 270, facing southwest.

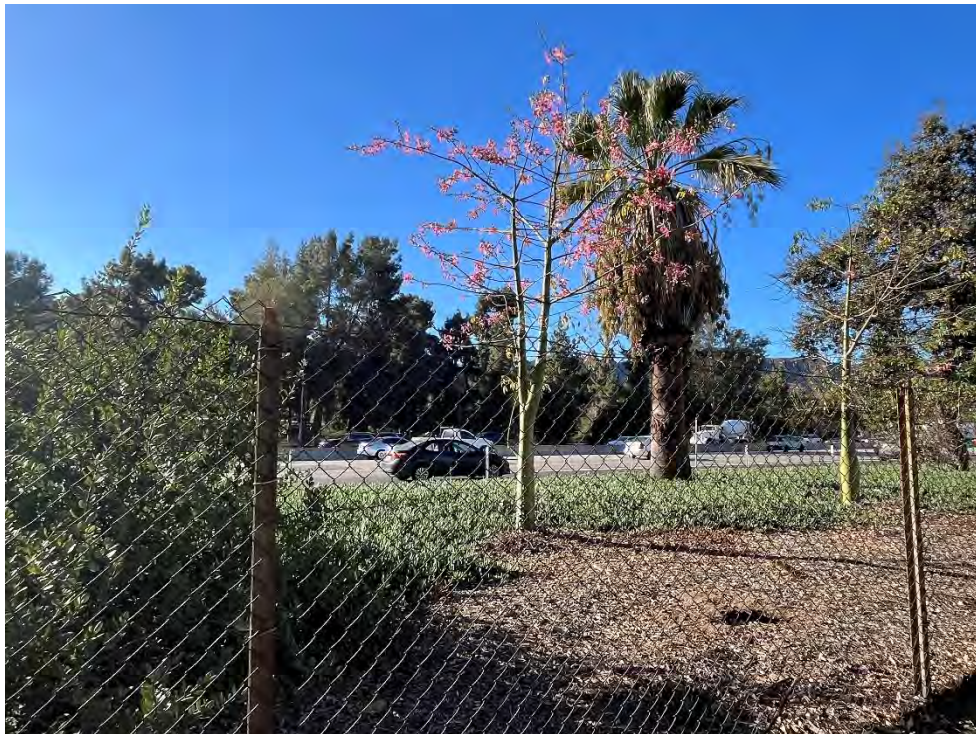
Photo 271: View of Tree Number 271, facing southwest.

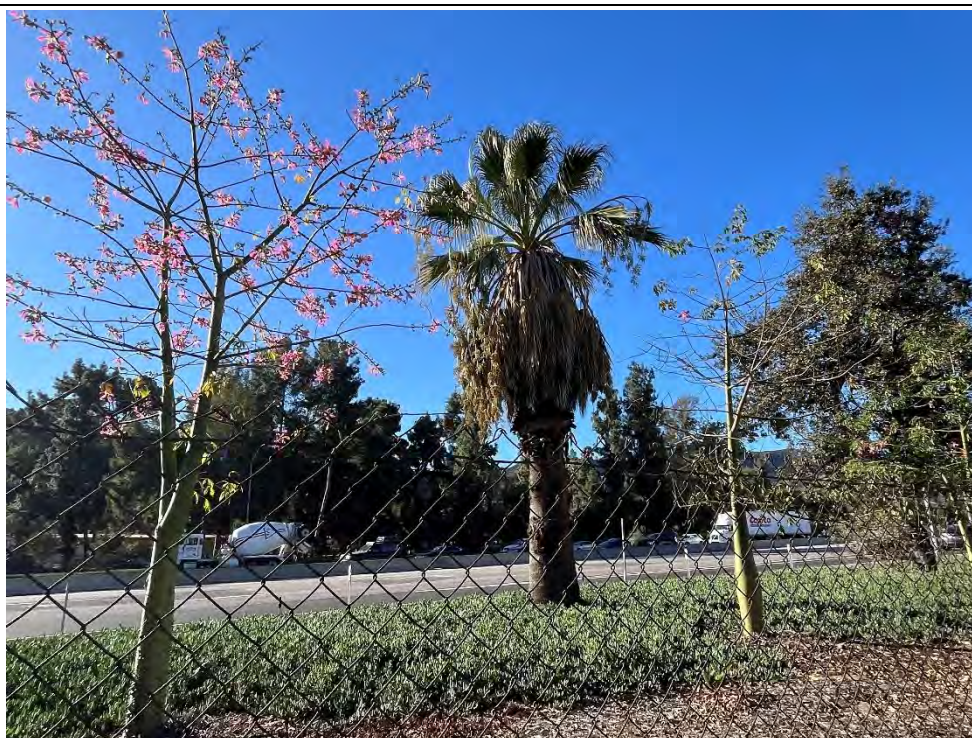
Photo 272: View of Tree Number 272, facing southwest.

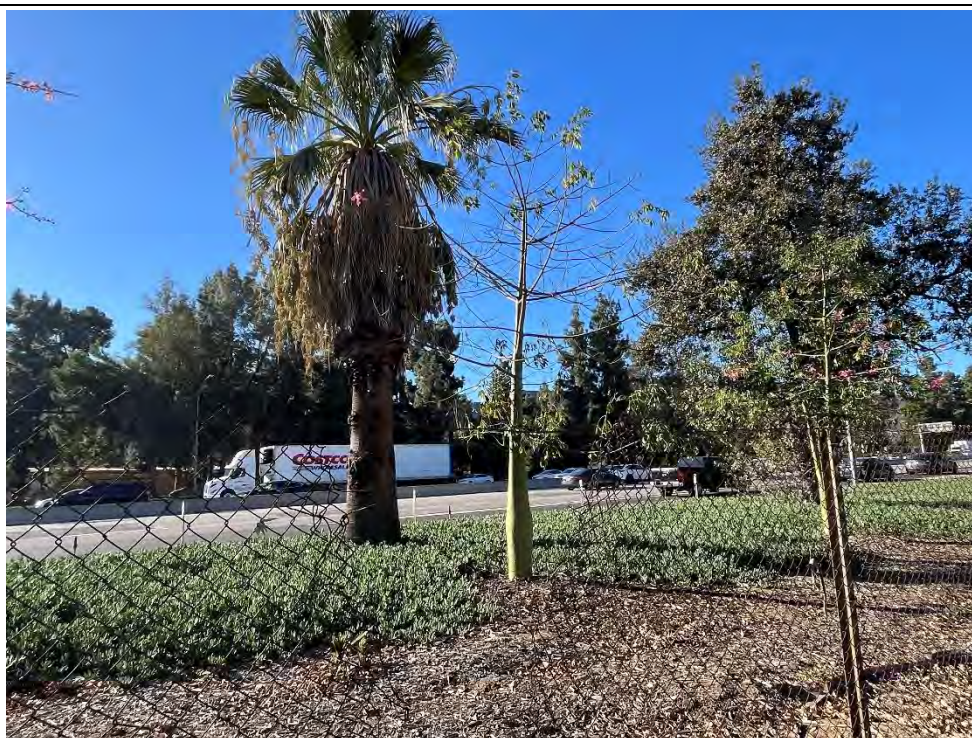
Photo 273: View of Tree Number 273, facing southwest.

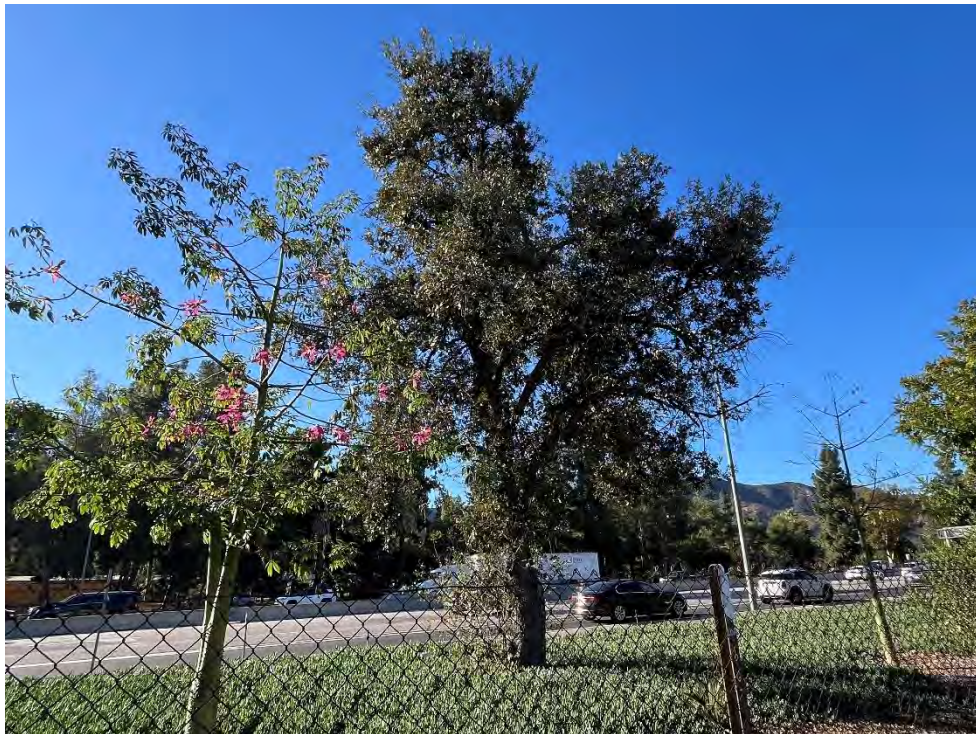
Photo 275: View of Tree Number 275, facing southwest.

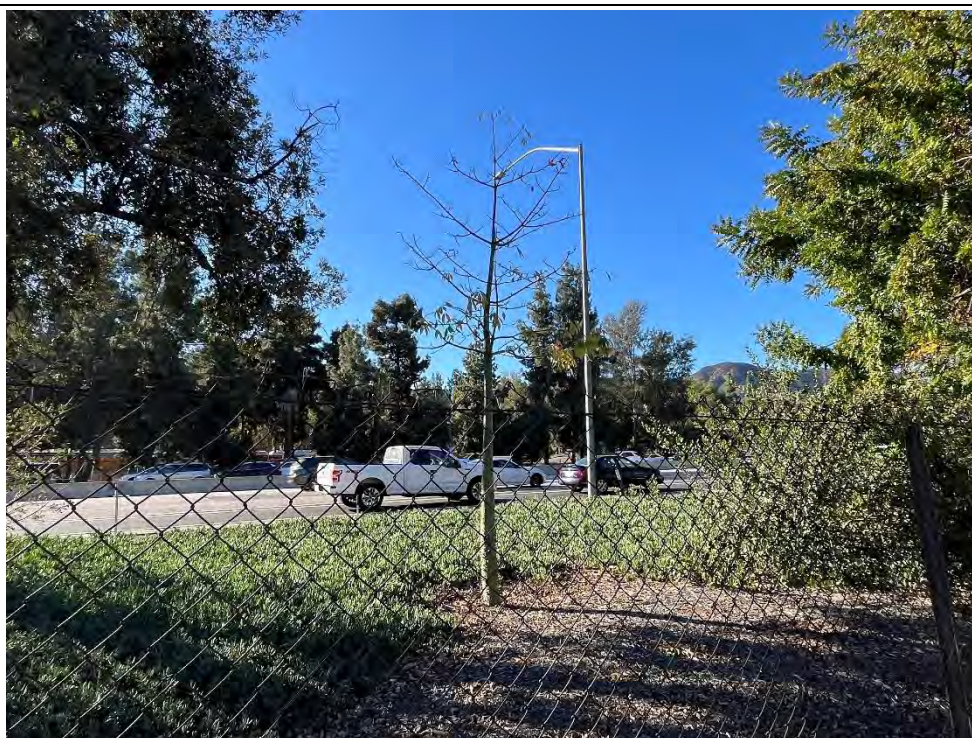
Photo 276: View of Tree Number 276, facing southwest.

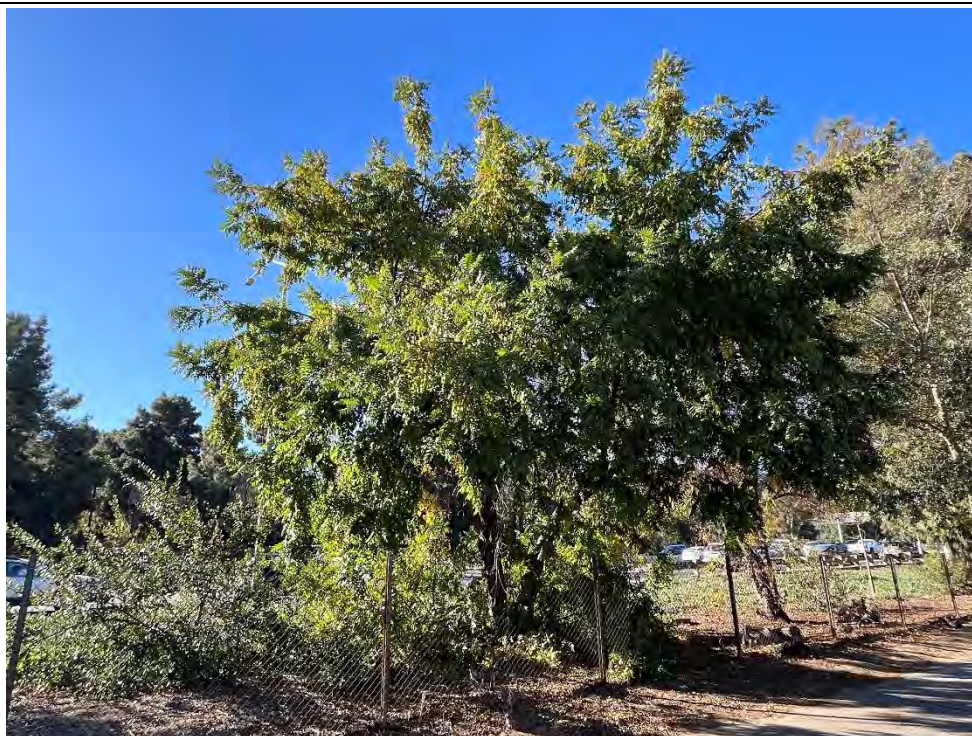
Photo 277: View of Tree Number 277, facing southwest.

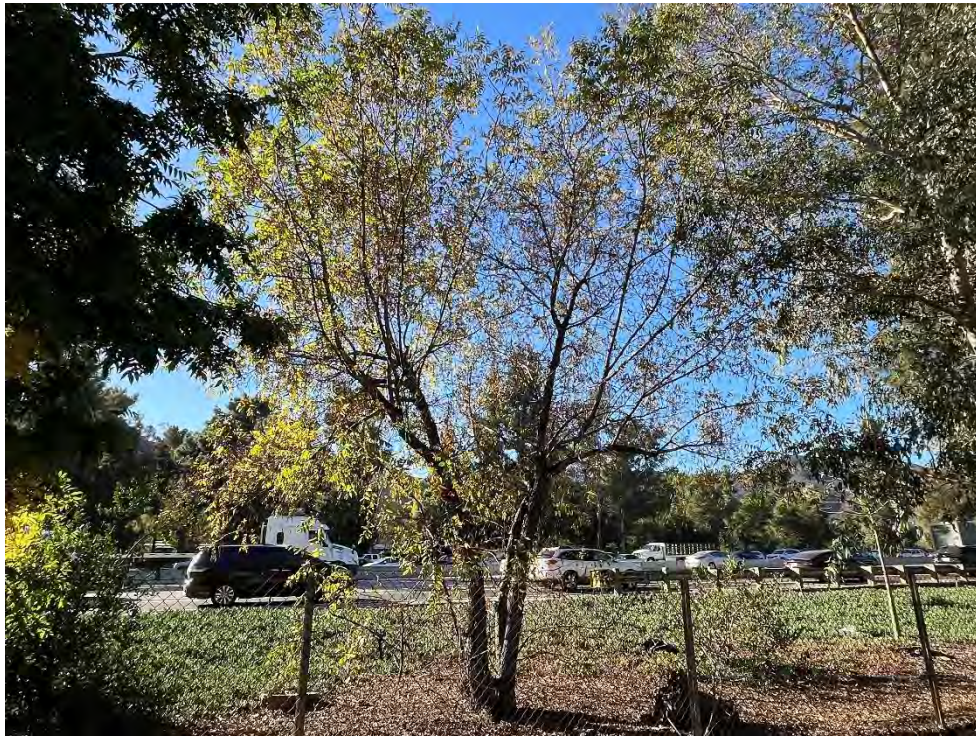
Photo 278: View of Tree Number 278, facing southwest.
