LOS ANGELES RIVER PHASE IV BIKE PATH PROJECT

Park Tree Inventory Report

Prepared for
City of Los Angeles Department of Public Works
- Bureau of Engineering

February 2025

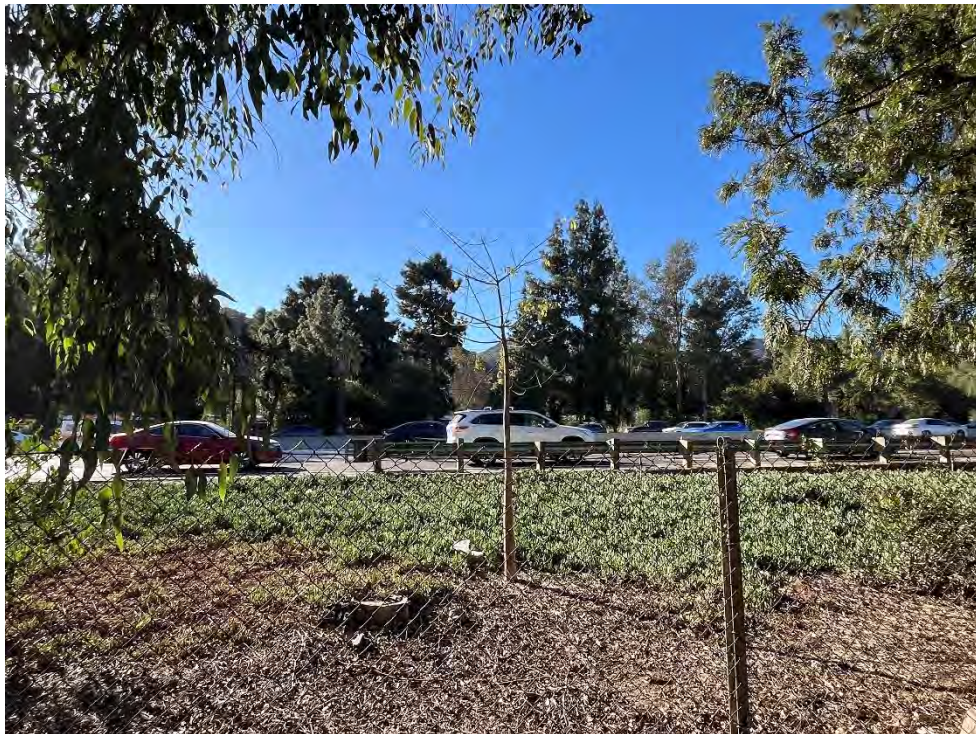
Photo 279: View of Tree Number 279, facing southwest.

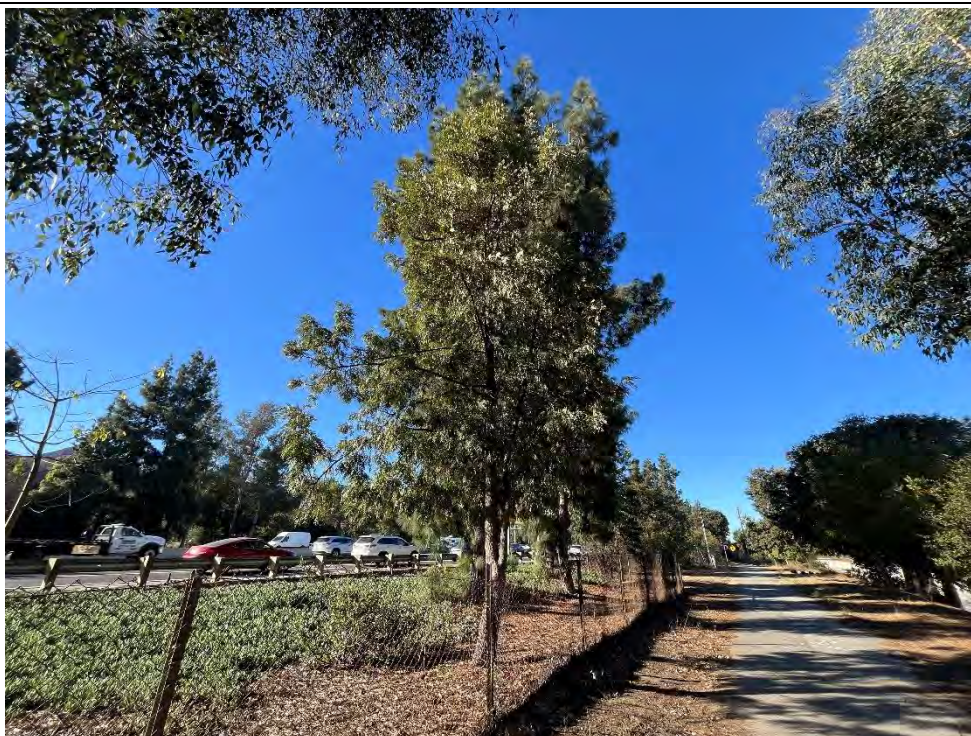
Photo 280: View of Tree Number 280, facing south.

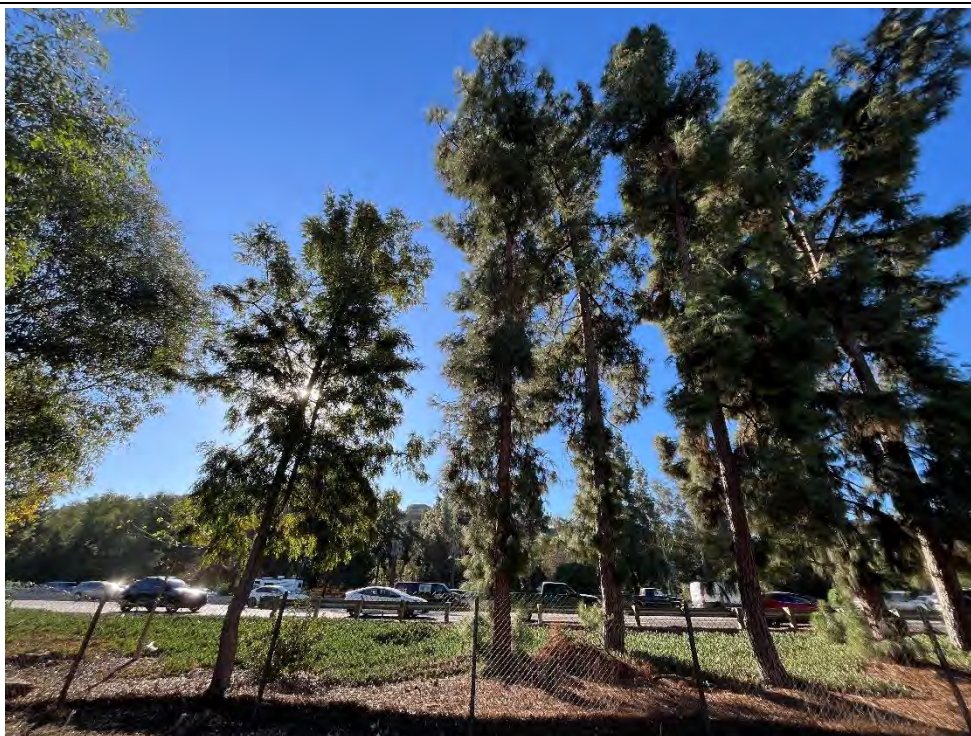
Photo 281: View of Tree Number 281, facing southwest.

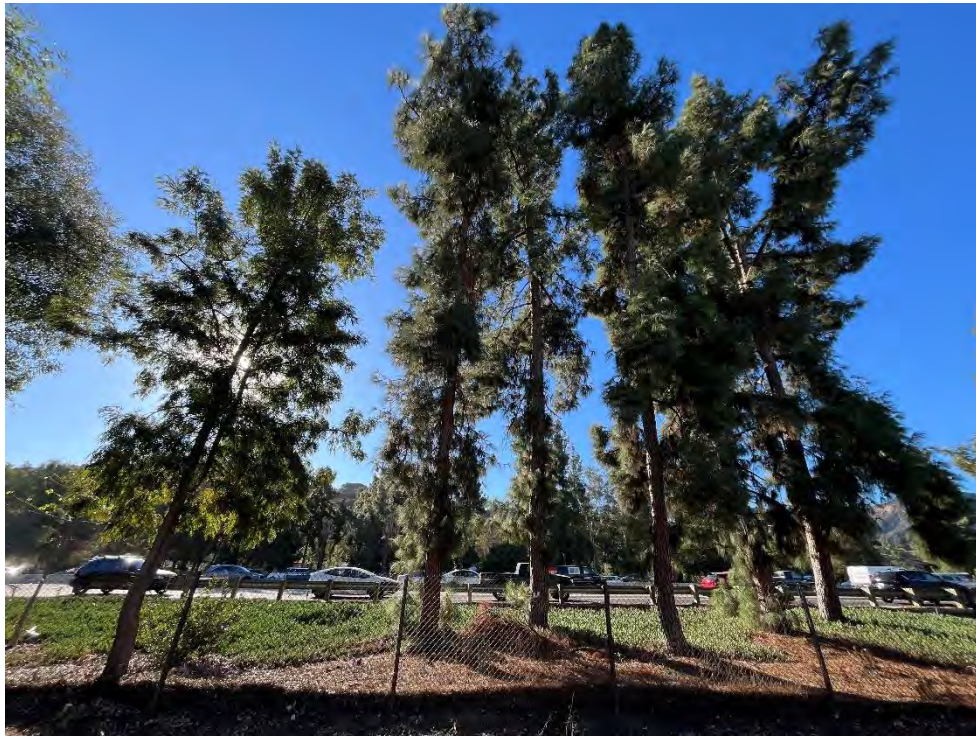
Photo 282: View of Tree Number 282, facing south.

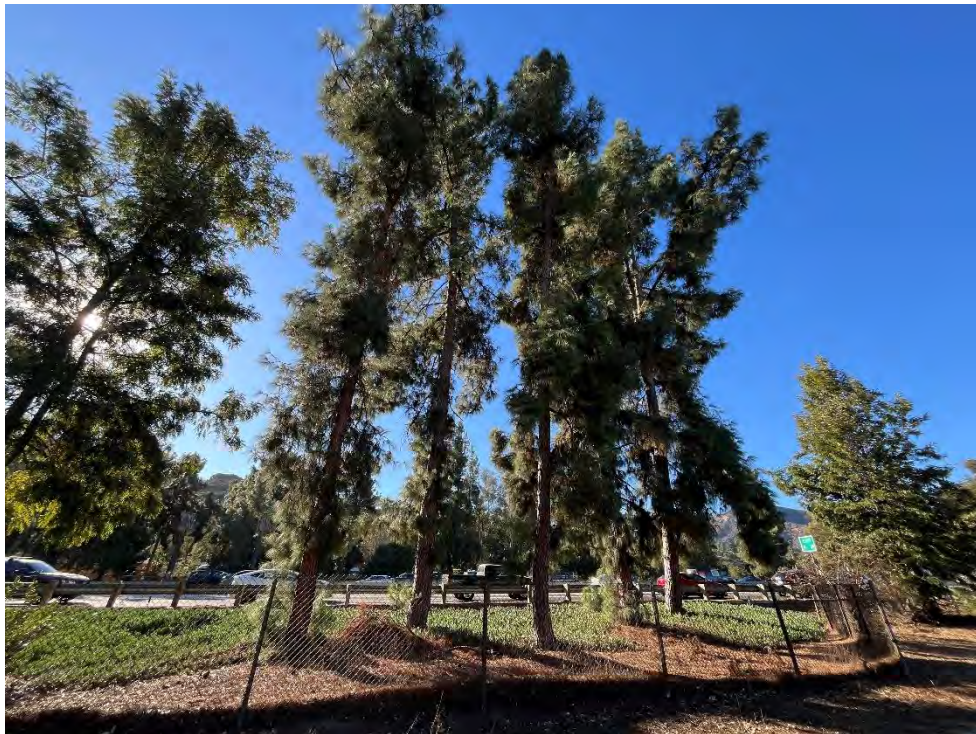
Photo 283: View of Tree Number 283, facing south.

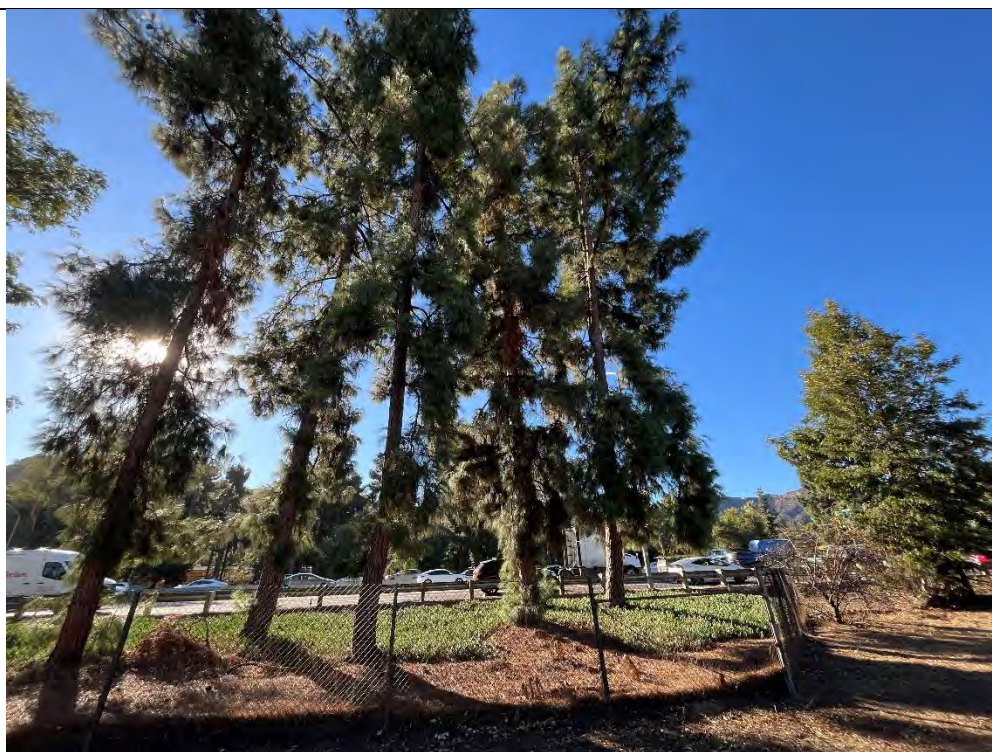
Photo 284: View of Tree Number 284, facing southwest.

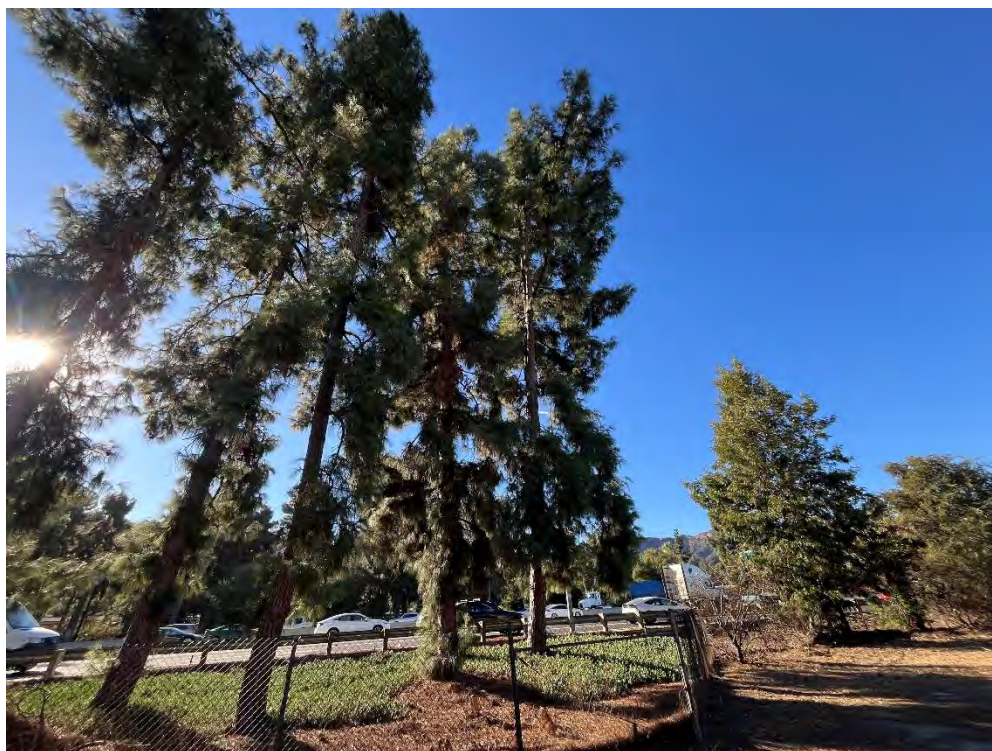
Photo 285: View of Tree Number 285, facing southwest.

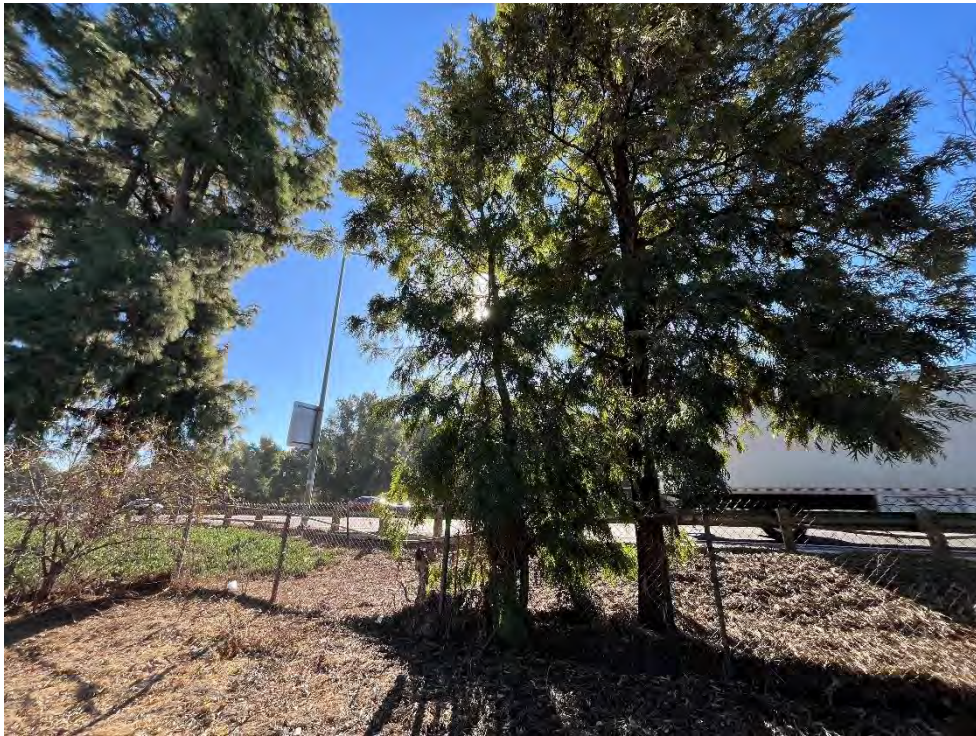
Photo 286: View of Tree Number 286, facing southwest.

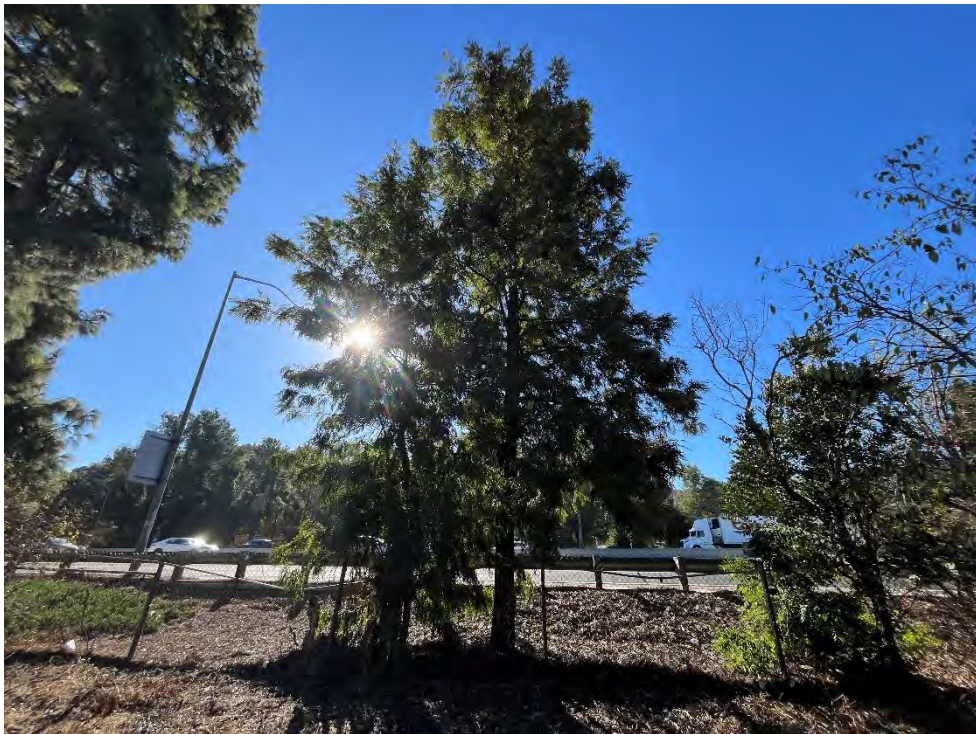
Photo 287: View of Tree Number 287, facing southeast.
